## **Inspection Report**

**To:** Bill McGraw (Cheswick Generating Station)  
**From:** Richard Southorn, P.E., P.G.  
**Re:** Cheswick Ash Disposal Site – Annual CCR Unit Inspection Report  
**Inspection Date:** November 12, 2020  
**Report Date:** January 15, 2021

**Project: Cheswick Landfill 2020 Annual Inspection**

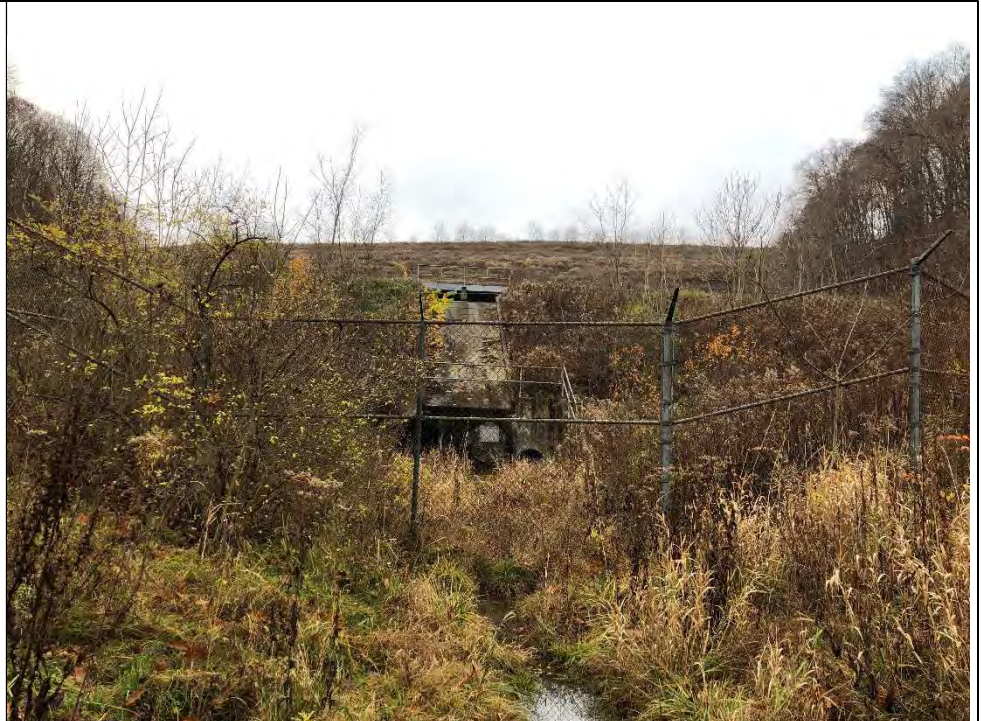
Image: 7990  
Date: 11/12/2020  
Time: 7:06 AM  
Direction: West

View of Sedimentation Pond spillway. Clear of debris. Landfill is in background.

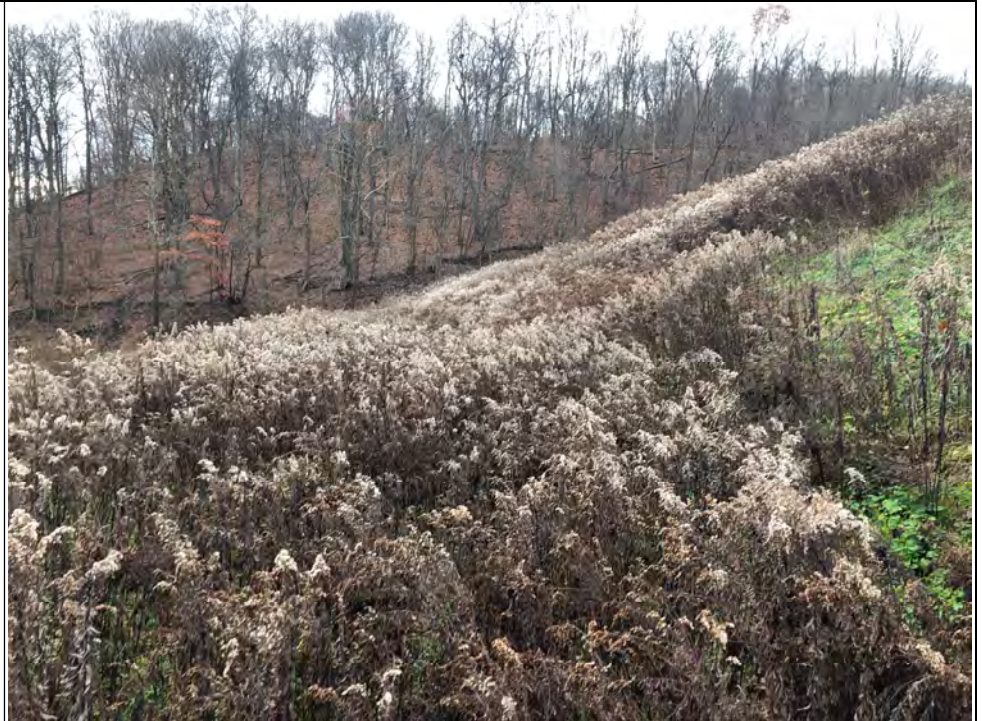
Image: 8020  
Date: 11/12/2020  
Time: 7:19 AM  
Direction: South-Southeast

Vegetation is healthy and present across the entire sideslope. No evidence of erosion, sloughing, or indications of stability issues.

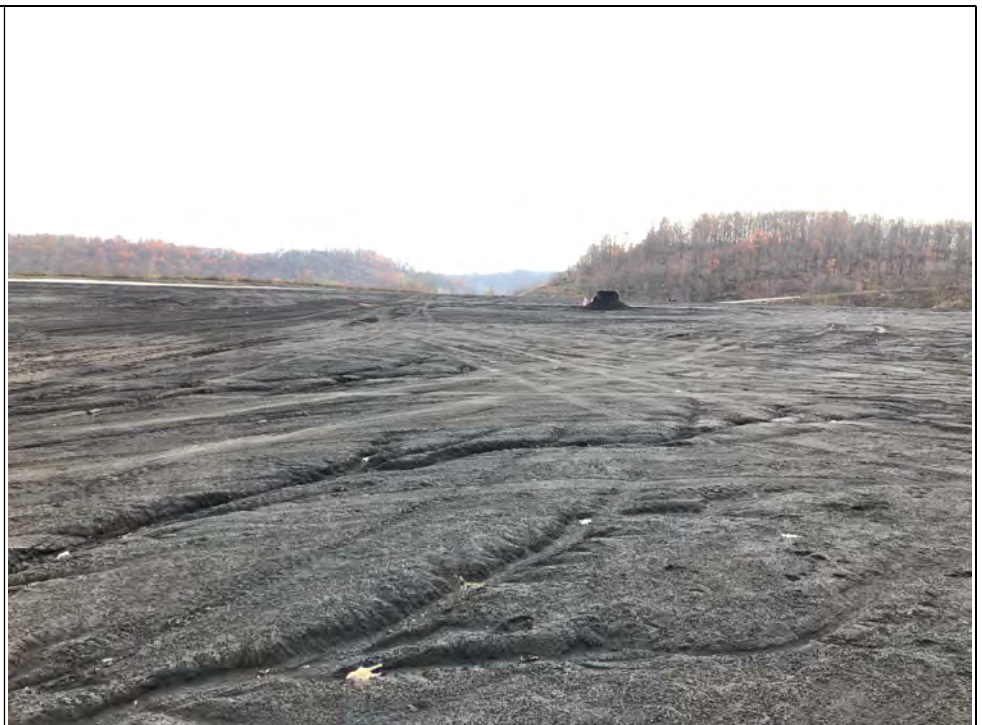
Image: 8030  
Date: 11/12/2020  
Time: 7:37 AM  
Direction: East-Southeast

Active area. Material is placed in even lifts that are spread and compacted. Some erosion ruts and rills have formed on the active face due to recent rains, but do not affect stability or safety of the landfill.

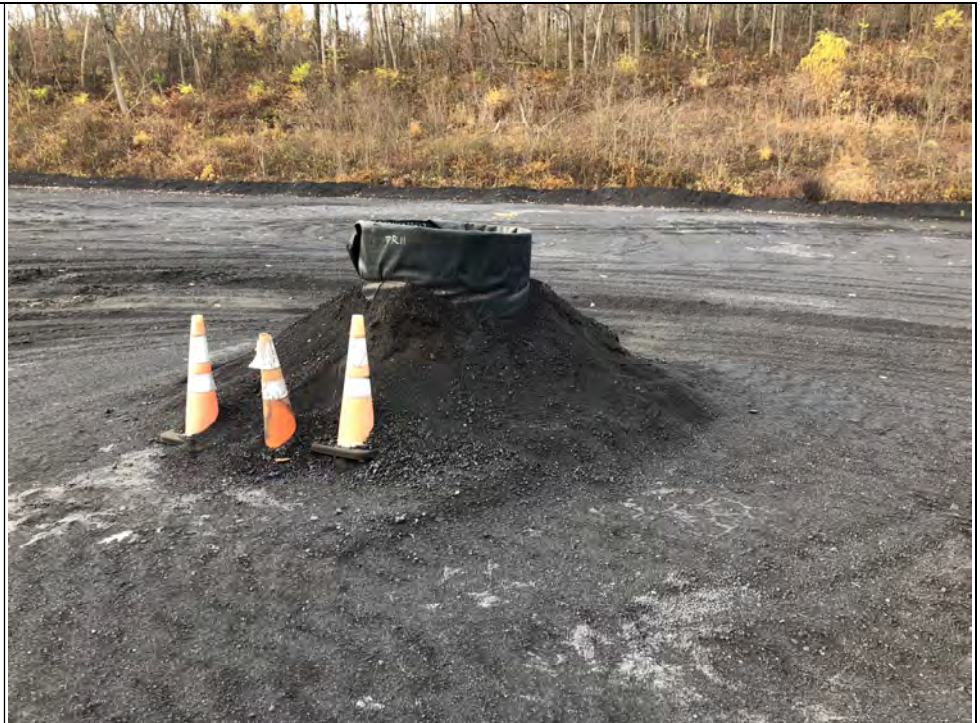
Image: 8032  
Date: 11/12/2020  
Time: 7:38 AM  
Direction: Southwest

A perforated contact stormwater (leachate) riser is shown. This riser is wrapped in filter fabric and surrounded with bottom ash. It will be extended prior to additional CCR material placement.

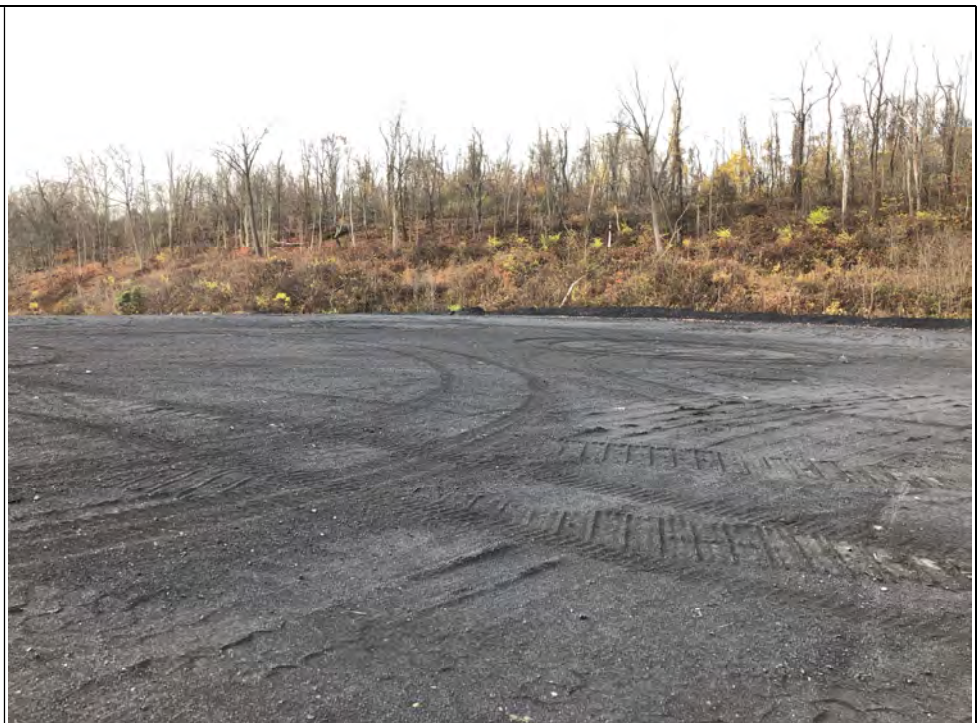
Image: 8034  
Date: 11/12/2020  
Time: 7:38 AM  
Direction: Southwest

The active area is well maintained with no ponding water. CCR material is spread and rolled shortly after being received.

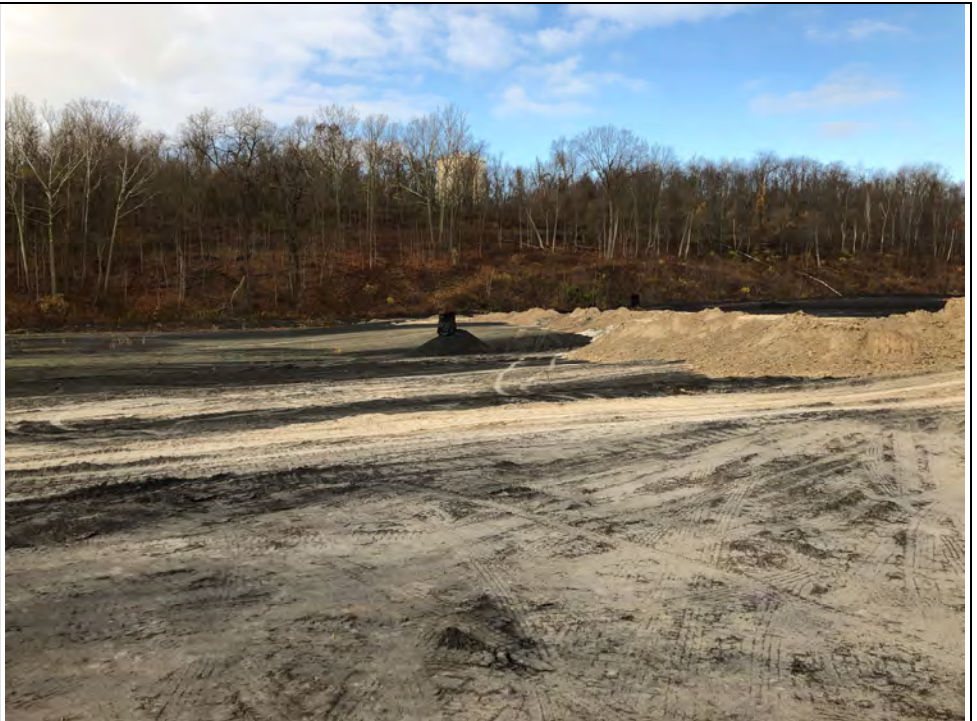
Image: 8070  
 Date: 11/12/2020  
 Time: 7:47 AM  
 Direction: West

Active area with recently received loads of gypsum.

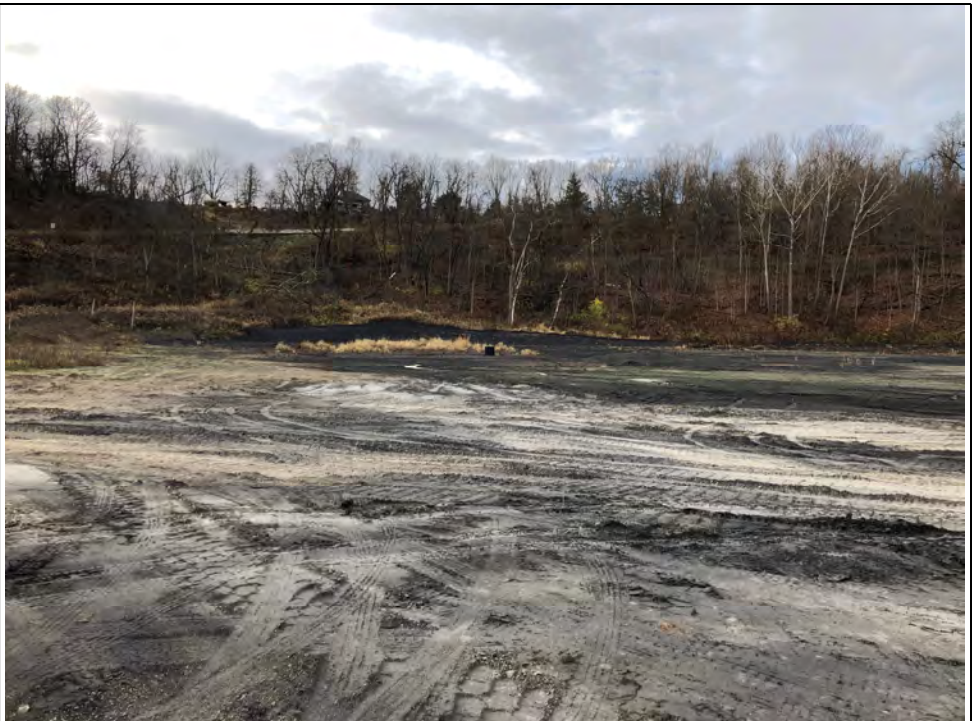
Image: 8072  
 Date: 11/12/2020  
 Time: 7:47 AM  
 Direction: South-Southwest

Active area drains toward low area near treeline. No standing water is present.
