Inspection Report

To: Bill McGraw (Cheswick Generating Station)
From: Richard Southorn, P.E., P.G.
Re: Cheswick Ash Disposal Site – Annual CCR Unit Inspection Report
Inspection Date: November 12, 2020
Report Date: January 15, 2021

Project: Cheswick Landfill 2020 Annual Inspection

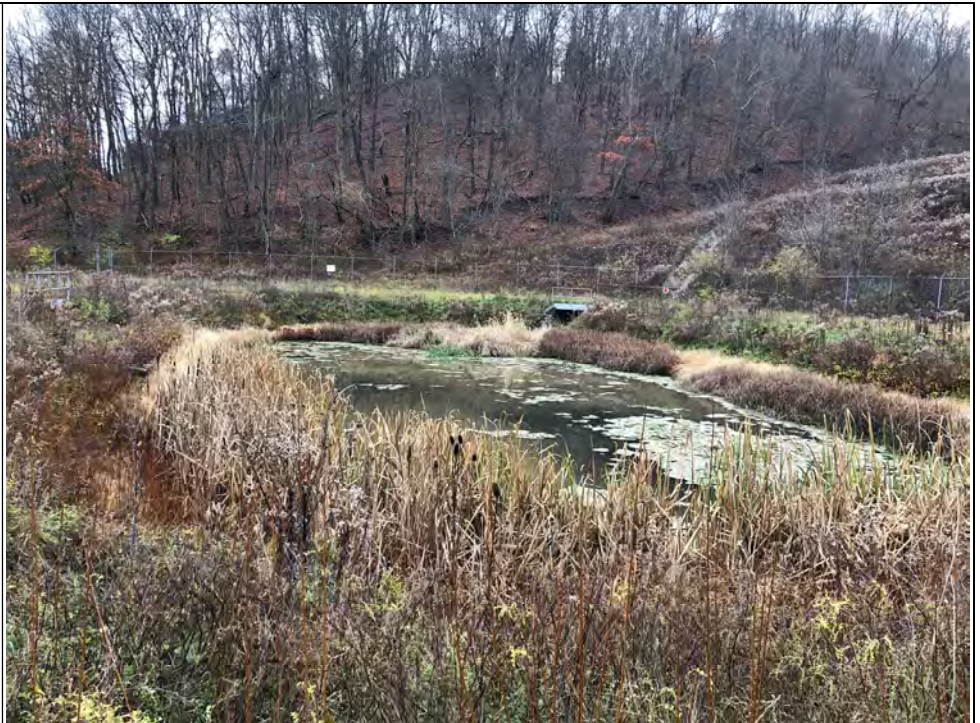
Image: 7994
Date: 11/12/2020
Time: 7:10 AM
Direction: South

Sedimentation Pond.
Healthy vegetation on pond
sideslopes. No trash noted
on water surface or in
surrounding vegetation.

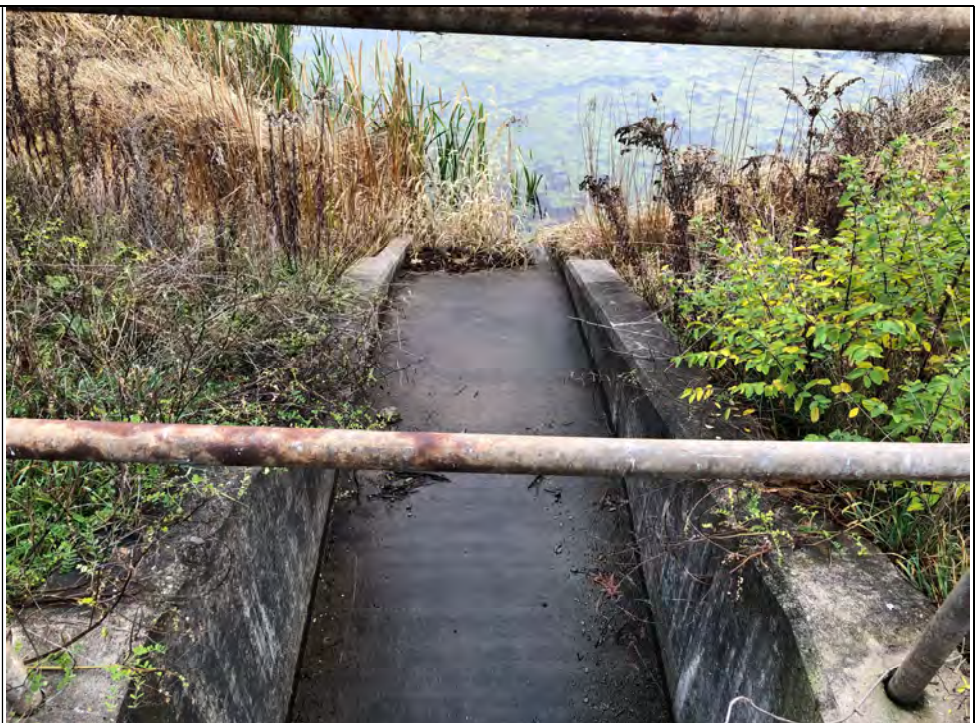
Image: 7996
Date: 11/12/2020
Time: 7:11 AM
Direction: East

Outfall 010 inlet to
Sedimentation Pond
looking downslope.
Functioning as intended.

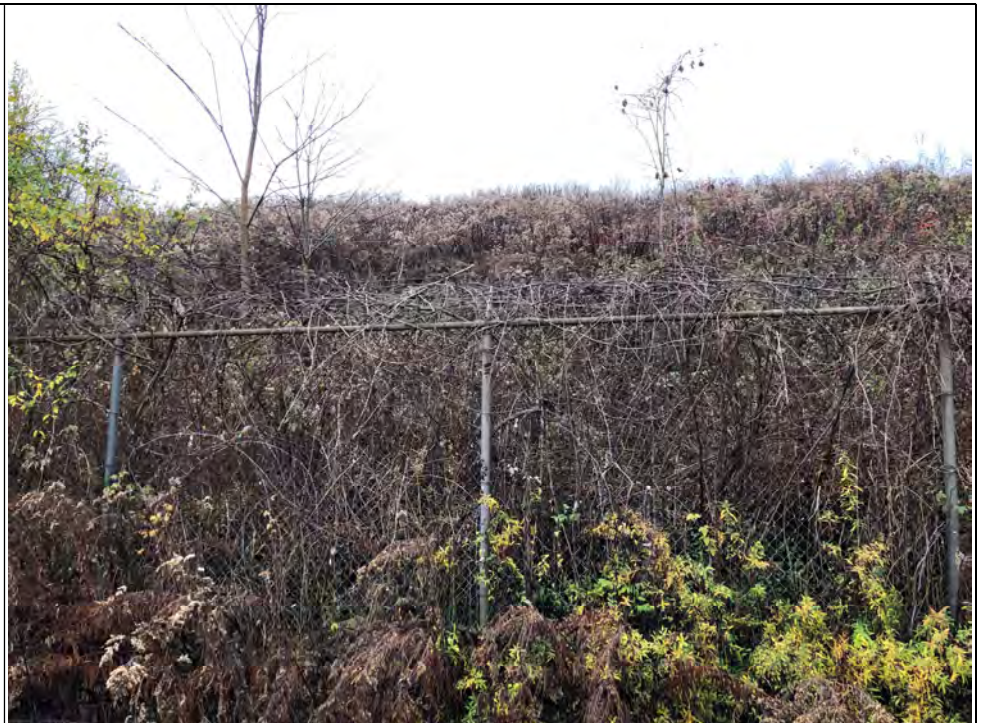
Image: 8001
 Date: 11/12/2020
 Time: 7:12 AM
 Direction: West-Southwest

The toe of the landfill slope is located at the fenceline. No evidence of erosion, sloughing, or indications of stability issues. Vegetation is healthy and present across the entire sideslope.

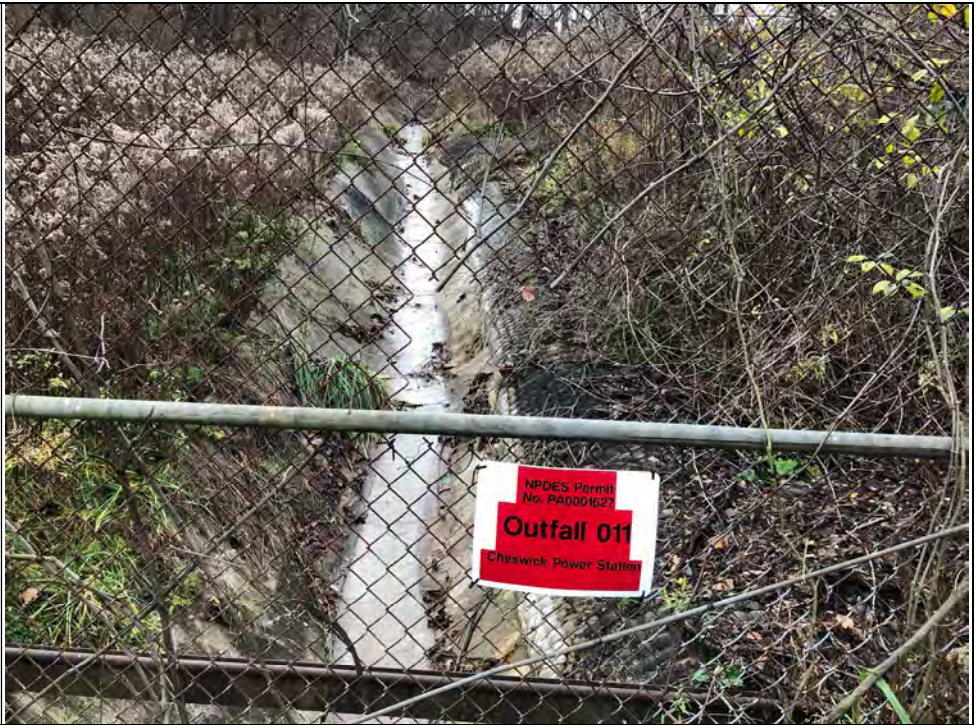
Image: 8003
 Date: 11/12/2020
 Time: 7:12 AM
 Direction: Southwest

South non-contact water channel (at Outfall 011) inlet to Sedimentation Pond looking upslope. Clear of debris. Functioning as intended.

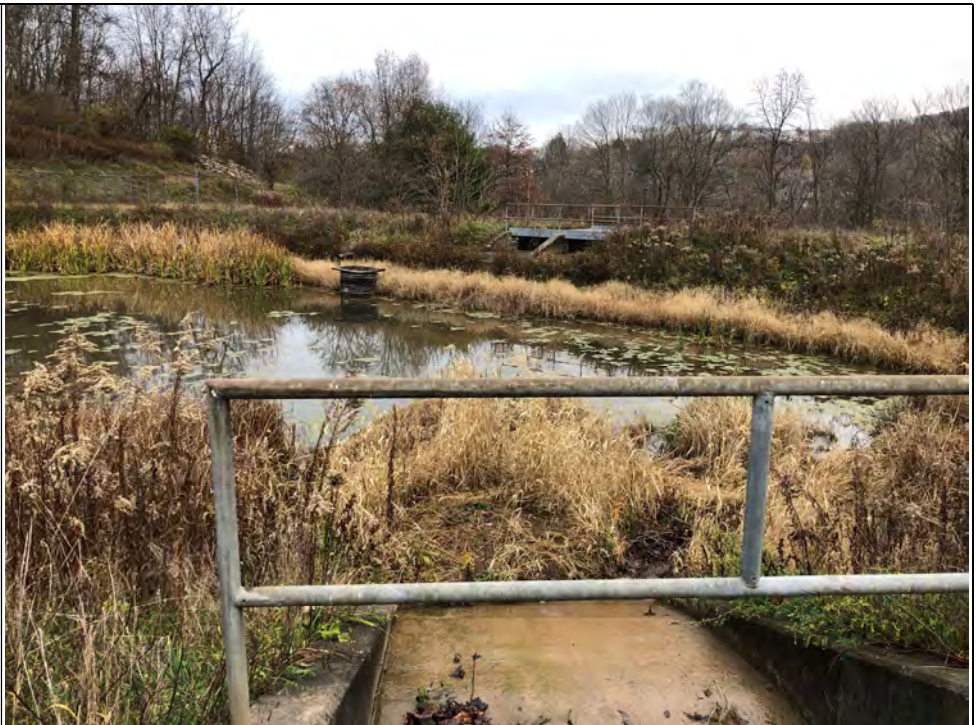
Image: 8005
 Date: 11/12/2020
 Time: 7:13 AM
 Direction: North-Northeast

Outfall 011 inlet to Sedimentation Pond looking downslope. Concrete flume has minor leaves and autumnal debris, which are regularly removed. Functioning as intended.

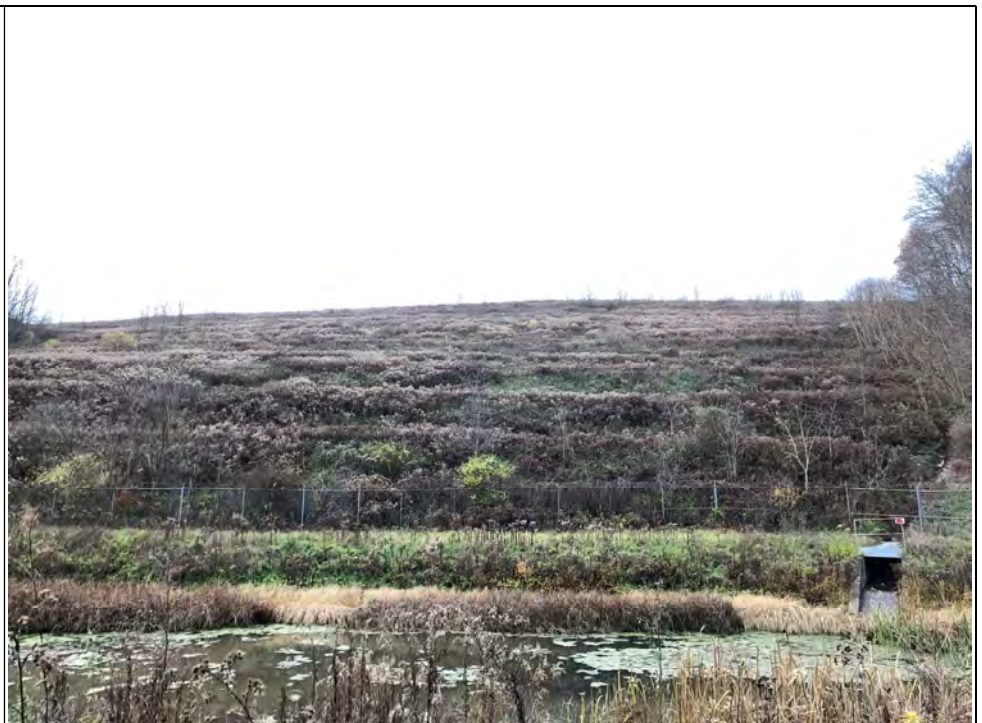
Image: 8010
Date: 11/12/2020
Time: 7:15 AM
Direction: West

Overview of landfill. Vegetation is healthy with no identified distressed vegetation areas.

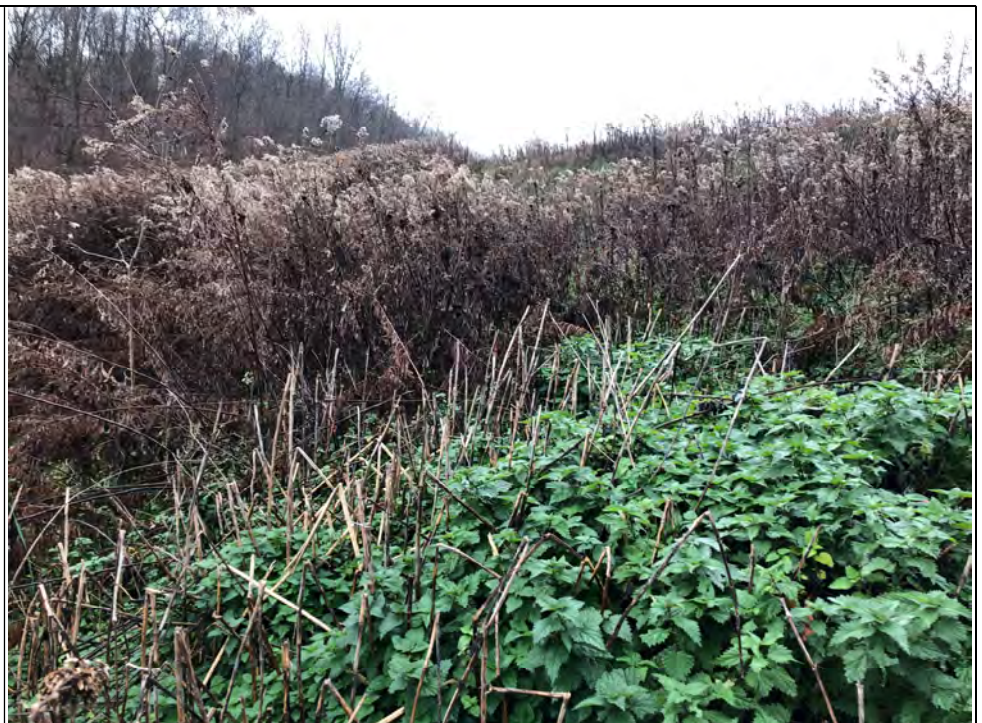
Image: 8014
Date: 11/12/2020
Time: 7:17 AM
Direction: Southwest

Vegetation is healthy and present across the entire sideslope. No evidence of erosion, sloughing, or indications of stability issues.

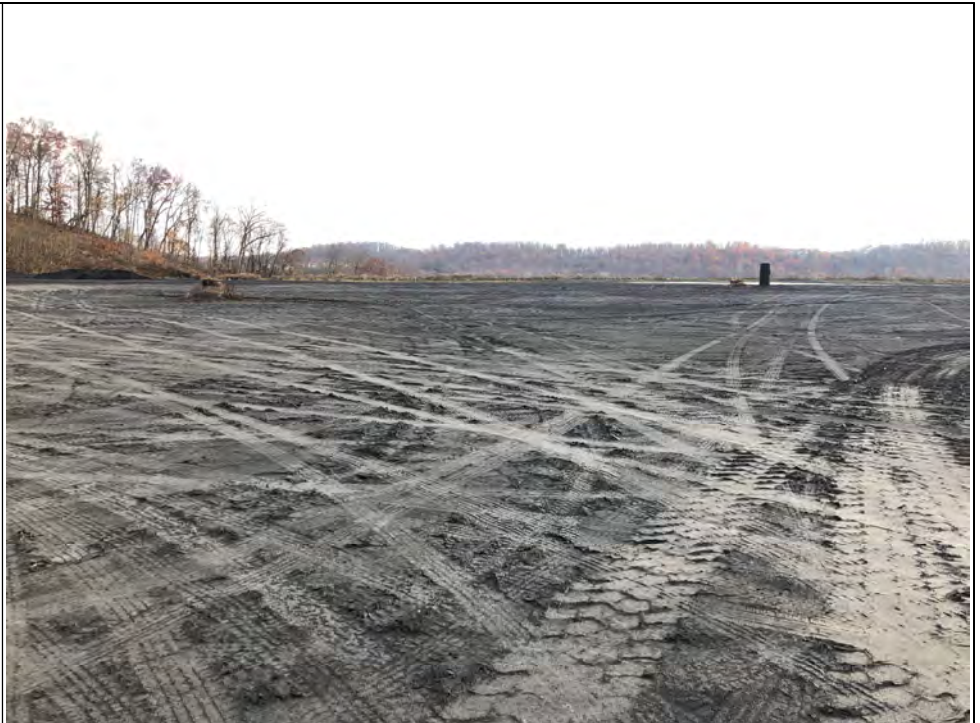
Image: 8024
Date: 11/12/2020
Time: 7:34 AM
Direction: East-Northeast

Active area. Material is placed in even lifts that are spread and compacted. Top surface is well maintained, with no ponding water.

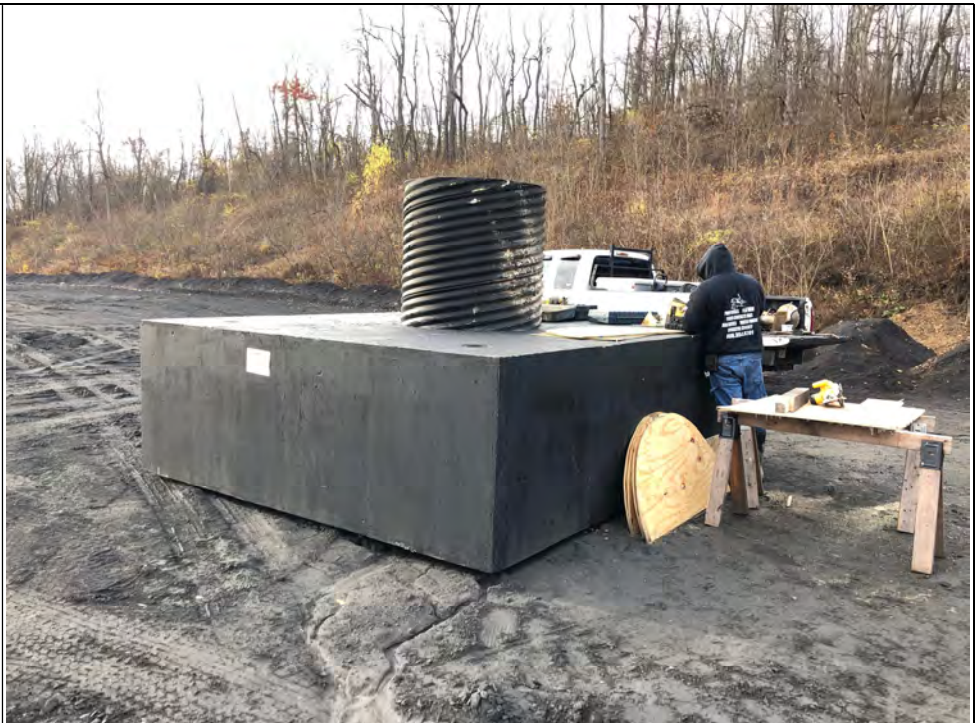
Image: 8026
Date: 11/12/2020
Time: 7:34 AM
Direction: Southwest

A junction box lid and riser are being fabricated to extend a non-contact stormwater pipe (see Image 8028 for location where this will be installed).

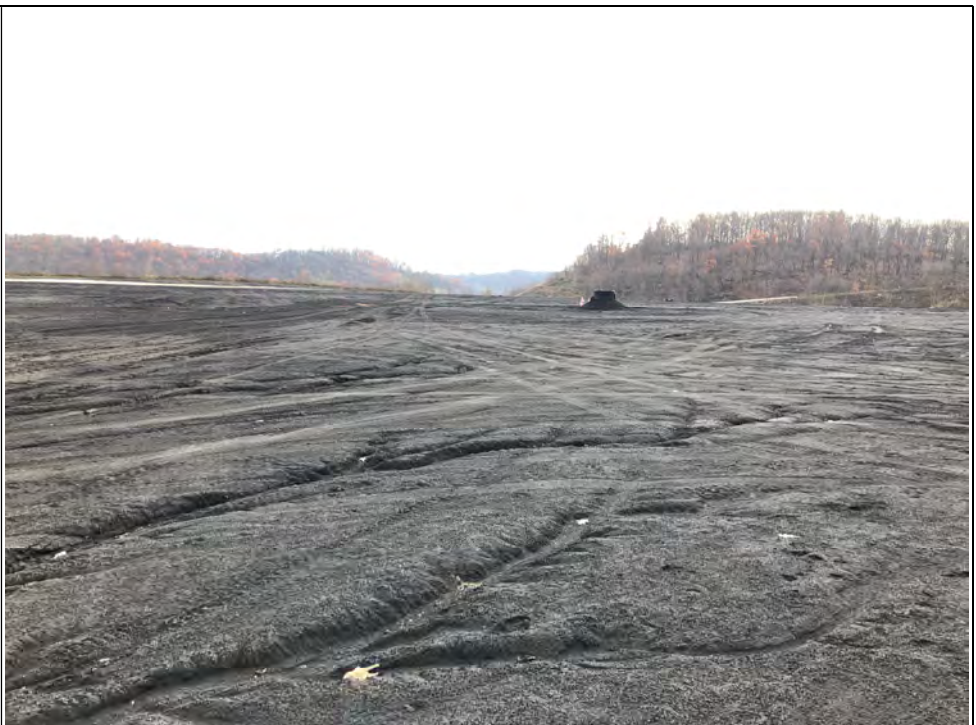
Image: 8030
Date: 11/12/2020
Time: 7:37 AM
Direction: East-Southeast

Active area. Material is placed in even lifts that are spread and compacted. Some erosion ruts and rills have formed on the active face due to recent rains, but do not affect stability or safety of the landfill.

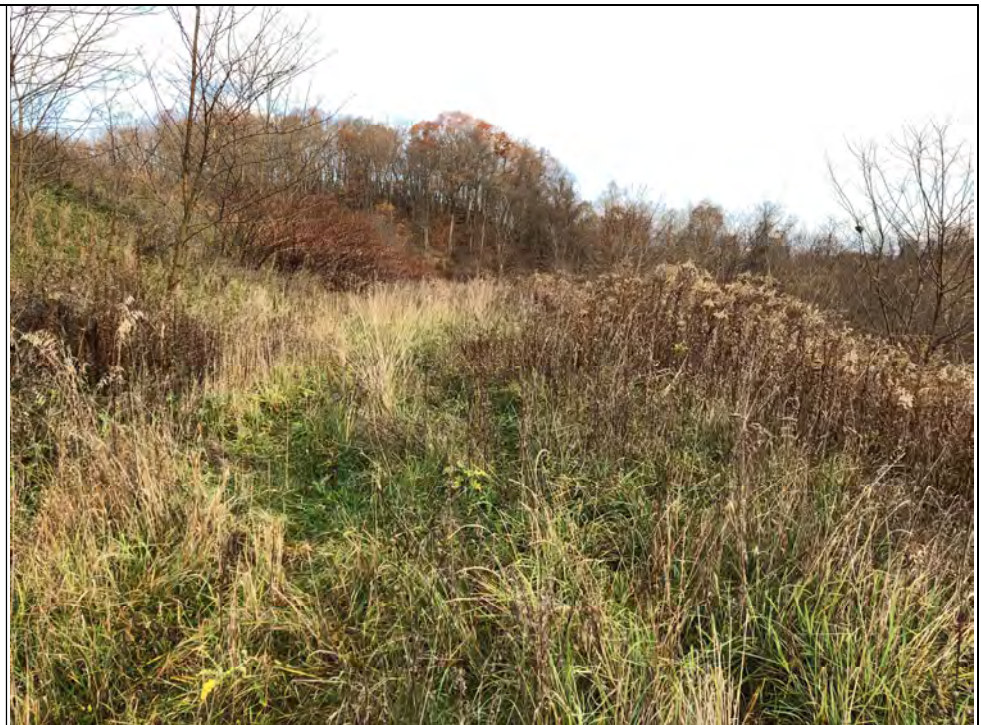
Image: 8046
Date: 11/12/2020
Time: 7:41 AM
Direction: North-Northwest

Vegetation is healthy and present across the entire sideslope. No evidence of erosion, sloughing, or indications of stability issues. Some woody vegetation is present.

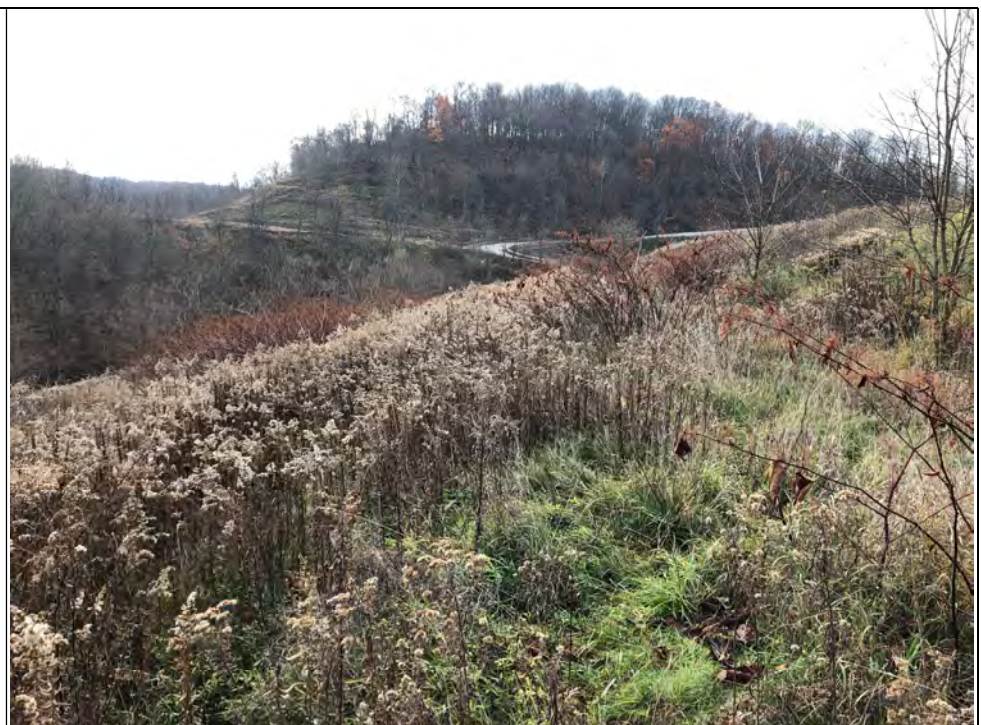
Image: 8048
Date: 11/12/2020
Time: 7:41 AM
Direction: Southeast

Vegetation is healthy and present across the entire sideslope. No evidence of erosion, sloughing, or indications of stability issues.
