## **Inspection Report**

**To:** Bill McGraw (Cheswick Generating Station)  
**From:** Richard Southorn, P.E., P.G.  
**Re:** Cheswick Ash Disposal Site – Annual CCR Unit Inspection Report  
**Inspection Date:** November 12, 2020  
**Report Date:** January 15, 2021

**Project: Cheswick Landfill 2020 Annual Inspection**

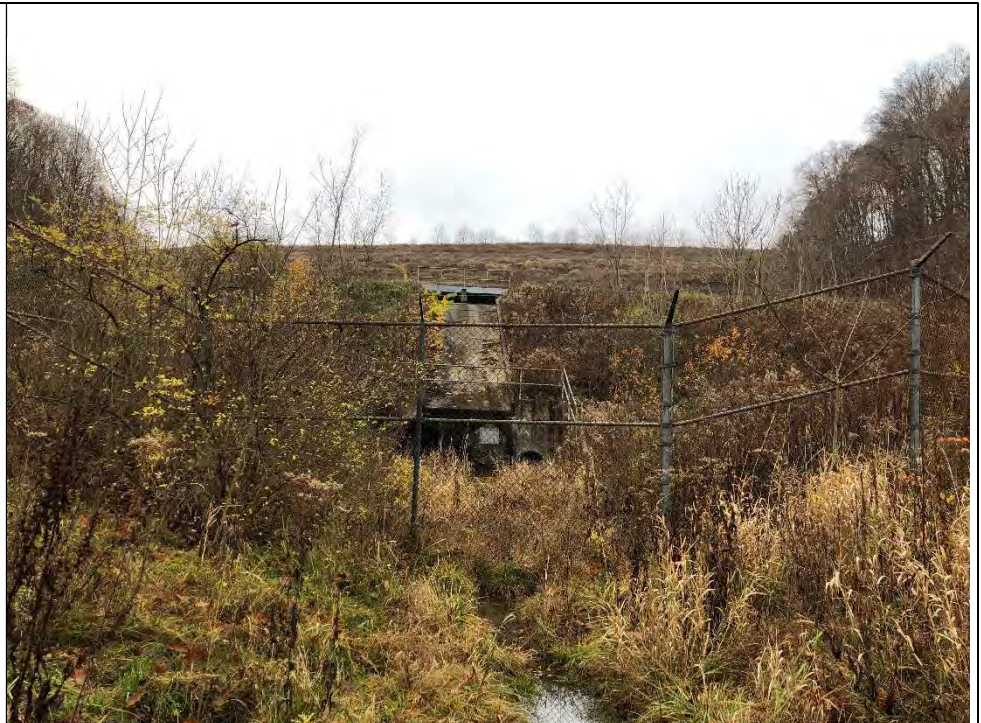
Image: 7990  
Date: 11/12/2020  
Time: 7:06 AM  
Direction: West

View of Sedimentation Pond spillway. Clear of debris. Landfill is in background.

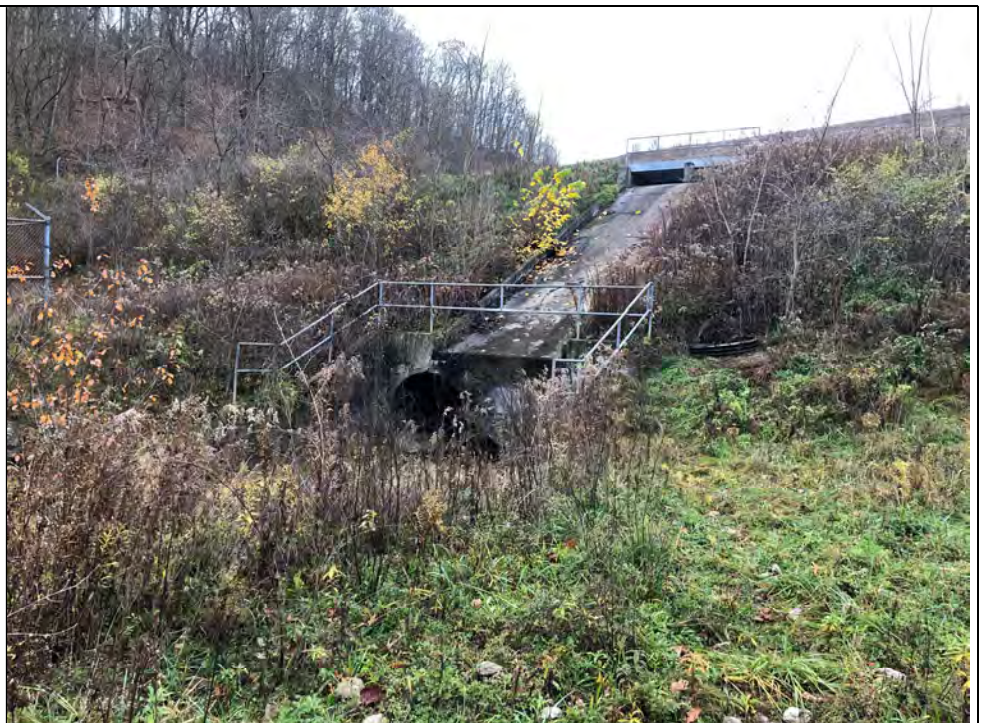
Image: 7992  
Date: 11/12/2020  
Time: 7:07 AM  
Direction: Southwest

Description: View of Sedimentation Pond spillway. Clear of debris.

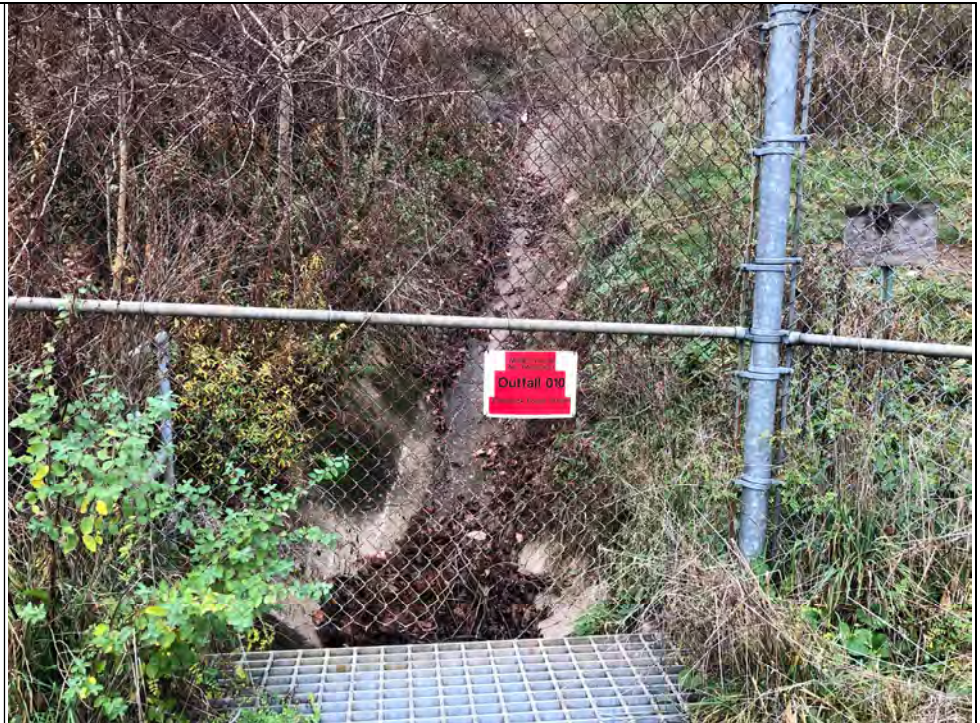
Image: 7998  
Date: 11/12/2020  
Time: 7:11 AM  
Direction: West-Northwest

North non-contact water channel (at Outfall 010) inlet to Sedimentation Pond looking upslope. Some leaves are present in channel, which are regularly removed during autumn. Functioning as intended.

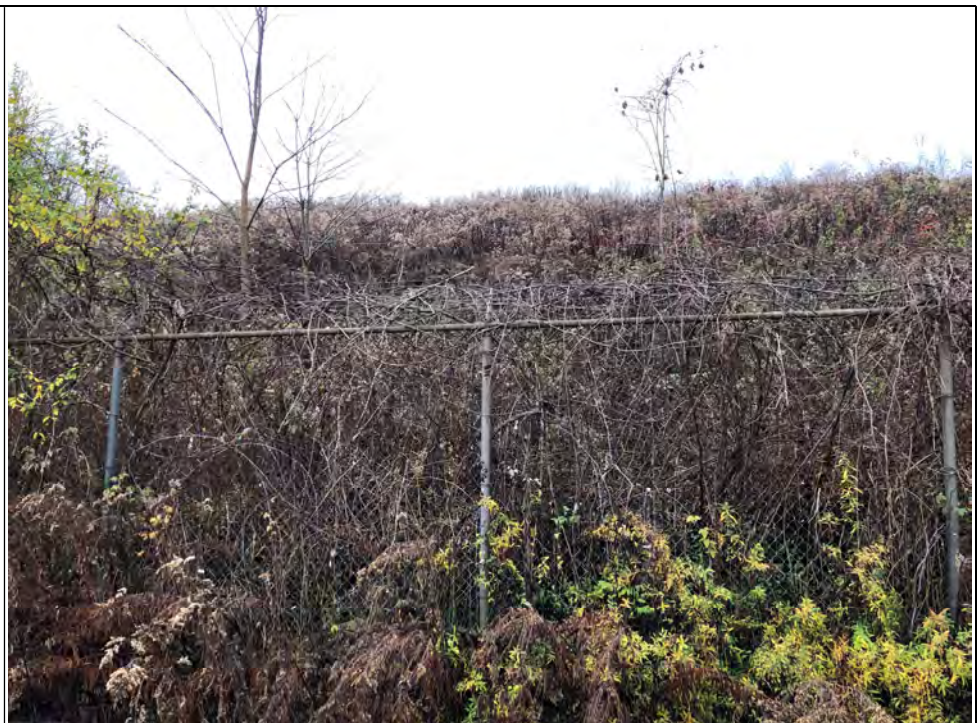
Image: 8001  
Date: 11/12/2020  
Time: 7:12 AM  
Direction: West-Southwest

The toe of the landfill slope is located at the fenceline. No evidence of erosion, sloughing, or indications of stability issues. Vegetation is healthy and present across the entire sideslope.

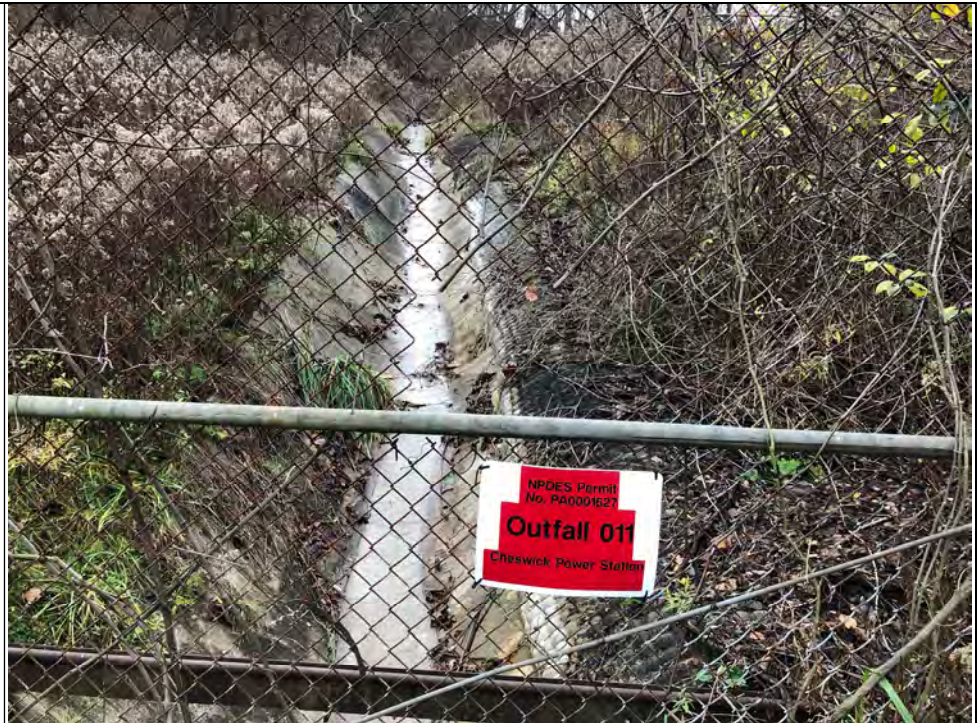
Image: 8003  
Date: 11/12/2020  
Time: 7:12 AM  
Direction: Southwest

South non-contact water channel (at Outfall 011) inlet to Sedimentation Pond looking upslope. Clear of debris. Functioning as intended.

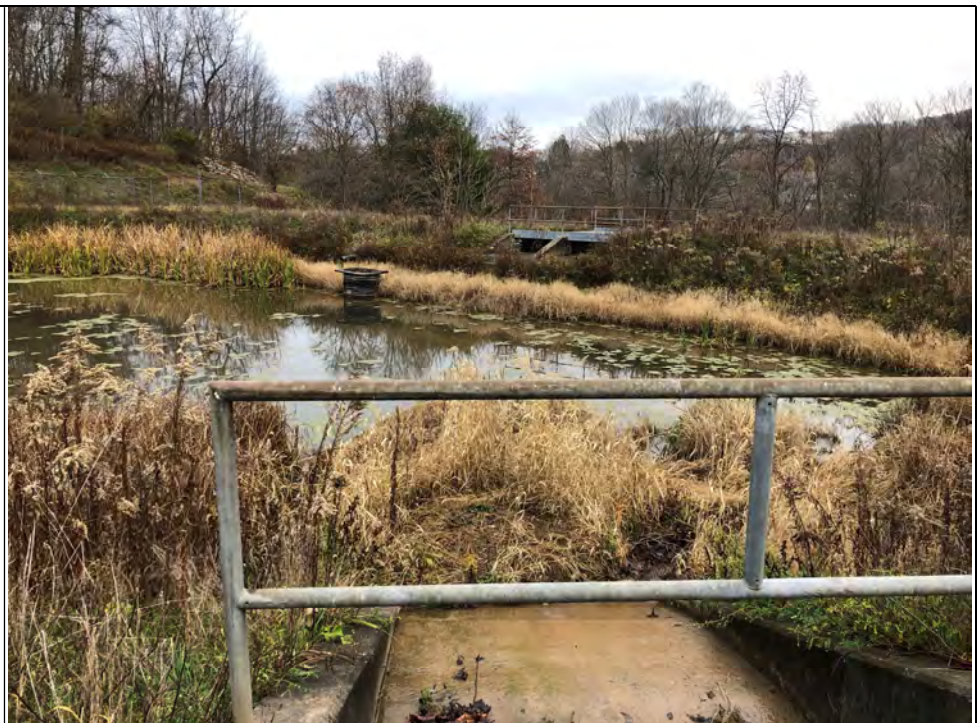
Image: 8005  
Date: 11/12/2020  
Time: 7:13 AM  
Direction: North-Northeast

Outfall 011 inlet to Sedimentation Pond looking downslope. Concrete flume has minor leaves and autumnal debris, which are regularly removed. Functioning as intended.

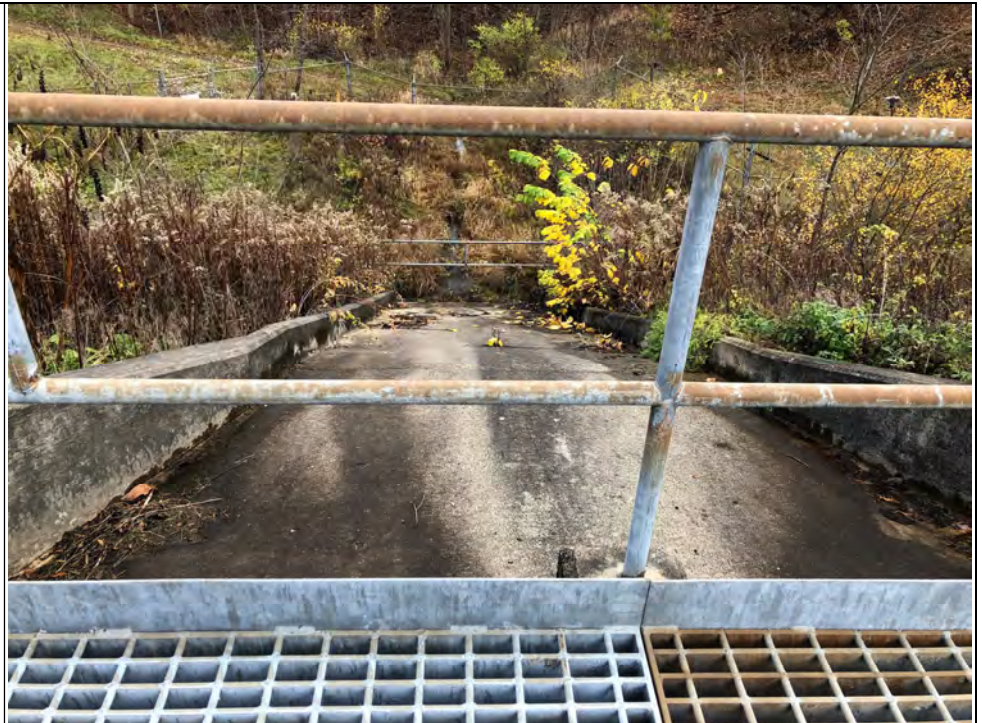
Image: 8008  
Date: 11/12/2020  
Time: 7:15 AM  
Direction: Northeast

View of Sedimentation Pond spillway from above. Clear and in good condition.

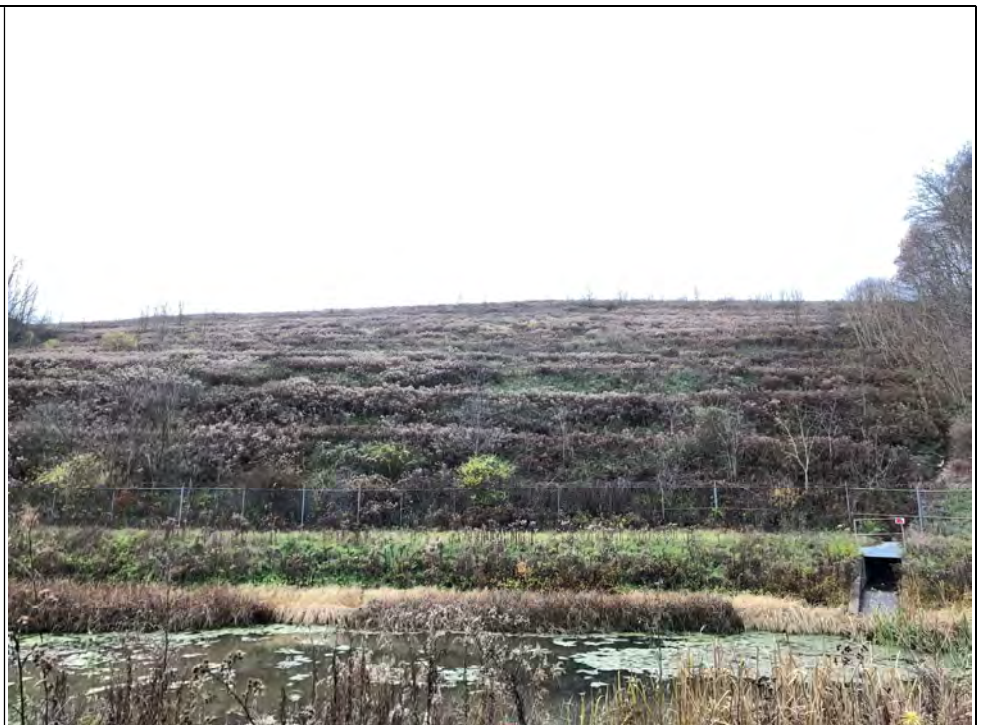
Image: 8010  
Date: 11/12/2020  
Time: 7:15 AM  
Direction: West

Overview of landfill. Vegetation is healthy with no identified distressed vegetation areas.

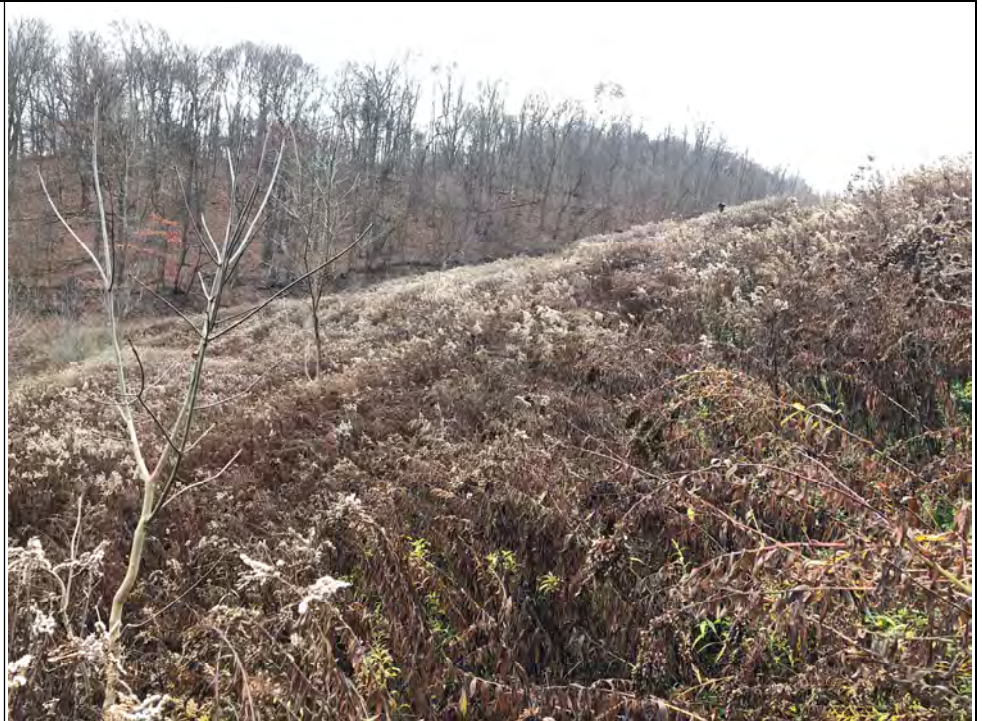
Image: 8012  
Date: 11/12/2020  
Time: 7:17 AM  
Direction: South

Vegetation is healthy and present across the entire sideslope. No evidence of erosion, sloughing, or indications of stability issues.

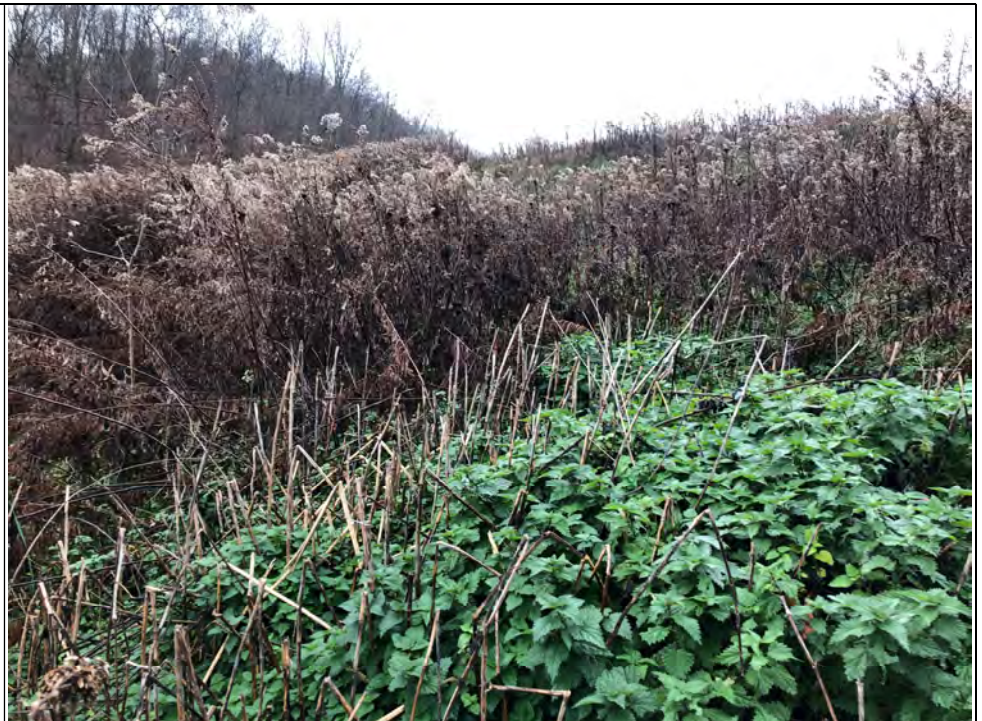
Image: 8014  
Date: 11/12/2020  
Time: 7:17 AM  
Direction: Southwest

Vegetation is healthy and present across the entire sideslope. No evidence of erosion, sloughing, or indications of stability issues.

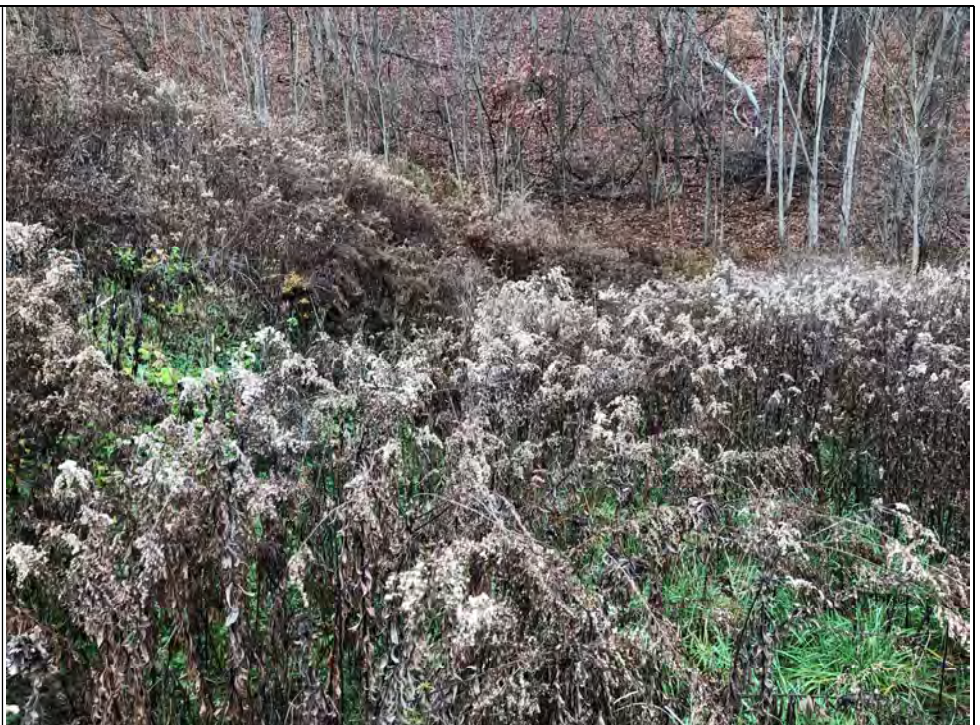
Image: 8018  
Date: 11/12/2020  
Time: 7:18 AM  
Direction: Northwest

Vegetation is healthy and present across the entire sideslope. No evidence of erosion, sloughing, or indications of stability issues.

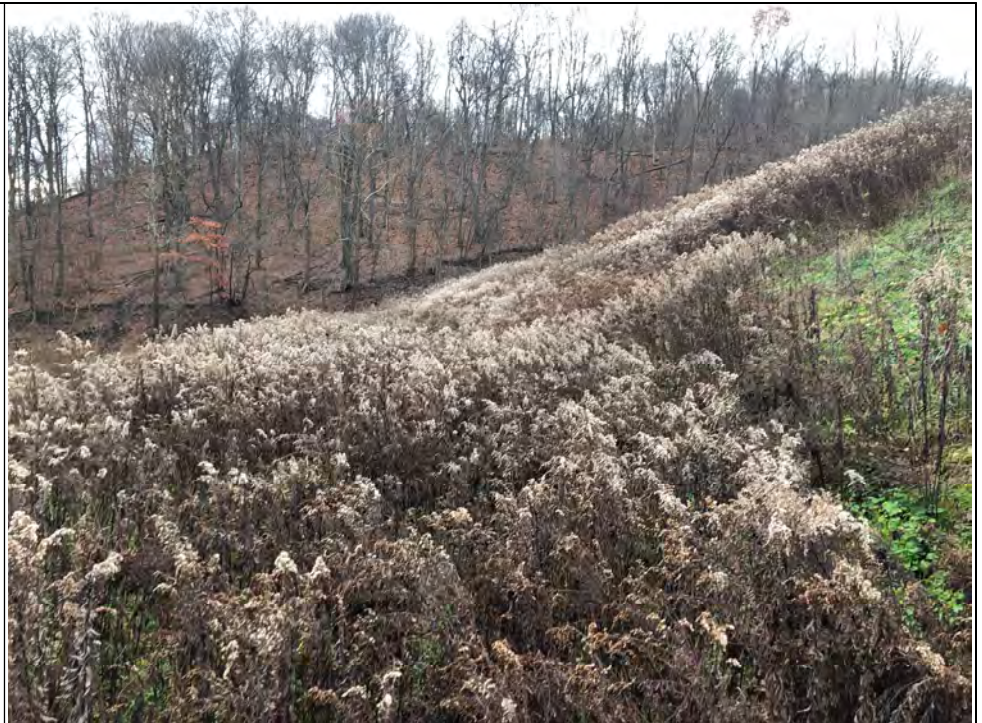
Image: 8020  
Date: 11/12/2020  
Time: 7:19 AM  
Direction: South-Southeast

Vegetation is healthy and present across the entire sideslope. No evidence of erosion, sloughing, or indications of stability issues.

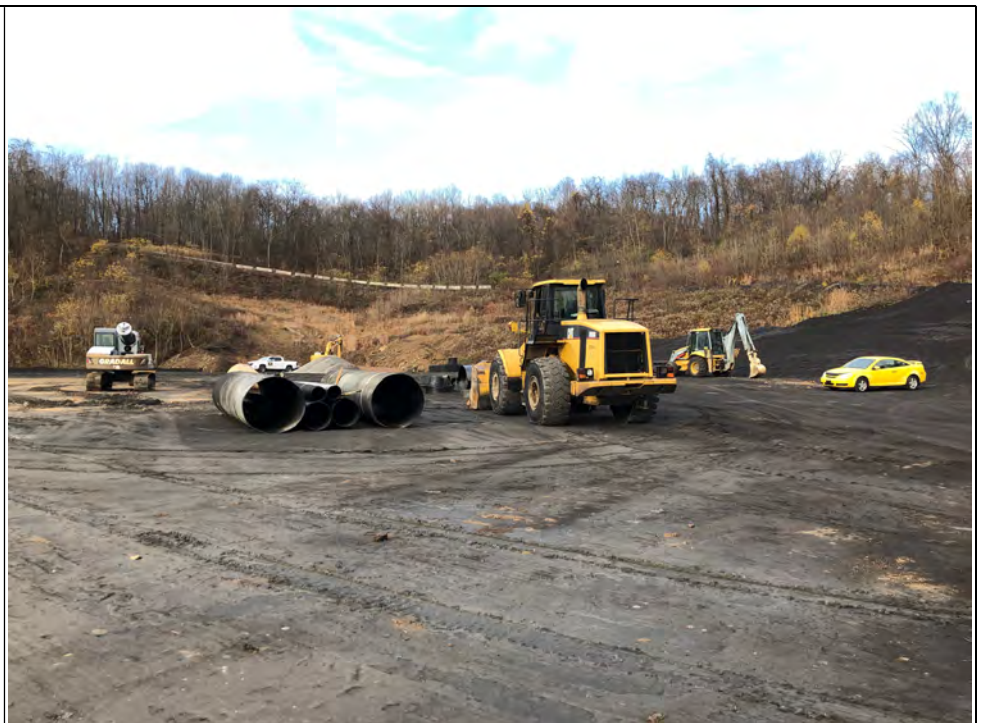
Image: 8022  
Date: 11/12/2020  
Time: 7:32 AM  
Direction: West

Contact and non-contact stormwater pipes were being extended at the time of inspection. Pipe to be used to extend a non-contact riser is shown. It will continue to be extended until reaching the final cover elevation and will accept stormwater after final cover is in place.

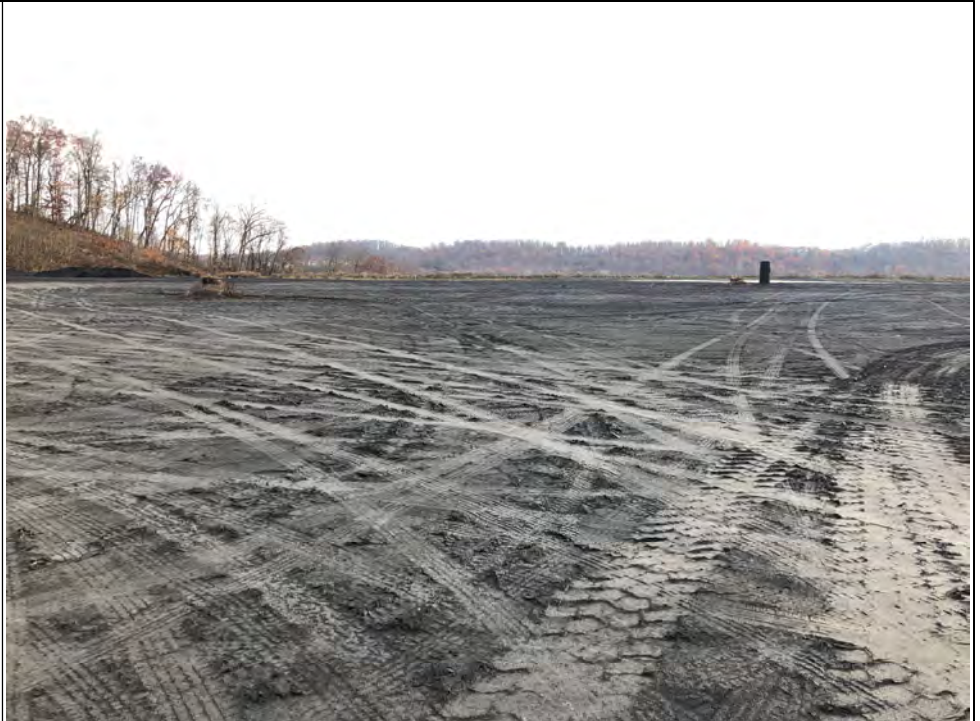
Image: 8024  
Date: 11/12/2020  
Time: 7:34 AM  
Direction: East-Northeast

Active area. Material is placed in even lifts that are spread and compacted. Top surface is well maintained, with no ponding water.

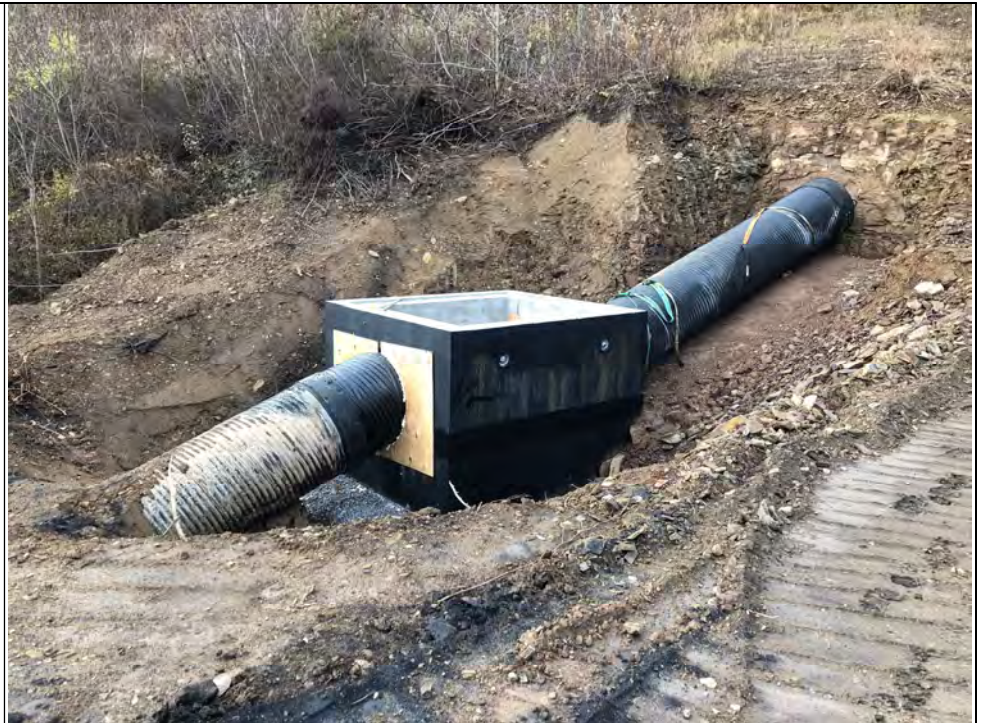
Image: 8028  
Date: 11/12/2020  
Time: 7:35 AM  
Direction: Southwest

A non-contact stormwater junction box is being installed.

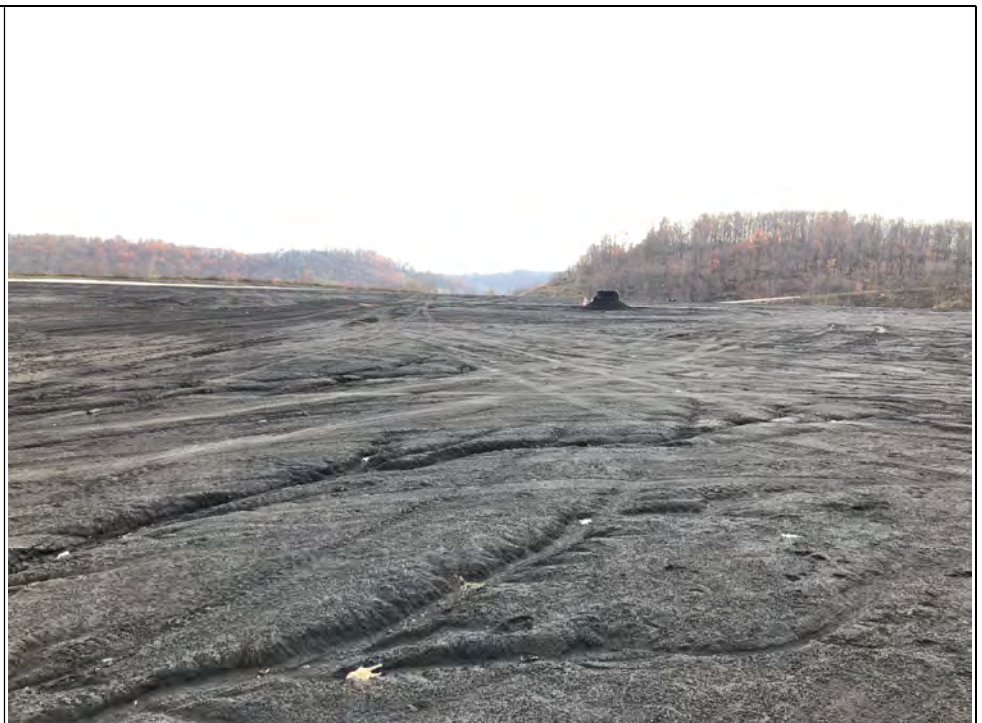
Image: 8030  
Date: 11/12/2020  
Time: 7:37 AM  
Direction: East-Southeast

Active area. Material is placed in even lifts that are spread and compacted. Some erosion ruts and rills have formed on the active face due to recent rains, but do not affect stability or safety of the landfill.

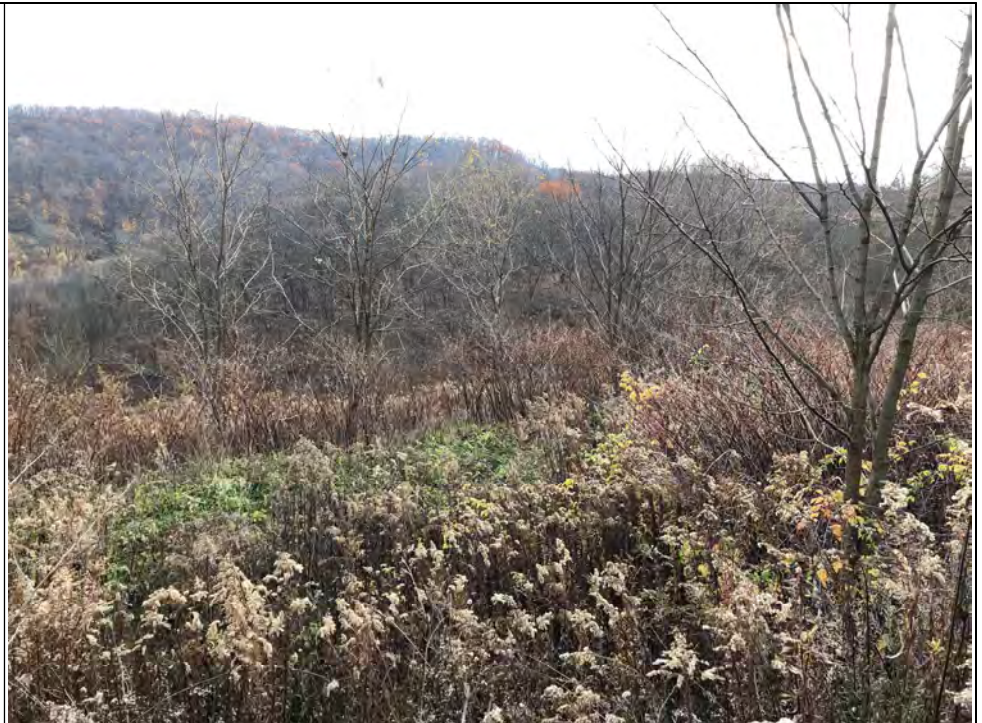
Image: 8050  
Date: 11/12/2020  
Time: 7:41 AM  
Direction: East-Southeast

Vegetation is healthy and present across the entire sideslope. No evidence of erosion, sloughing, or indications of stability issues. Some woody vegetation is present.

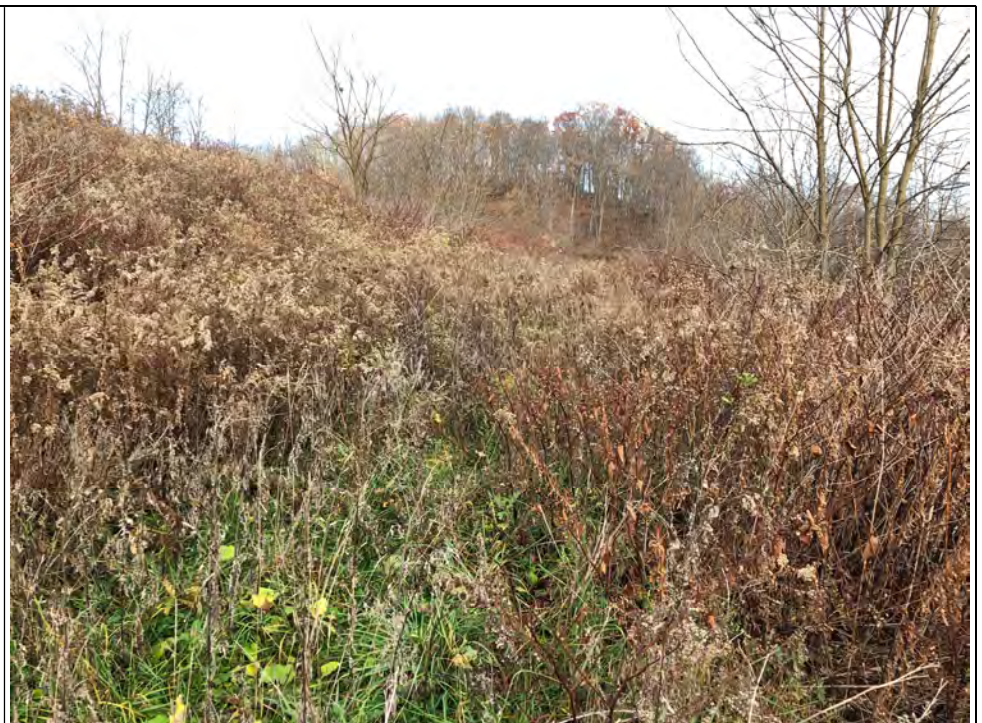
Image: 8054  
Date: 11/12/2020  
Time: 7:42 AM  
Direction: Northwest

Vegetation on sideslopes is healthy and present across the entire sideslope. No evidence of erosion, sloughing, or indications of stability issues. Some woody vegetation is present.

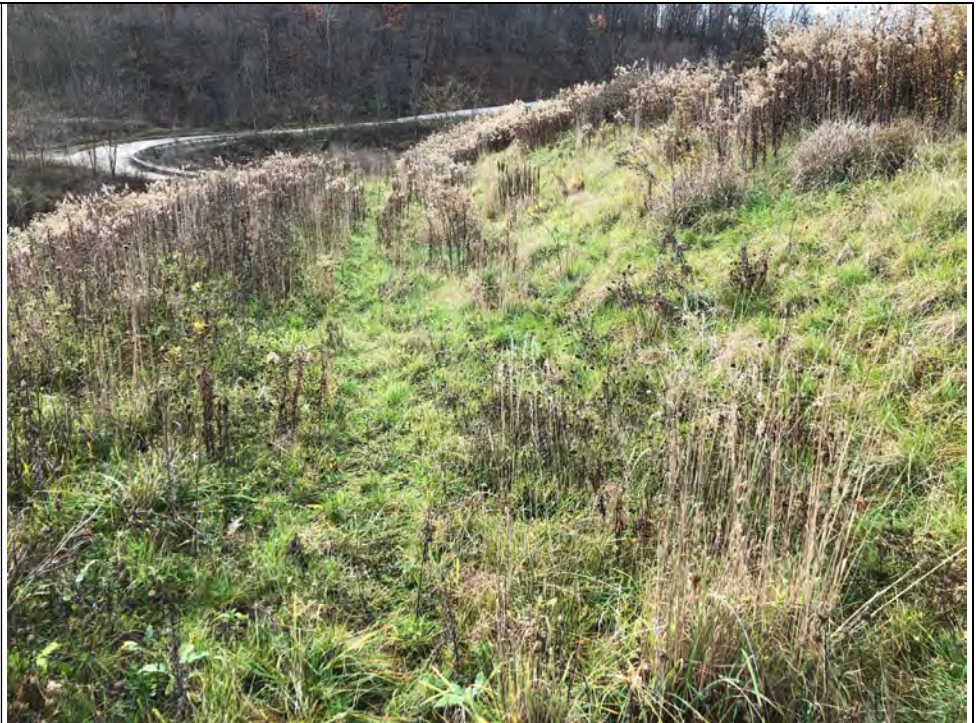
Image: 8062  
Date: 11/12/2020  
Time: 7:45 AM  
Direction: South-Southeast

Vegetation on sideslopes is healthy and present across the entire sideslope. No evidence of erosion, sloughing, or indications of stability issues.

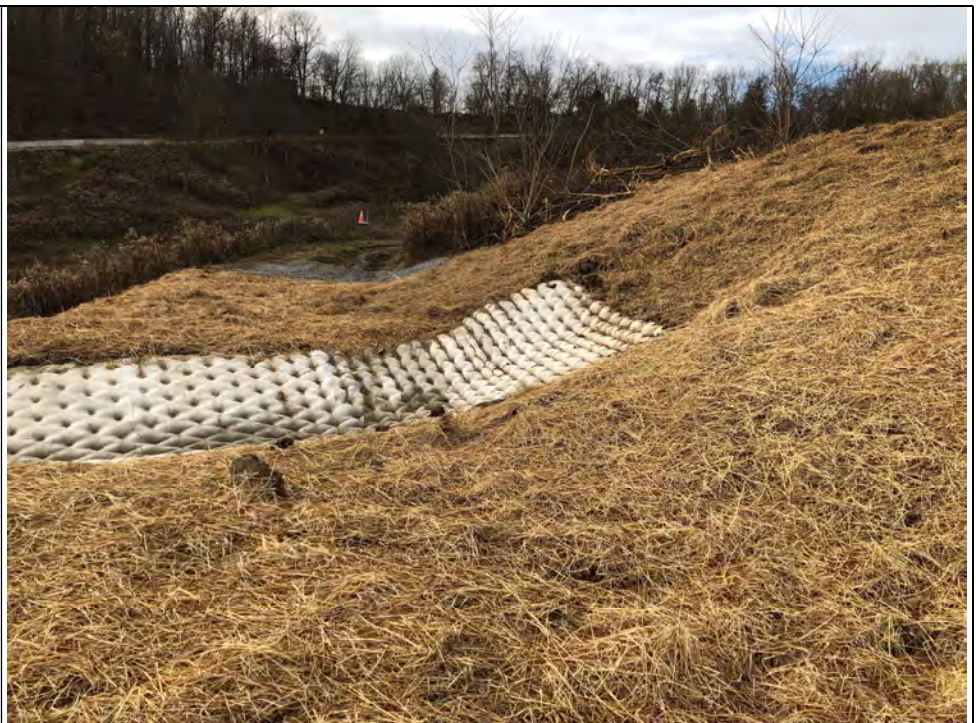
Image: 8064  
Date: 11/12/2020  
Time: 7:46 AM  
Direction: Southwest

Recently installed revetment matting. This matting will be used to convey non-contact stormwater that falls on the closed landfill sideslope to Outfall 011.

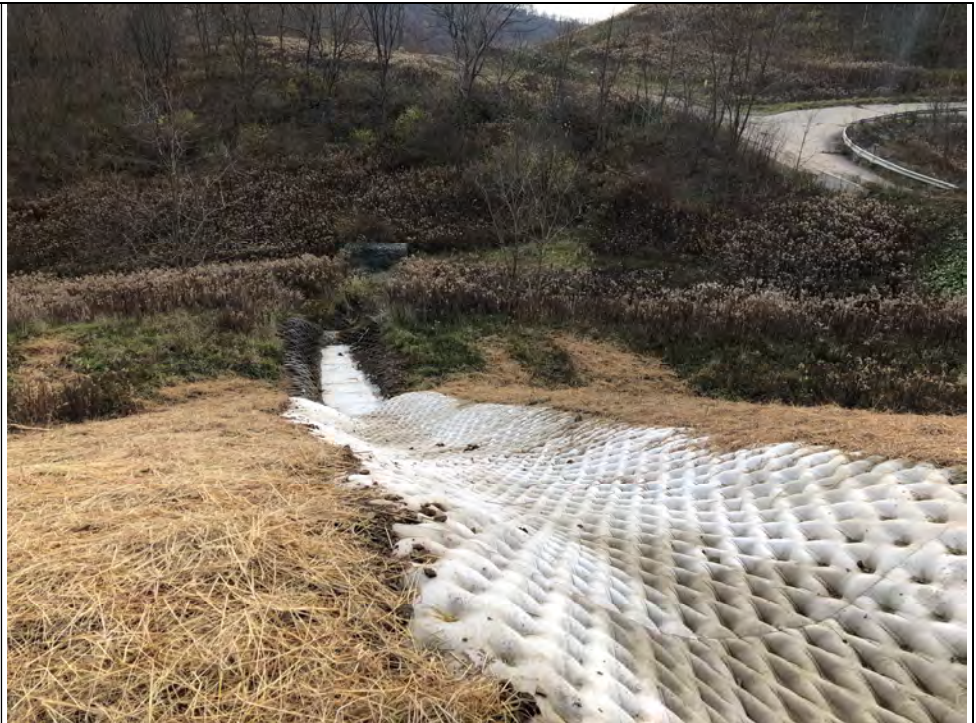
Image: 8066  
Date: 11/12/2020  
Time: 7:46 AM  
Direction: East

Recently installed  
revetment matting. This  
matting will be used to  
convey non-contact  
stormwater that falls on  
the closed landfill  
sideslope to Outfall 011.

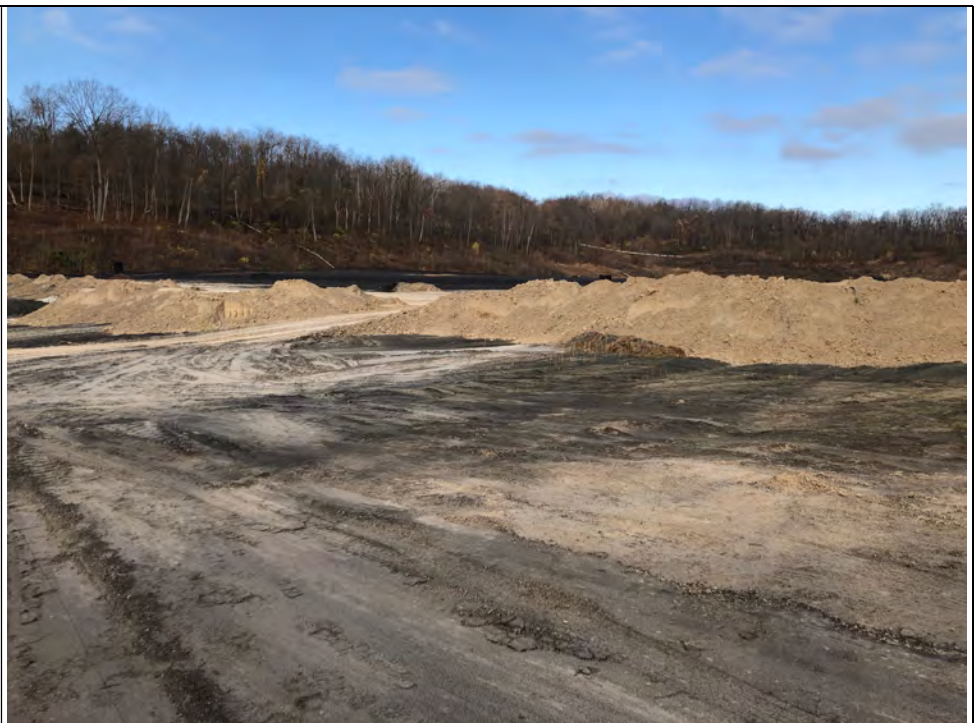
Image: 8068  
Date: 11/12/2020  
Time: 7:47 AM  
Direction: West-Northwest

Active area with recently  
received loads of gypsum.

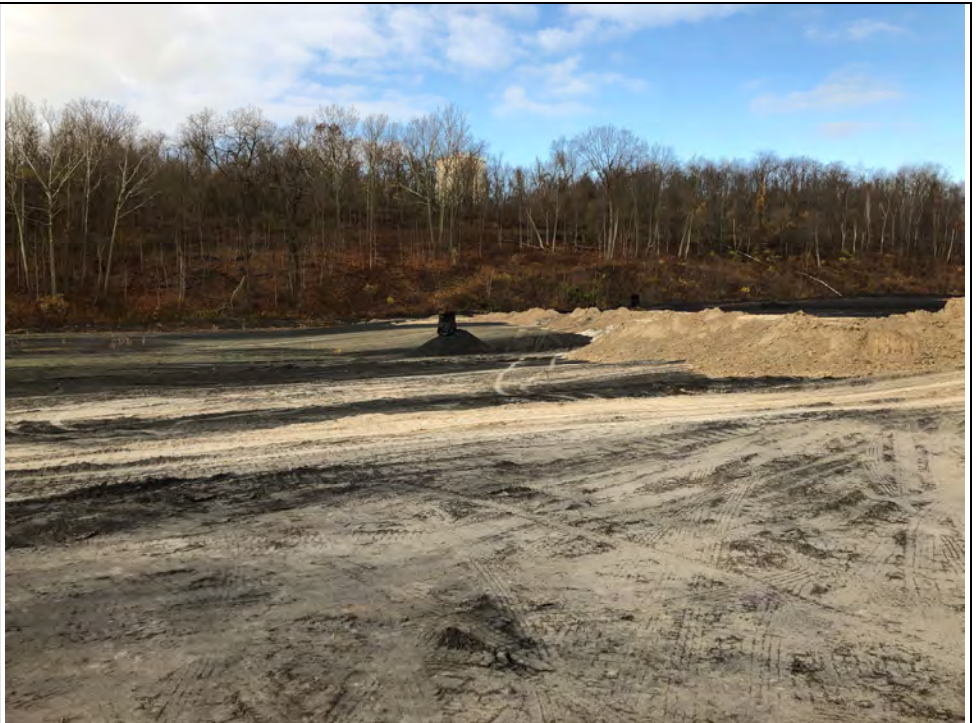
Image: 8070  
Date: 11/12/2020  
Time: 7:47 AM  
Direction: West

Active area with recently received loads of gypsum.

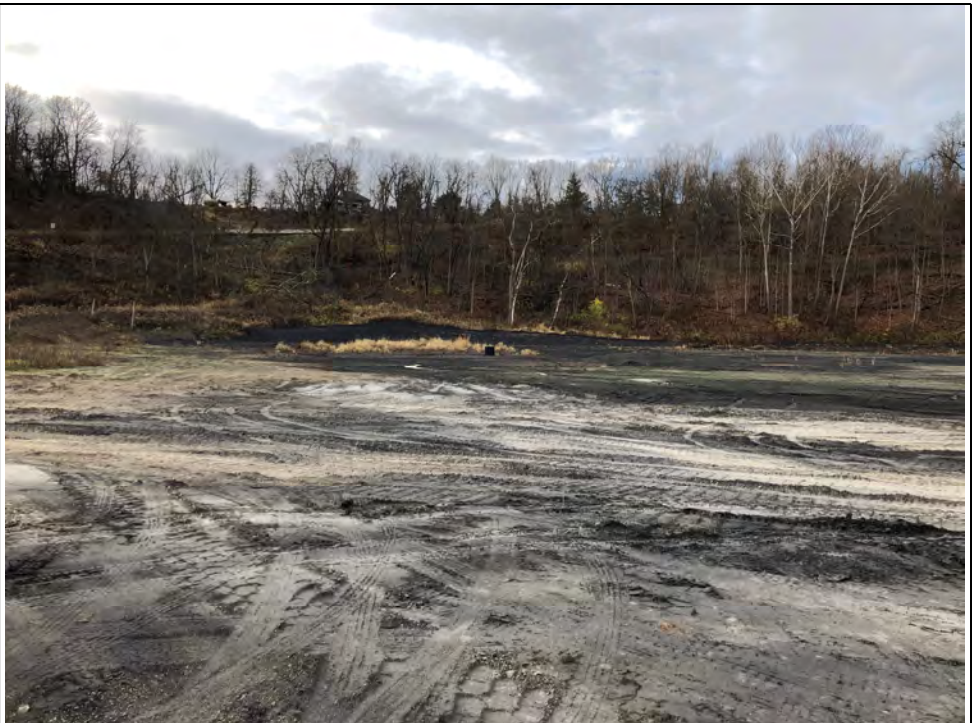
Image: 8072  
Date: 11/12/2020  
Time: 7:47 AM  
Direction: South-Southwest

Active area drains toward low area near treeline. No standing water is present.
