Inspection Report

To: Jill Buckley (Cheswick Generating Station)
From: Richard Southorn, P.E., P.G., CPSWQ
Re: Cheswick Ash Disposal Site – Annual CCR Unit Inspection Report
Inspection Date: October 17, 2017
Report Date: January 16, 2018

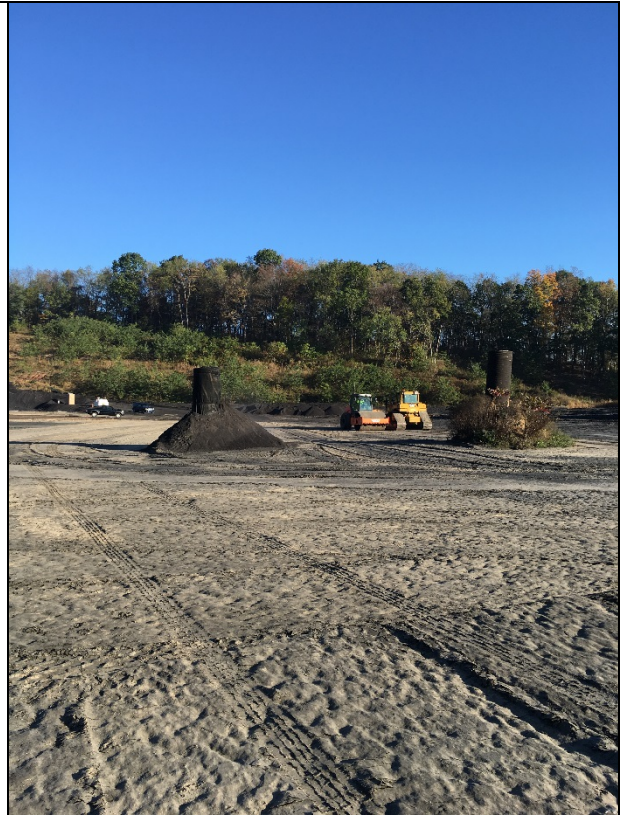
Photograph No. 1

Active filling area. A perforated contact-water (leachate) risers is shown on the left. This riser is wrapped in filter fabric and surrounded with bottom ash. A non-contact water (stormwater) non-perforated riser is shown on the right. This riser will be extended to final cover elevation and will accept stormwater after final cover is in place.

The active area is well maintained with no ponding water. CCR material is spread and rolled shortly after being received.

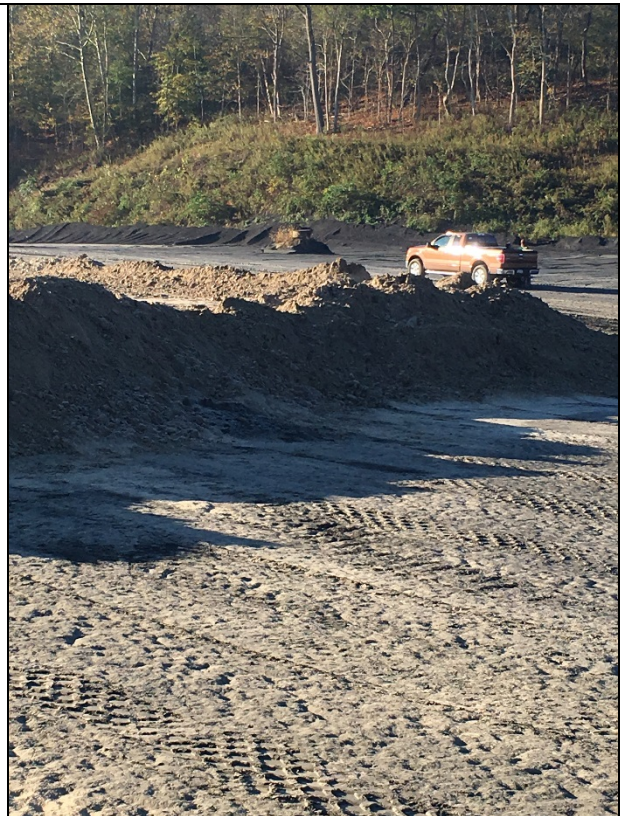
**Photograph No. 4****Date:**

Active area. CCR material has been received and is being placed in a new lift.

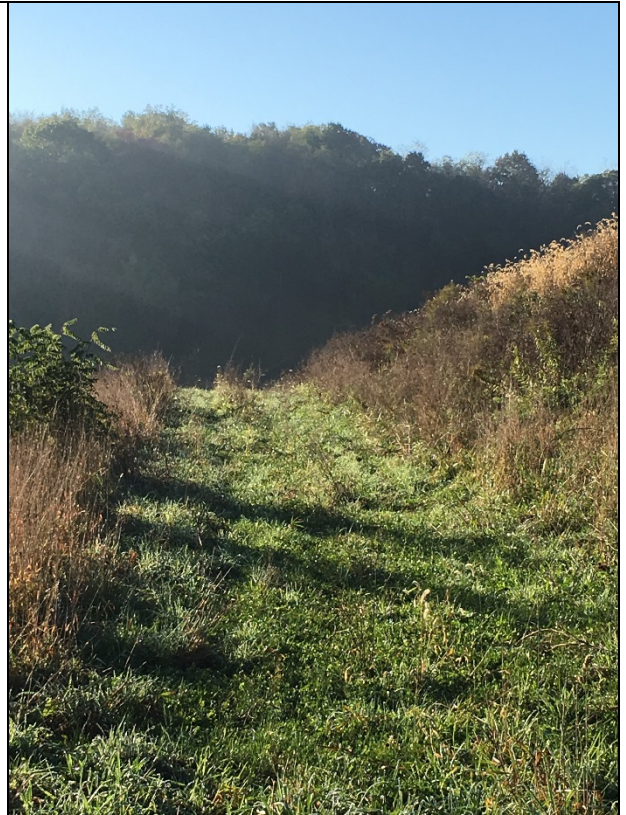
Photograph No. 9

Slope terrace. Terraces are well maintained with no evidence of sloughing or erosion. Vegetation is healthy.

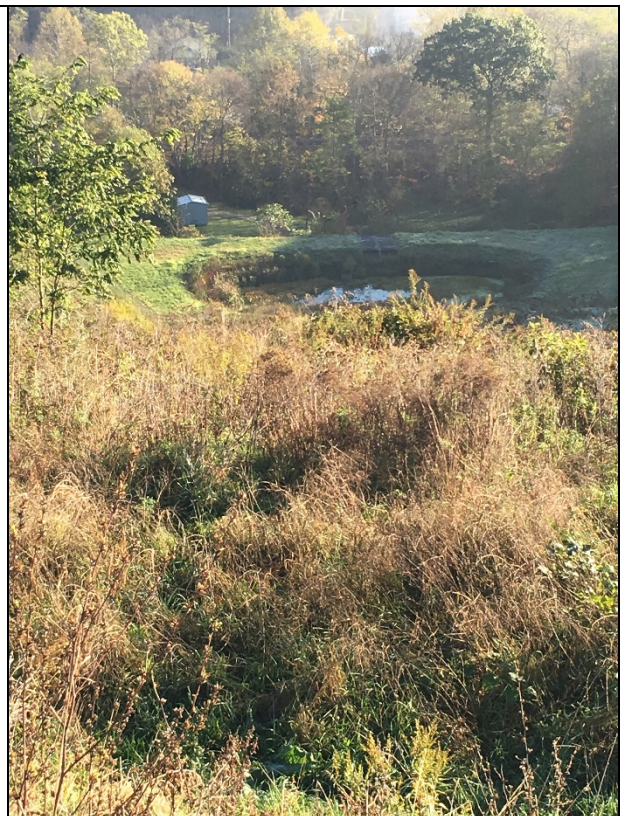
Photograph No. 10

Sedimentation Pond (non-contact stormwater) from upslope. Healthy vegetation.

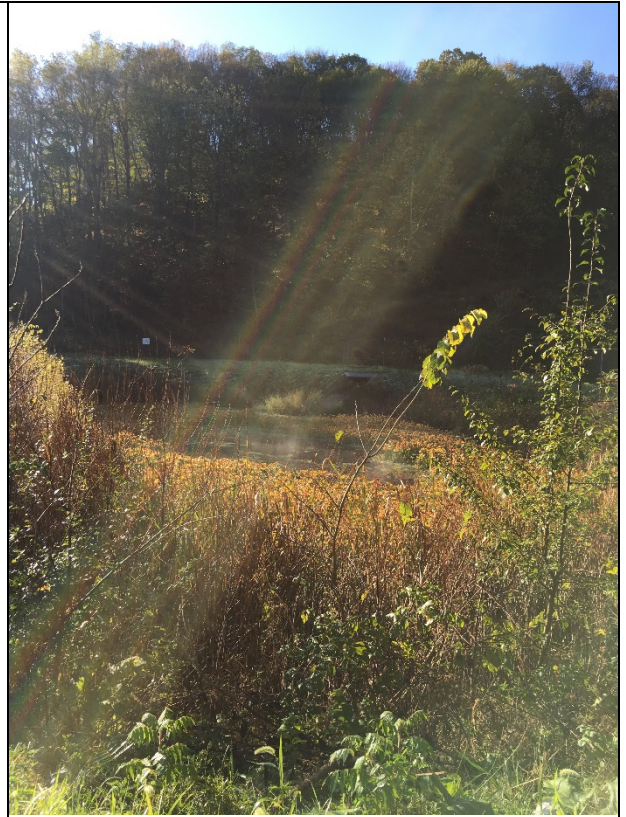
Photograph No. 19

Sedimentation Pond. Healthy vegetation on pond sideslopes. No trash or debris noted on water surface or in surrounding vegetation.

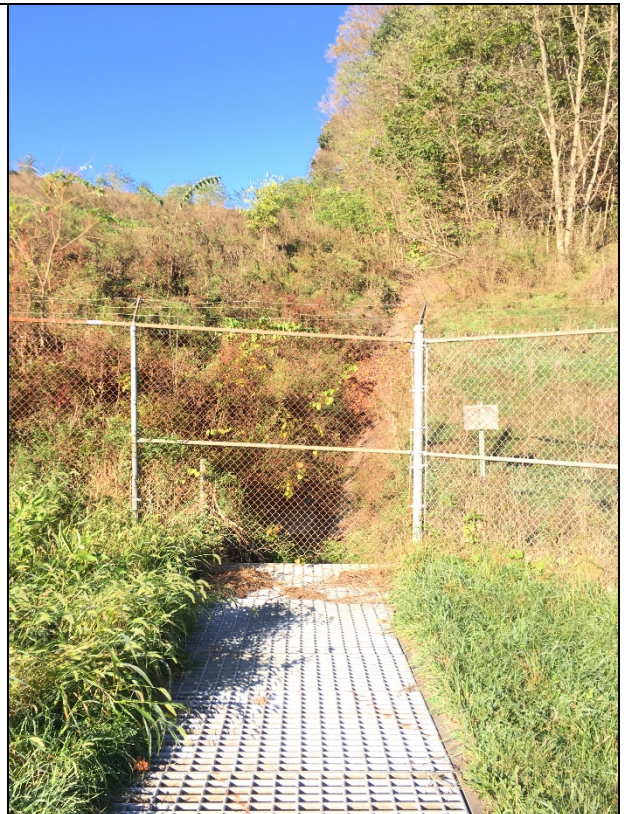
Photograph No. 20

North non-contact water channel at entry point into Sedimentation Pond (looking upslope). Free of debris and functioning as intended.

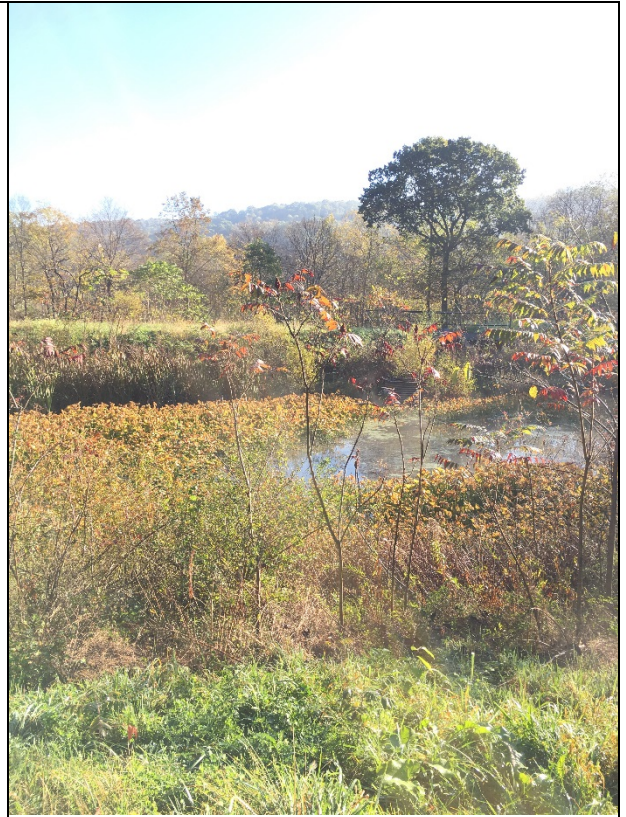
Photograph No. 21**Date:**

Sedimentation Pond. Healthy vegetation on sideslopes.

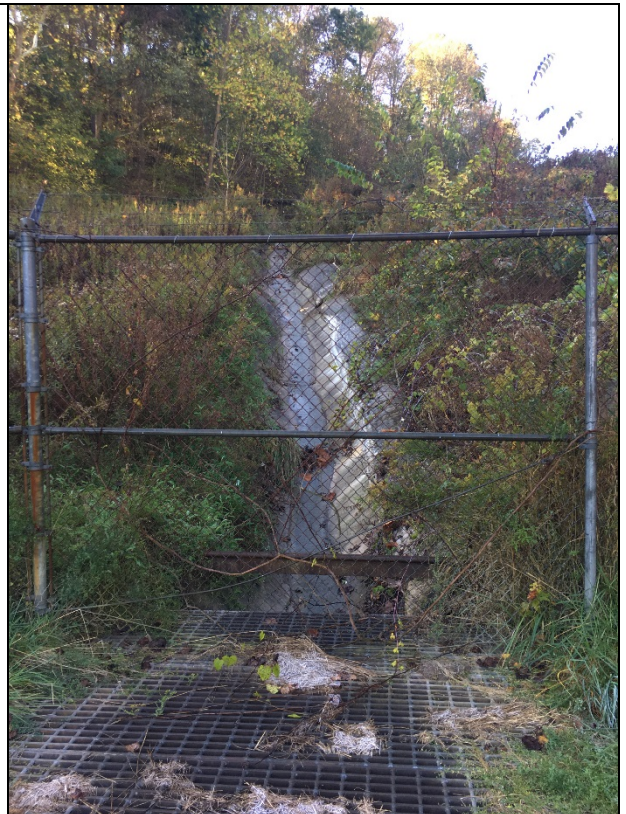
**Photograph No. 22****Date:**

South non-contact water channel at entry point into Sedimentation Pond (looking upslope). Free of debris and functioning as intended.

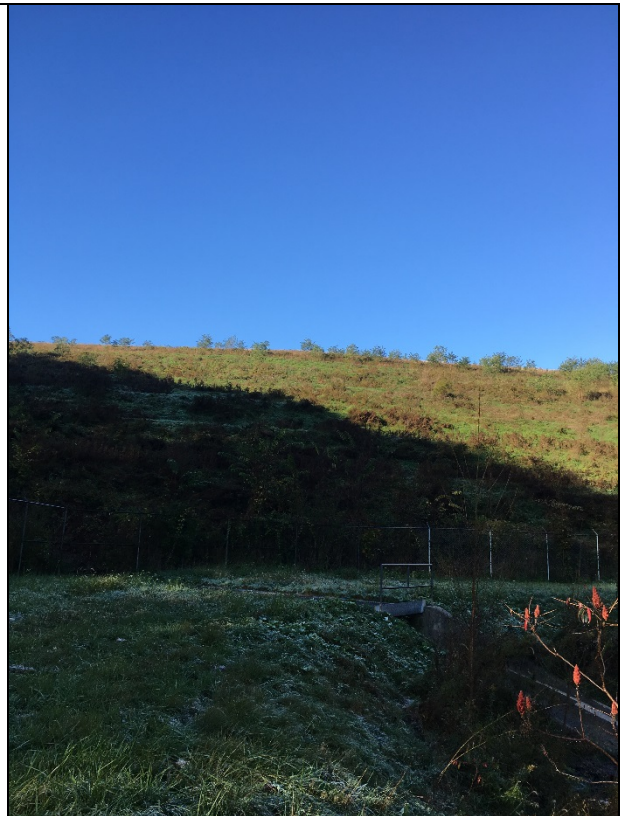
Photograph No. 24

Looking toward landfill sideslopes to give overview of healthy vegetation. No evidence of erosion, sloughing, or instability.

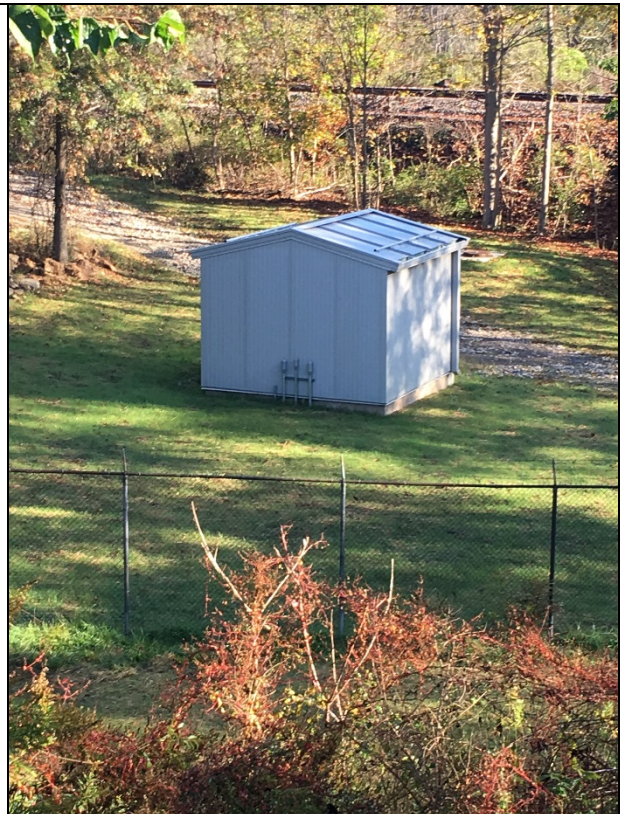
**Photograph No. 26****Date:**

Newly installed leachate pumphouse (2017).

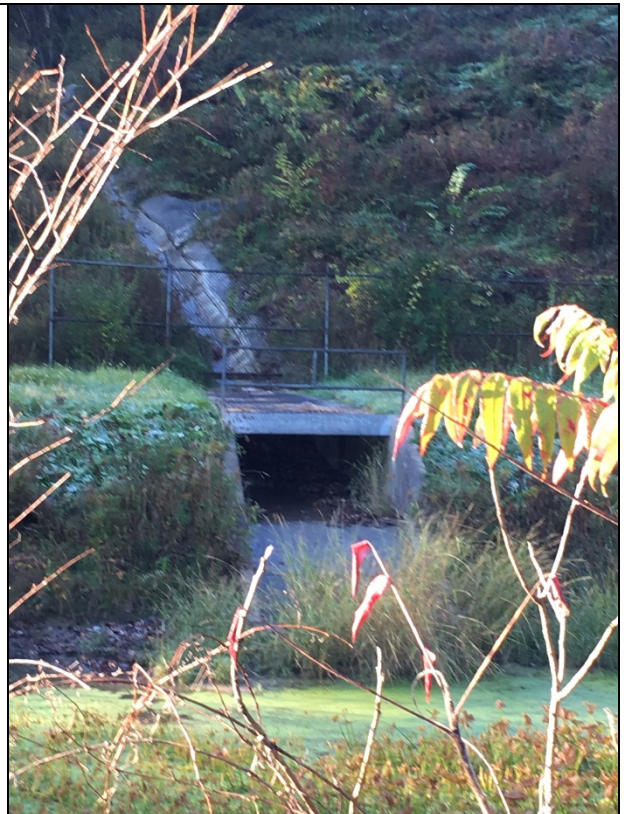
**Photograph No. 28****Date:**

South non-contact water channel inlet to Sedimentation Pond.

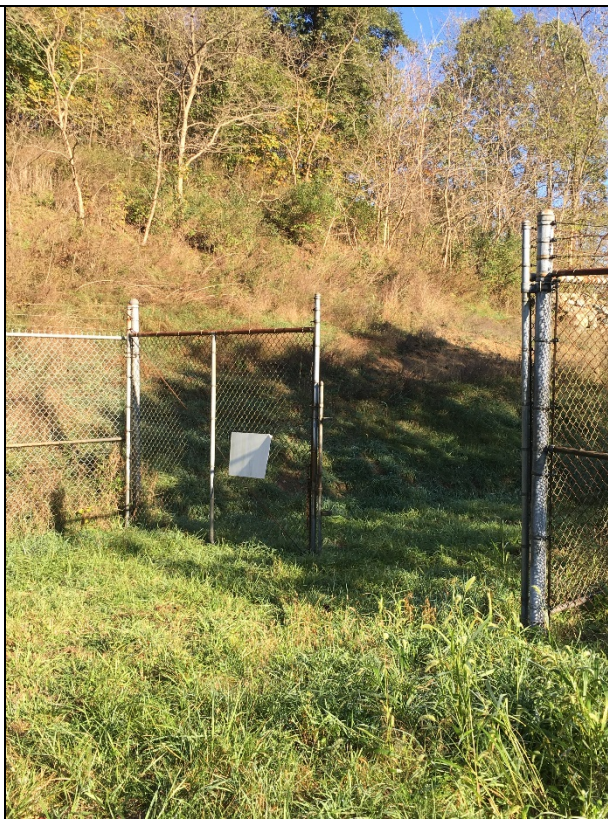
Photograph No. 29

Security fence around Sedimentation Pond.
