Inspection Report

Re: Cheswick Ash Disposal Site – Annual CCR Unit Inspection Report No. 2

Inspection Date: November 18, 2016

Report Date: January 16, 2017

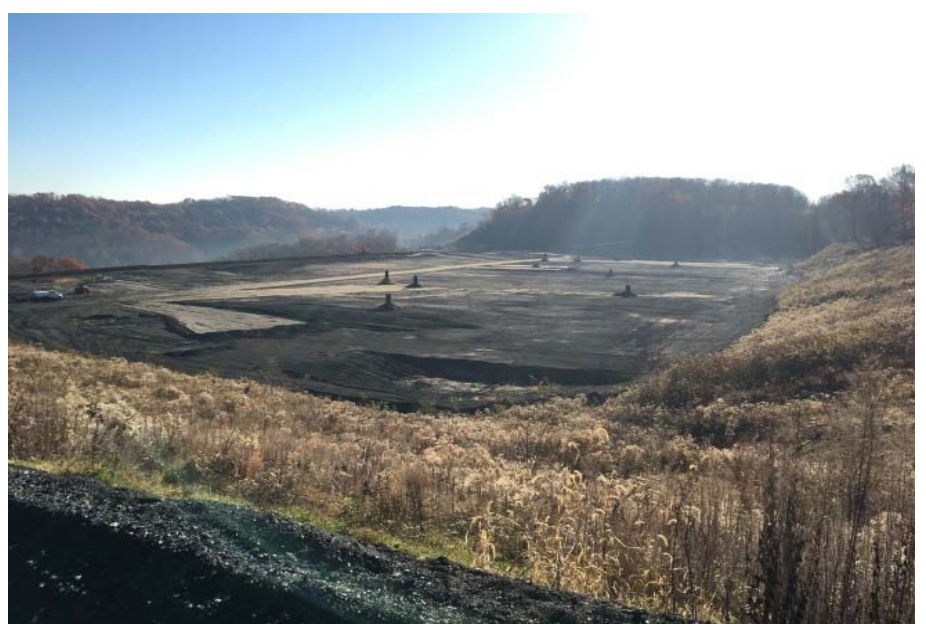
Photograph No. 1

Active filling area with leachate and “contact” stormwater collection manholes. No evidence of erosion or airborne dust.

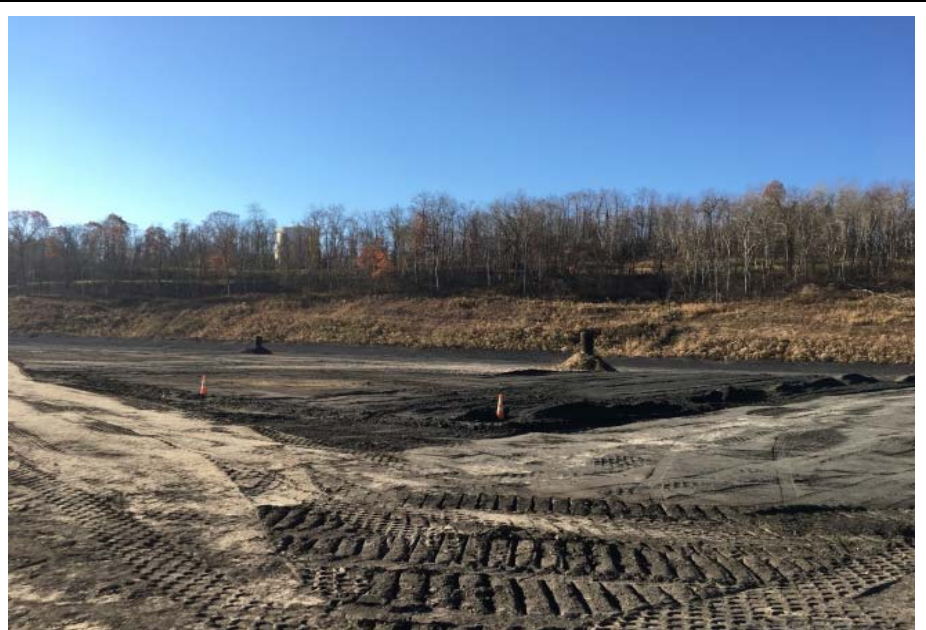
Photograph No. 2

Active filling area with collection manholes. No evidence of erosion or airborne dust. Gypsum and bottom ash materials noted.

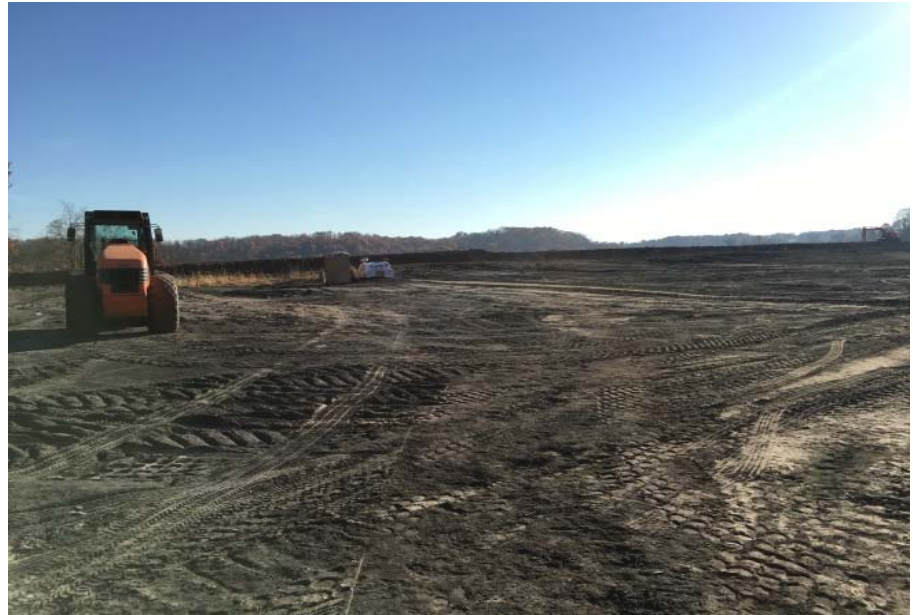
Photograph No. 3

Active filling operations in progress. No evidence of erosion or airborne dust.

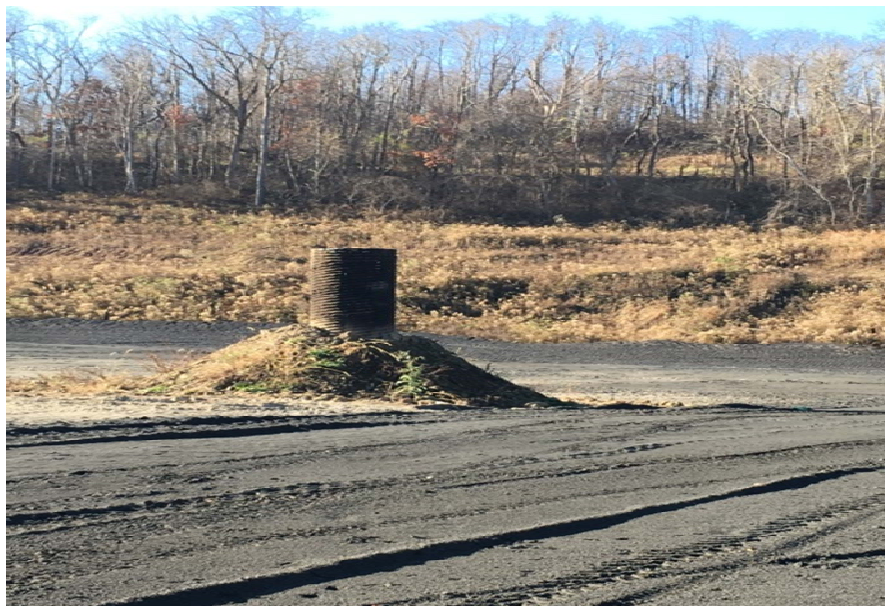
Photograph No. 4

"Contact" stormwater collection manhole. No evidence of distress or malfunction.

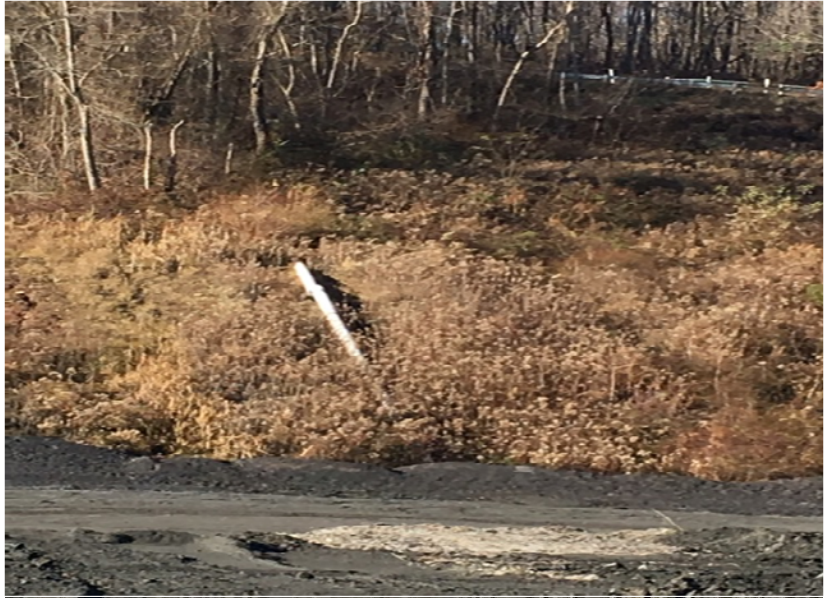
Photograph No. 5

"Non-contact" stormwater pipe along western side slope. No evidence of erosion or sloughing.

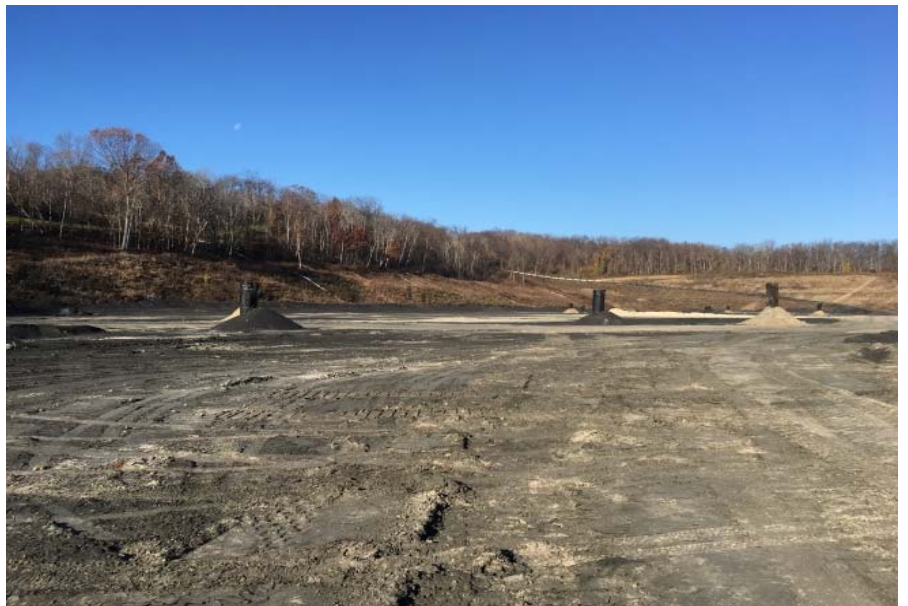
Photograph No. 6

Active filling area with leachate and "contact" stormwater collection manholes.

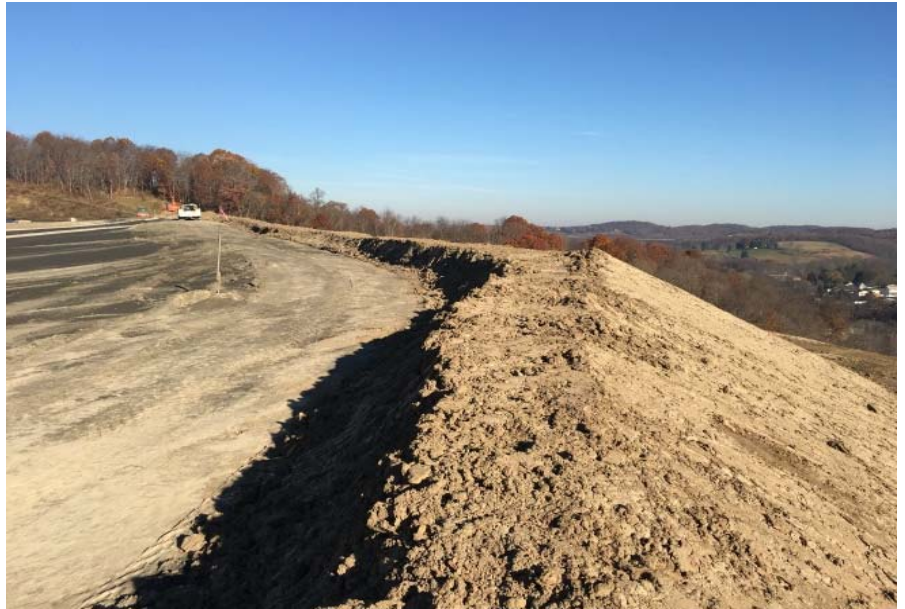
Photograph No. 7

Southern berm bounding the active filling area. No evidence of erosion, sloughing, or instability.

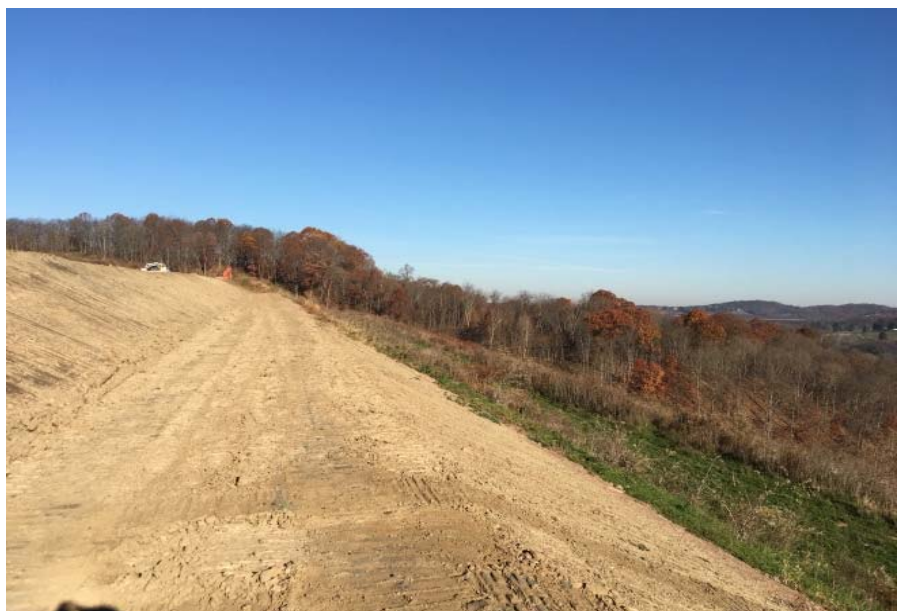
Photograph No. 8

Staged setback of the perimeter berm for the active area. Final cover will be installed following the completion of the active area perimeter berm. No evidence of erosion, sloughing, or instability.

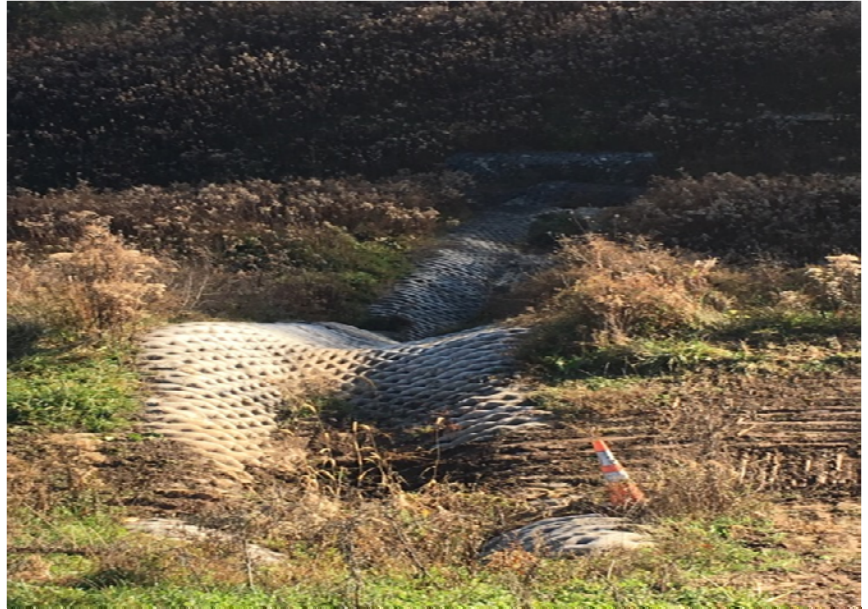
Photograph No. 9

"Non-contact" stormwater downchute installed within final cover along eastern side slope. No evidence of flow obstruction.

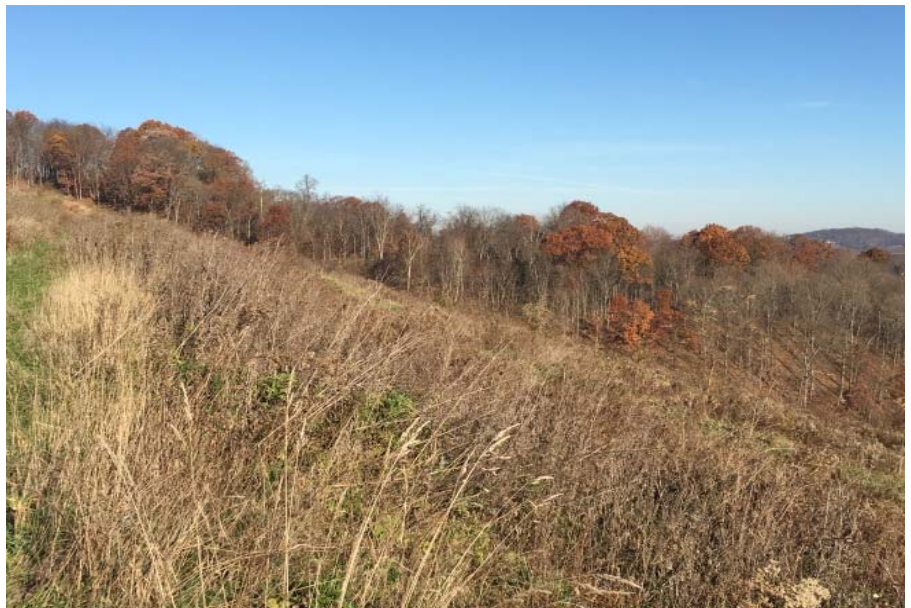
Photograph No. 10

Final cover system along eastern side slope. Vegetation is well established and maintained. No evidence of erosion or sloughing.

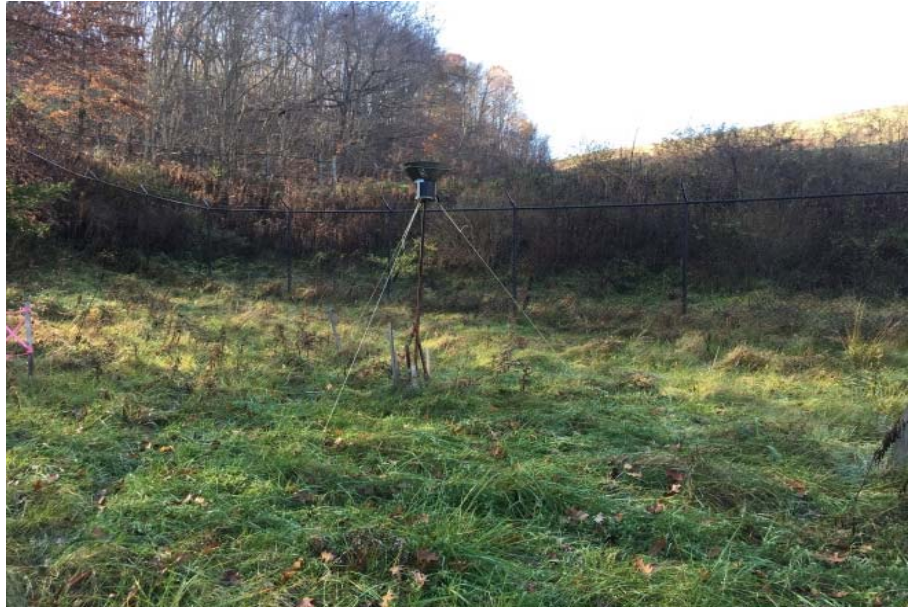
Photograph No. 11

Dust-fall monitor utilized to assess potential fugitive emissions.

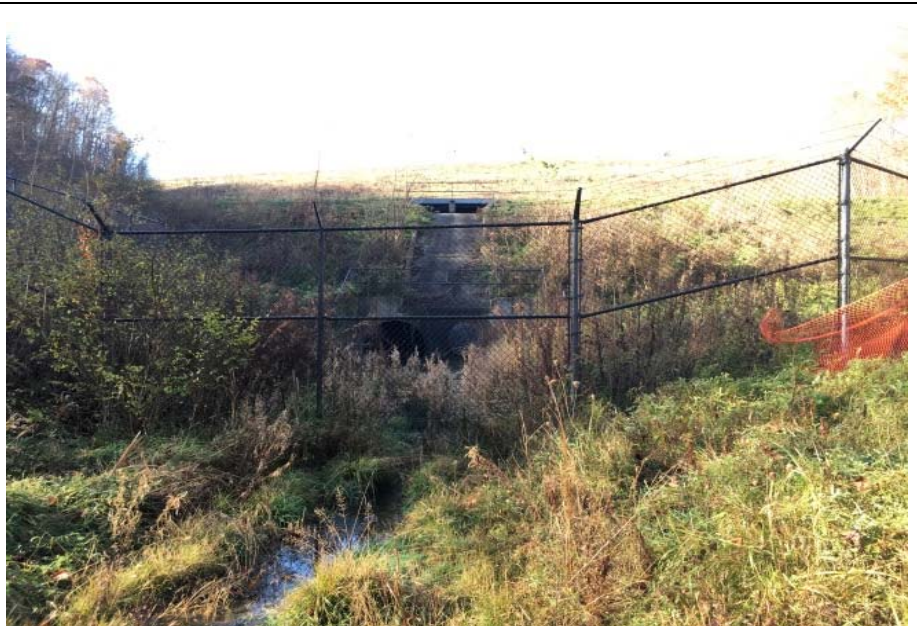
Photograph No. 12

Sedimentation pond ("non-contact" stormwater) outlet flume and pipe structure. No evidence of malfunction or flow obstruction.

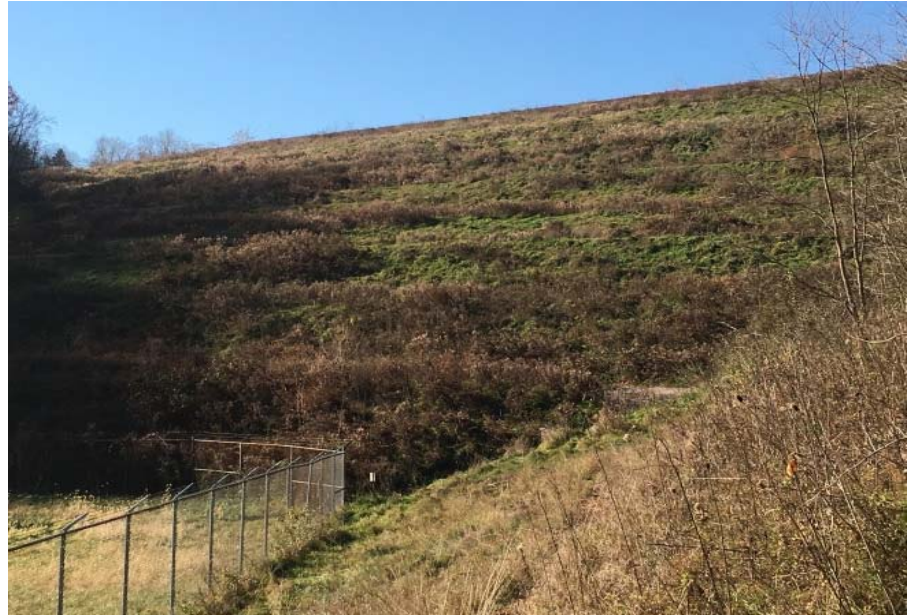
Photograph No. 13

Final cover system along the lower half of the landfill. Vegetation is well established and maintained. No evidence of erosion or sloughing. No slope stability issues identified.

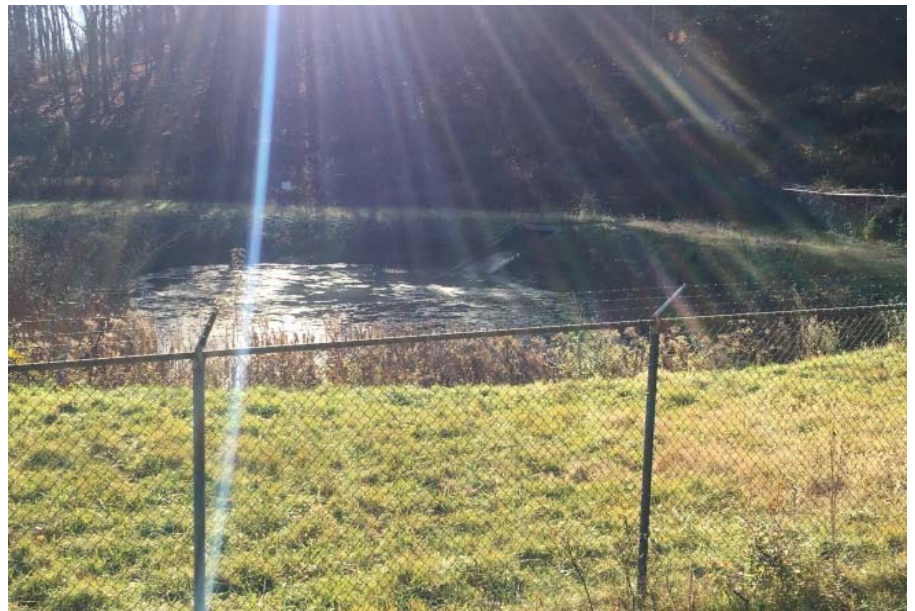
Photograph No. 14

Sedimentation pond. No evidence of sloughing or malfunction.

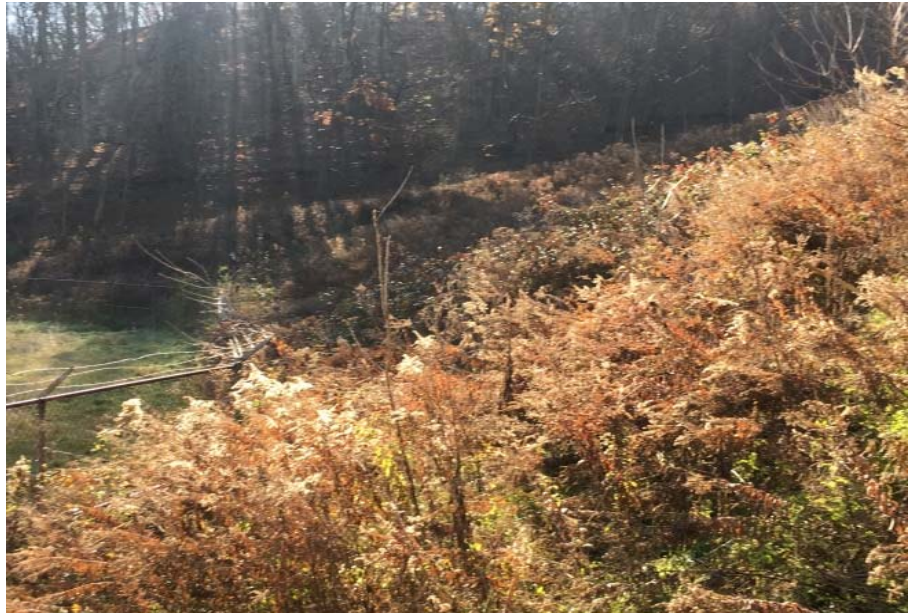
Photograph No. 15

Eastern slope final cover. No evidence of erosion or sloughing.

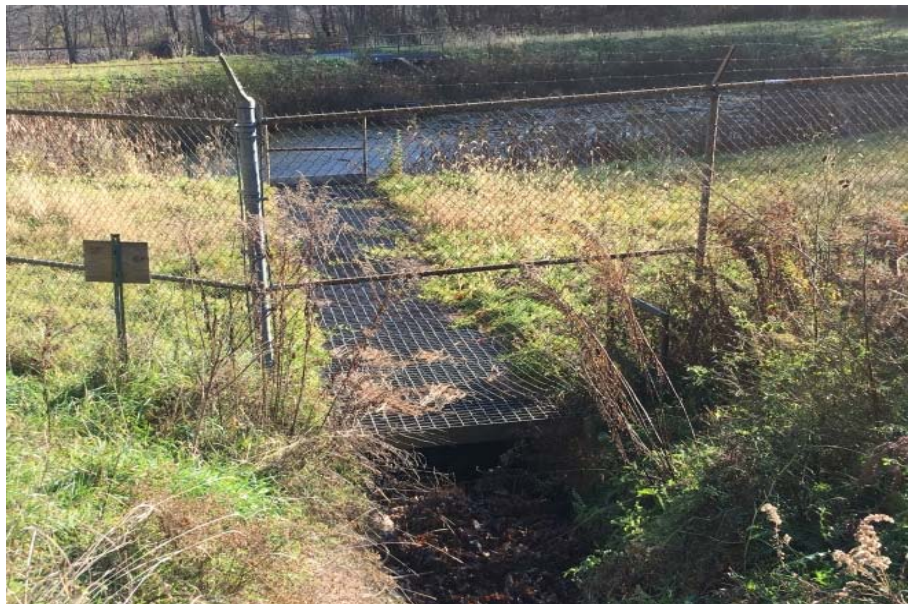
Photograph No. 16

Inlet channel (one of two) to the sedimentation pond.
