## **Inspection Report**

**To:** Norman Divers (Charah Solutions, Inc.)  
**From:** Robert Stolz, P.E., P.G.  
**Re:** Cheswick Ash Disposal Site – Annual CCR Unit Inspection Report  
**Inspection Date:** November 03, 2022  
**Report Date:** January 11, 2023

**Project:** Cheswick Landfill 2022 Annual Inspection

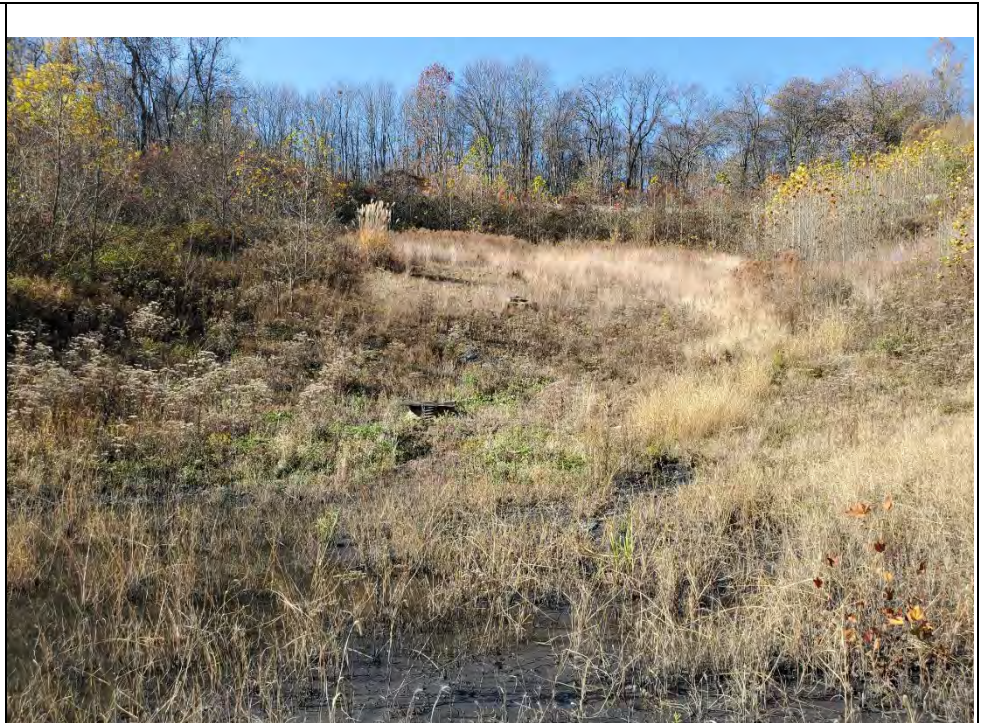
Image: 1  
Date: 11/03/2022  
Time: 11:28 AM  
Direction: West-Northwest

View upslope from active placement area with non-contact stormwater junction box riser visible at center. Well vegetated with no erosion or instability evident.

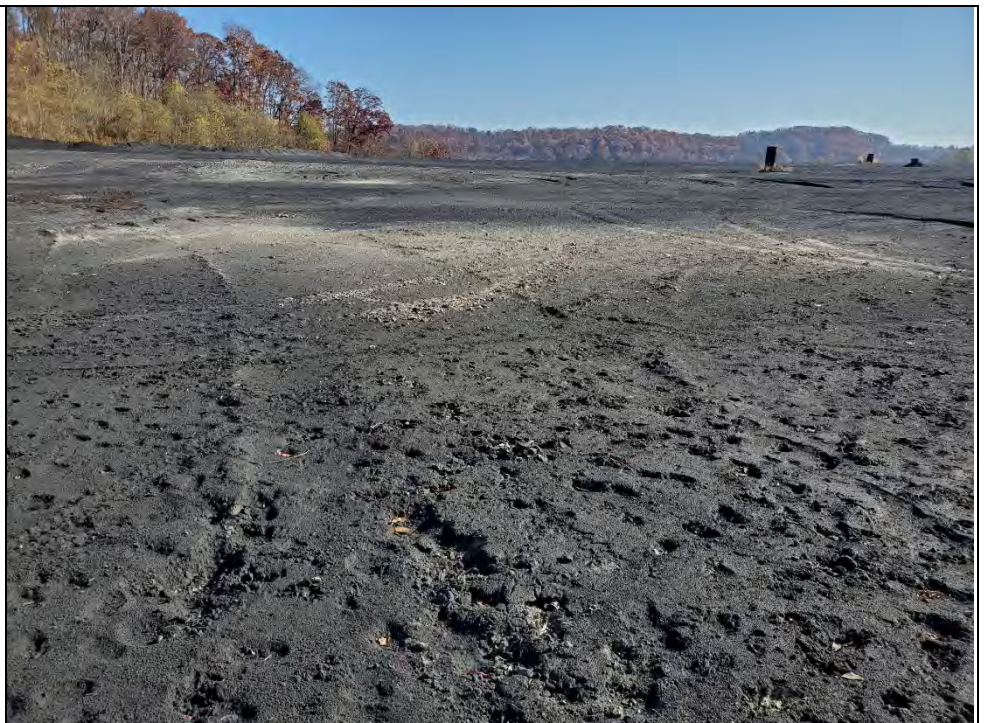
Image: 2  
Date: 11/03/2022  
Time: 11:30 AM  
Direction: East-Northeast

**Description:** View of active placement area. Graded and compacted.

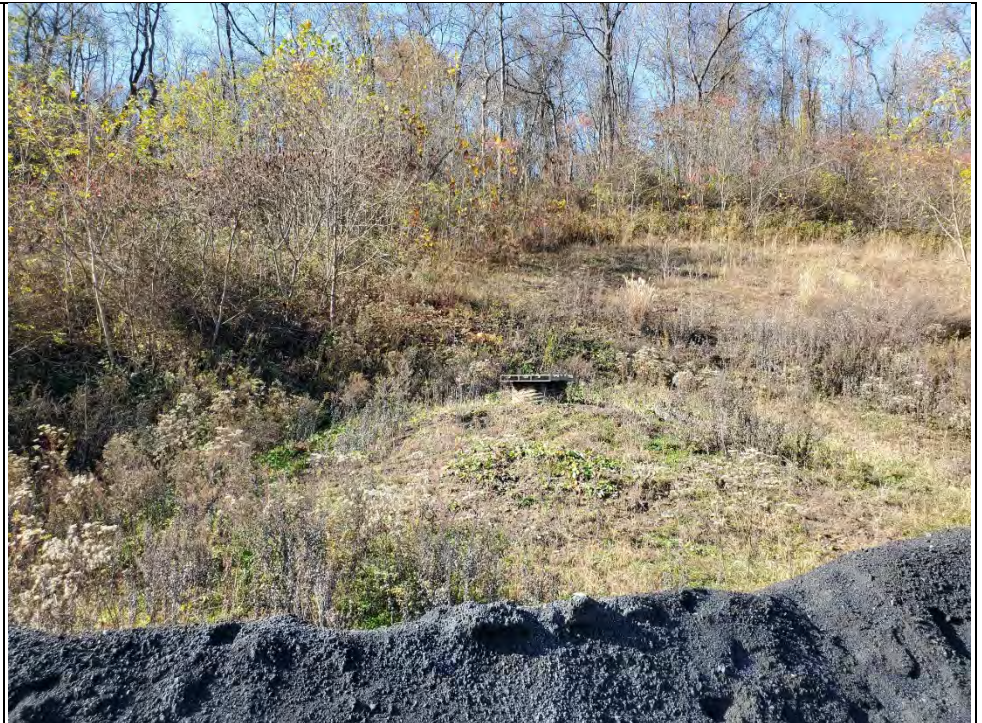
Image: 3  
Date: 11/03/2022  
Time: 11:32 AM  
Direction: West-Southwest

View upslope from active placement area with non-contact stormwater junction box riser visible at center. Well vegetated with no erosion or instability evident.

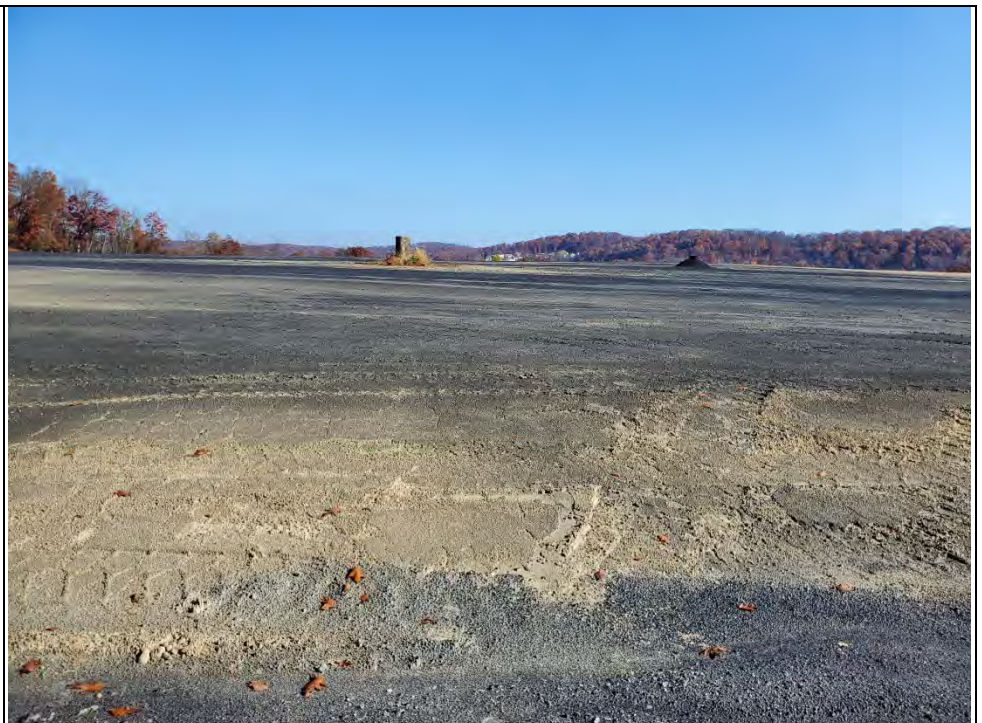
Image: 4  
Date: 11/03/2022  
Time: 11:35 AM  
Direction: East-Northeast

View of active placement area. Graded and compacted.

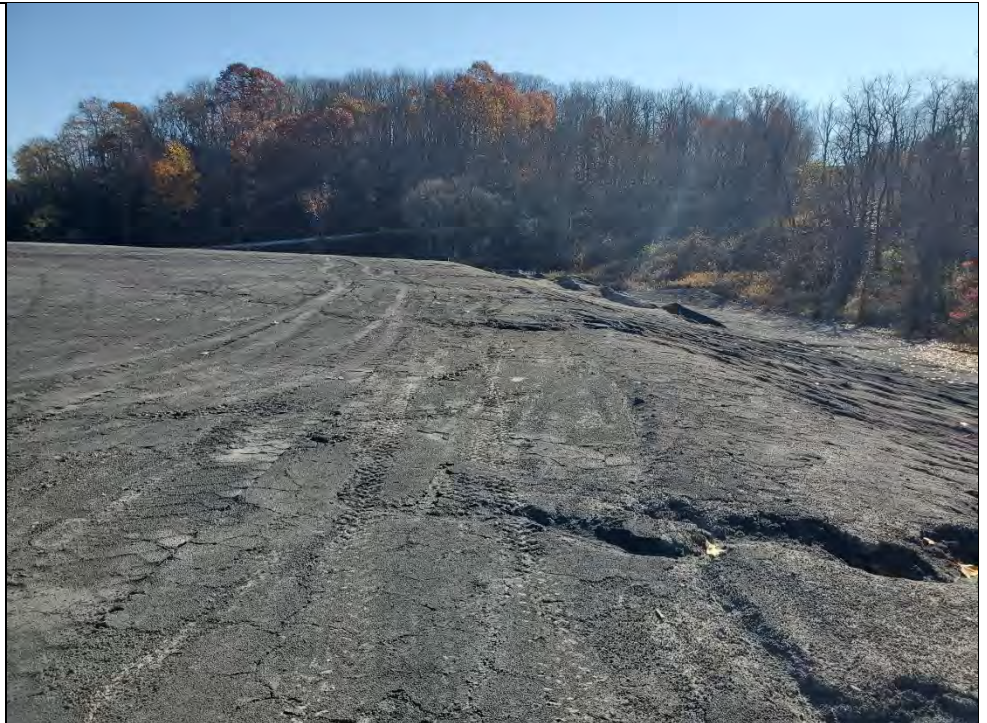
Image: 5  
Date: 11/03/2022  
Time: 11:42 AM  
Direction: South-Southeast

View of active placement area. Graded and compacted, with recent minor erosion rills. Contact water (leachate) drains to leachate collection layer.

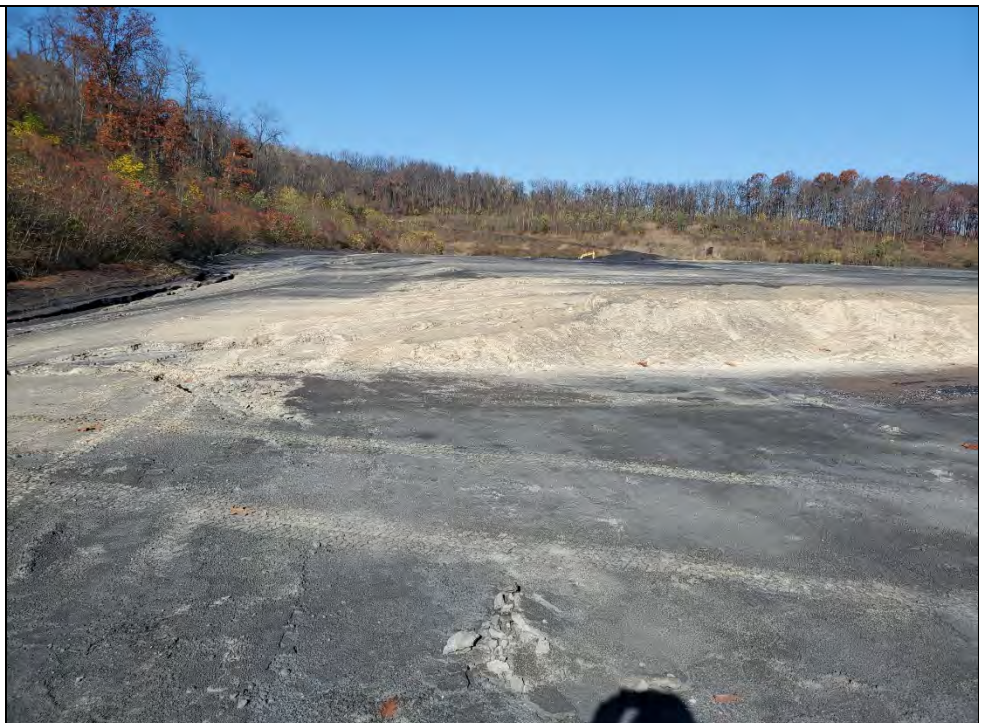
Image: 6  
Date: 11/03/2022  
Time: 11:43 AM  
Direction: North-Northwest

View of active placement area. Graded and compacted. Contact water (leachate) drains to leachate collection layer.

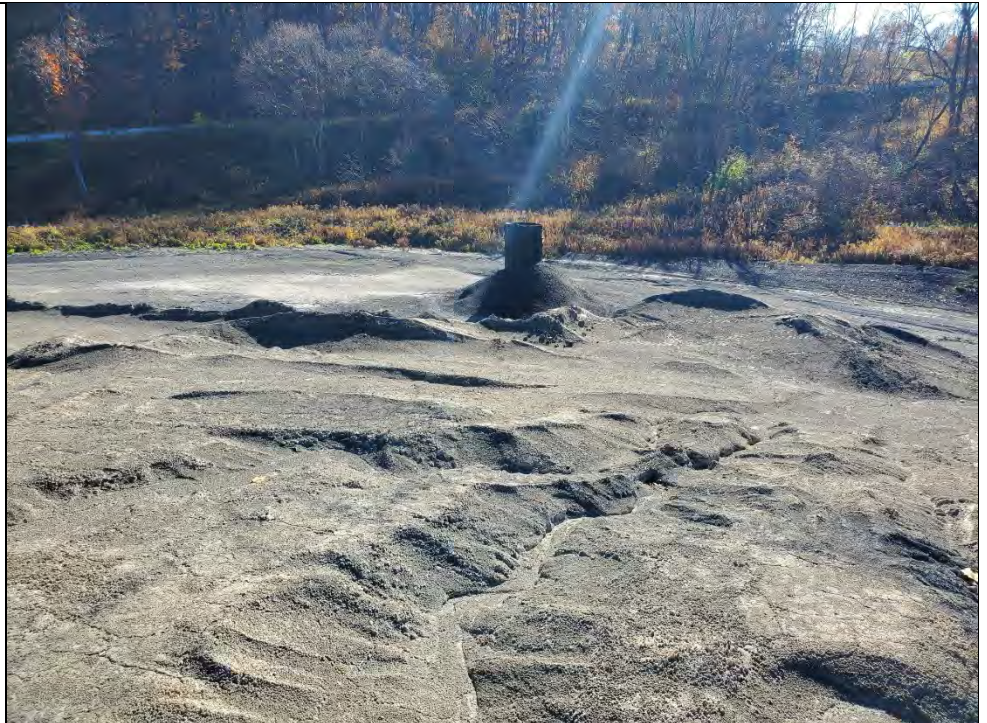
Image: 7  
Date: 11/03/2022  
Time: 11:45 AM  
Direction: South-Southeast

View of active placement area. Contact water (leachate) drains to leachate collection layer. Contact water (leachate) riser is present in center of photo.

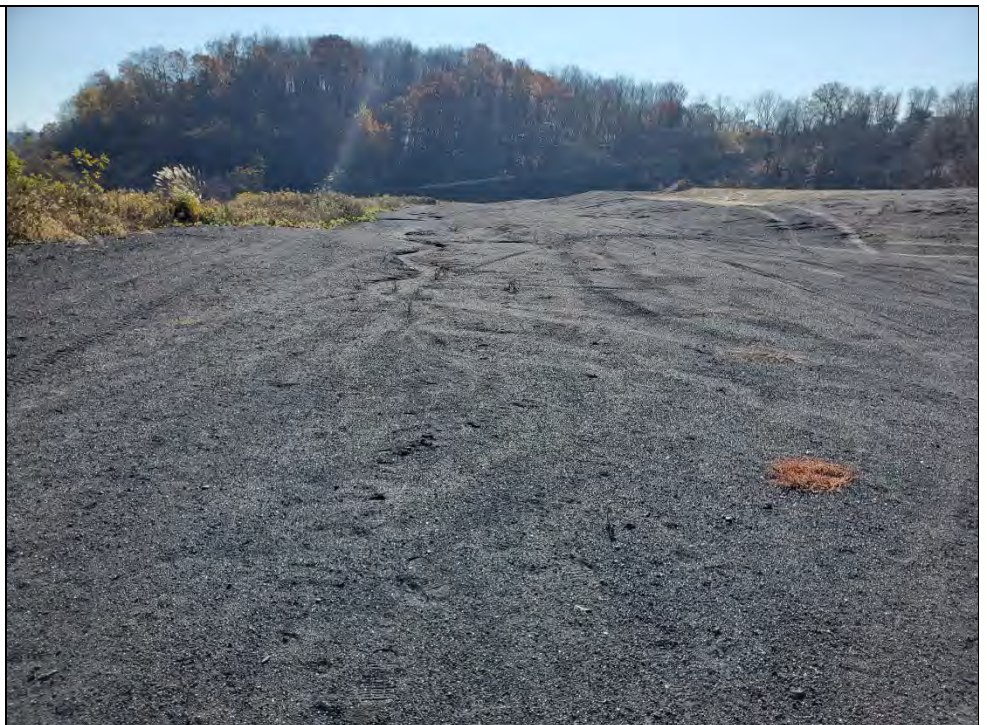
Image: 8  
Date: 11/03/2022  
Time: 11:52 AM  
Direction: South

View of active placement area. Graded and compacted. Contact water (leachate) drains to leachate collection layer.

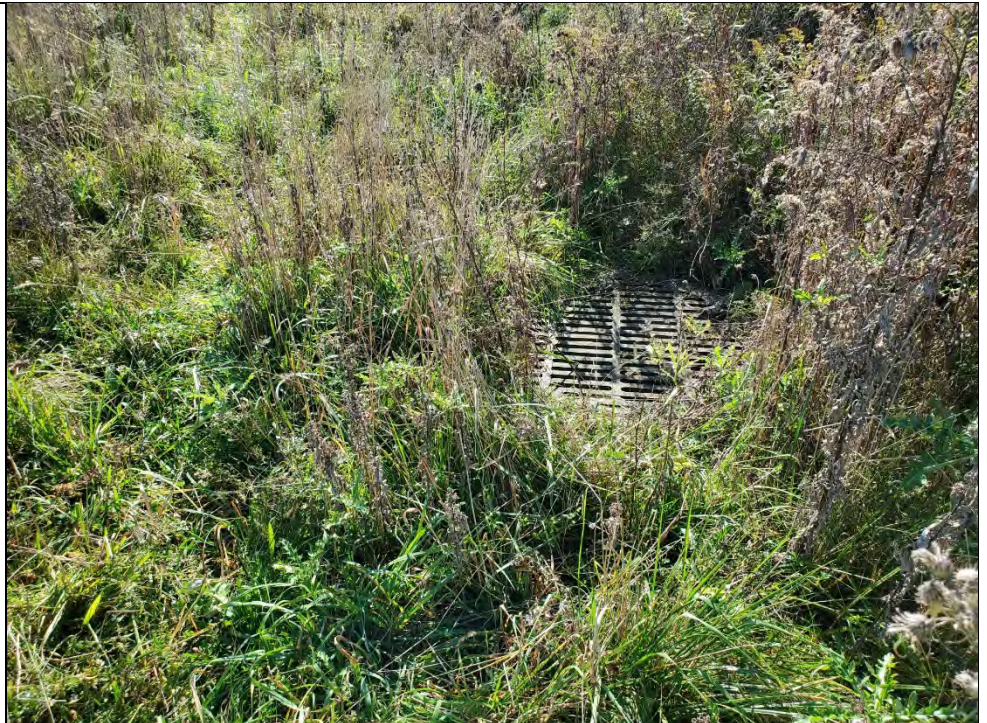
Image: 9  
Date: 11/03/2022  
Time: 12:03 PM  
Direction: South-Southeast

View of upper bench and non-contact stormwater inlet on east landfill slope. Well vegetated with no indications of erosion or instability.

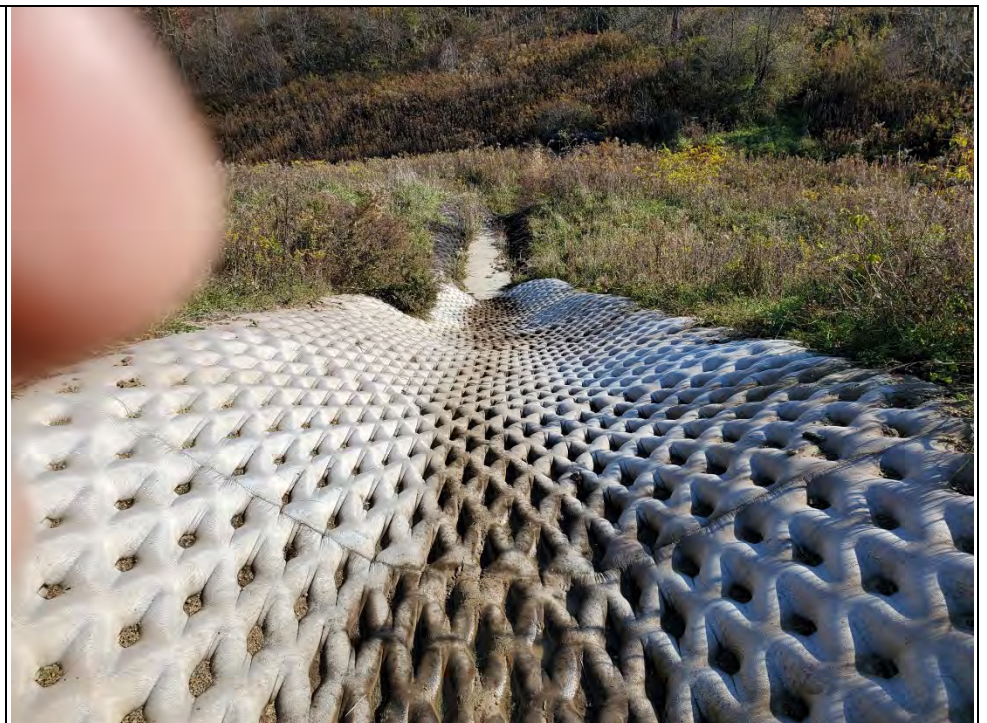
Image: 10  
Date: 11/03/2022  
Time: 12:05 PM  
Direction: Southeast

View of revetment-lined stormwater channel at the south end of the upper bench on the east landfill slope. Channel is in good condition with no obstructions.

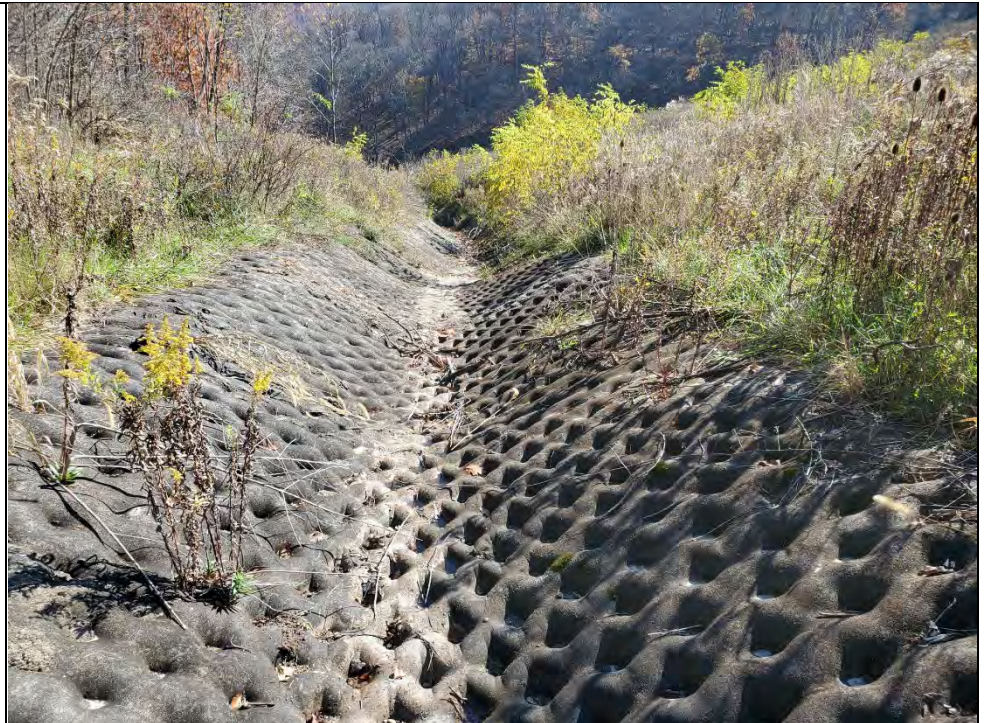
Image: 11  
Date: 11/03/2022  
Time: 12:34 PM  
Direction: Southeast

View of revetment-lined stormwater channel at the north edge of the east landfill slope. Channel is in good condition with no obstructions.

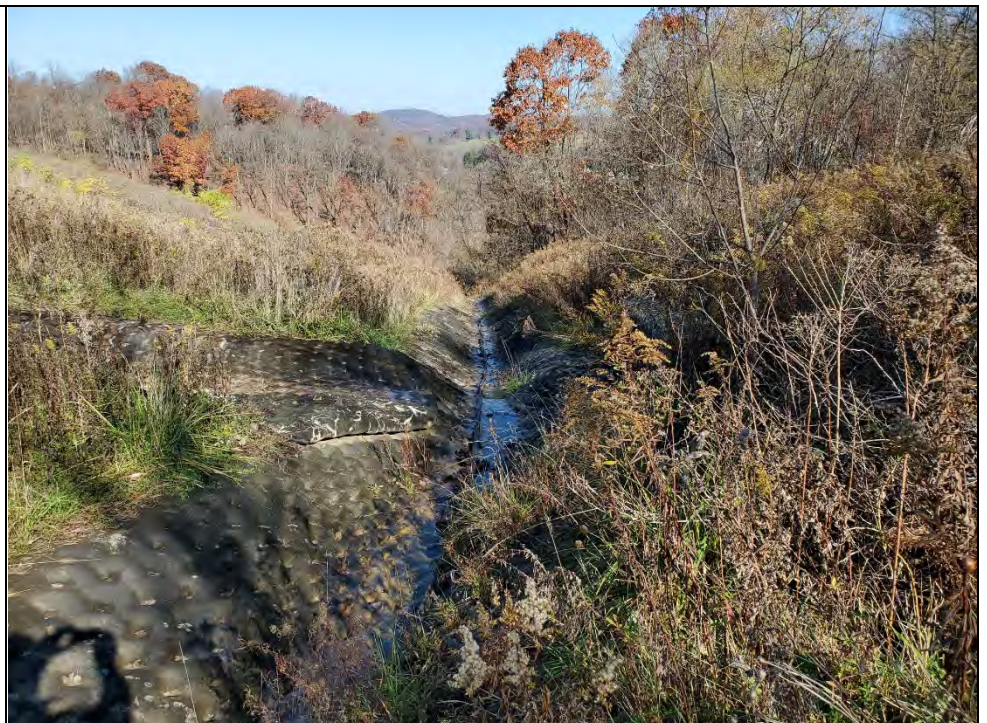
Image: 12  
Date: 11/03/2022  
Time: 12:09 PM  
Direction: Northeast

View of revetment-lined stormwater channel at the south edge of the east landfill slope (further downslope than Photo 10) Channel is in good condition with no obstructions.

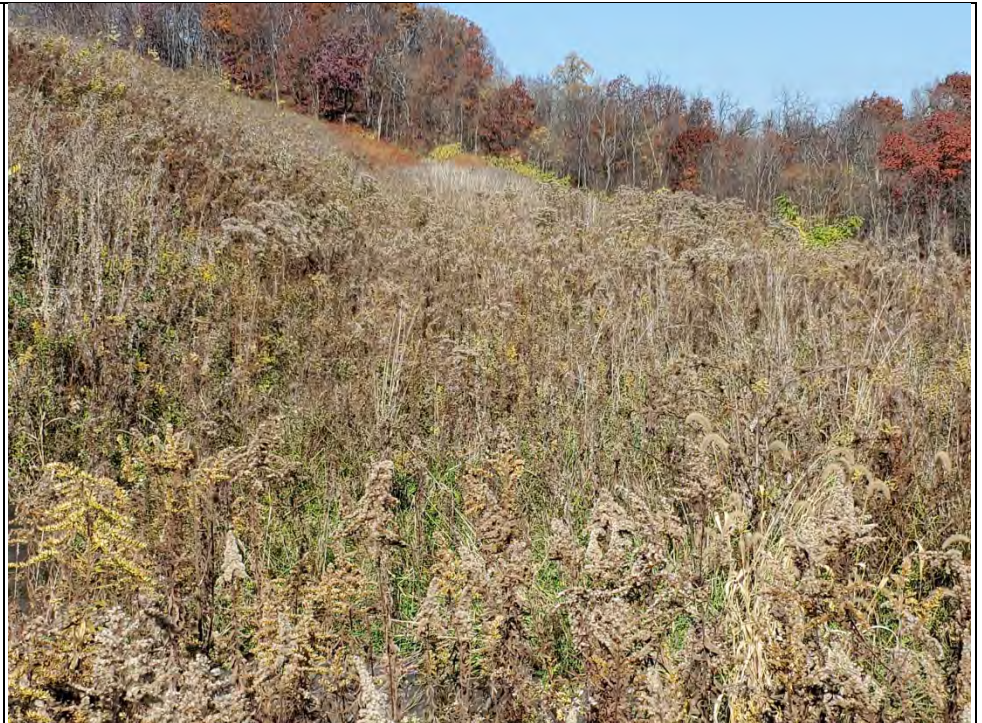
Image: 13  
 Date: 11/03/2022  
 Time: 12:10 PM  
 Direction: North

Northward view of well vegetated east landfill bench with no indication of erosion or instability. End of growing season mowing event has yet to take place.

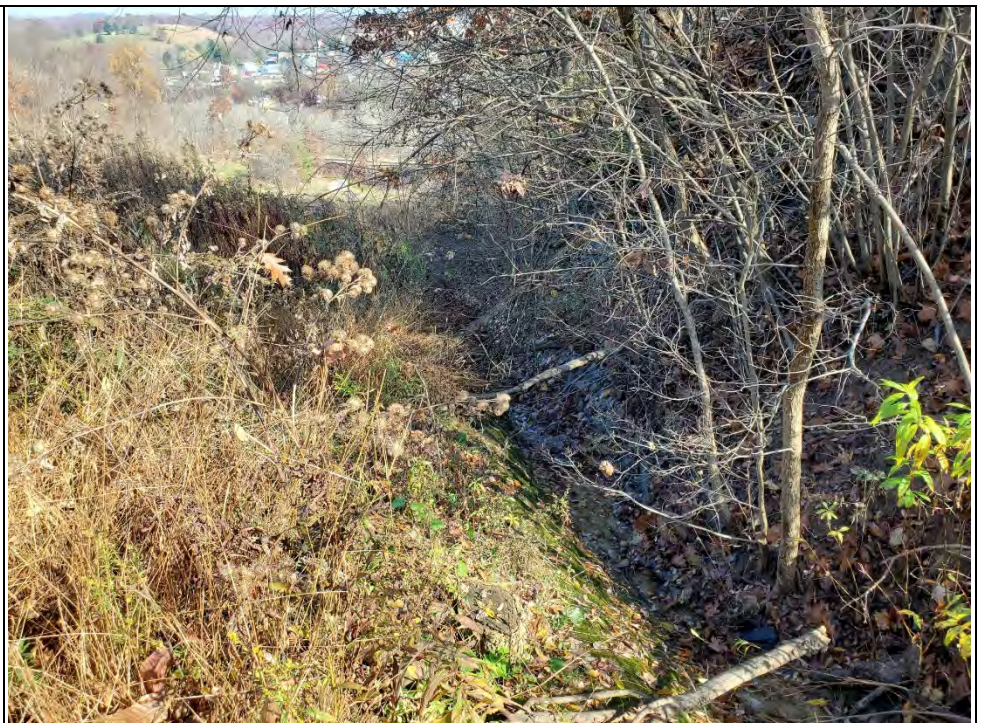
Image: 14  
 Date: 11/03/2022  
 Time: 12:17 PM  
 Direction: Northeast

View of concrete-lined stormwater channel at the south edge of the east landfill slope (further downslope than Photo 12).

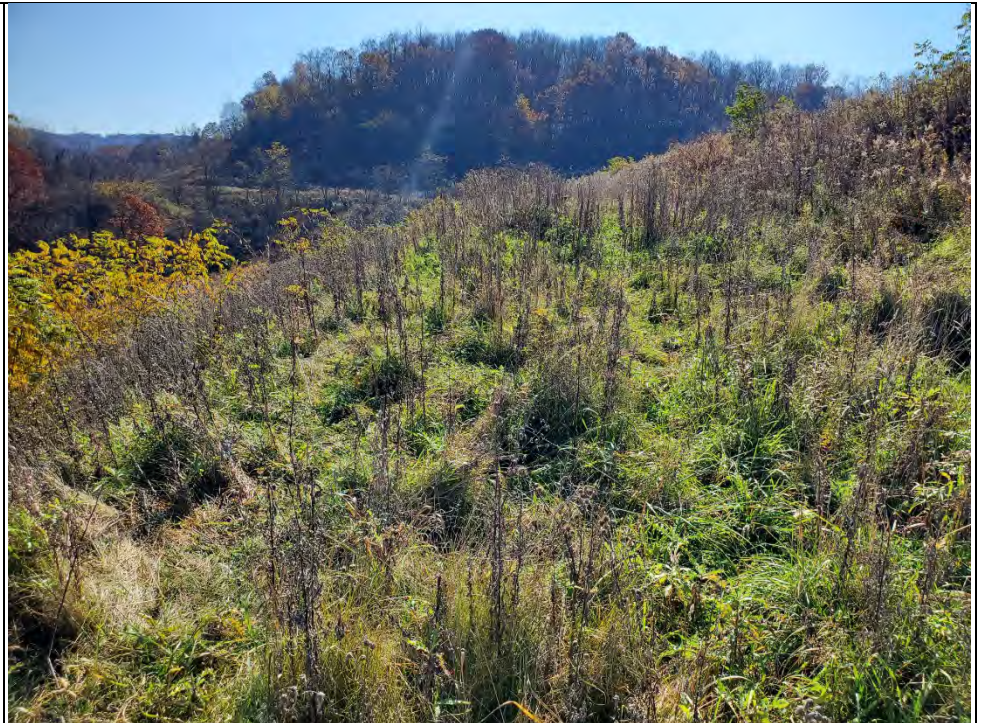
Image: 15  
Date: 11/03/2022  
Time: 11:55 AM  
Direction: South-Southeast

Southward view of well vegetated mid-slope landfill bench with no indication of erosion or instability.

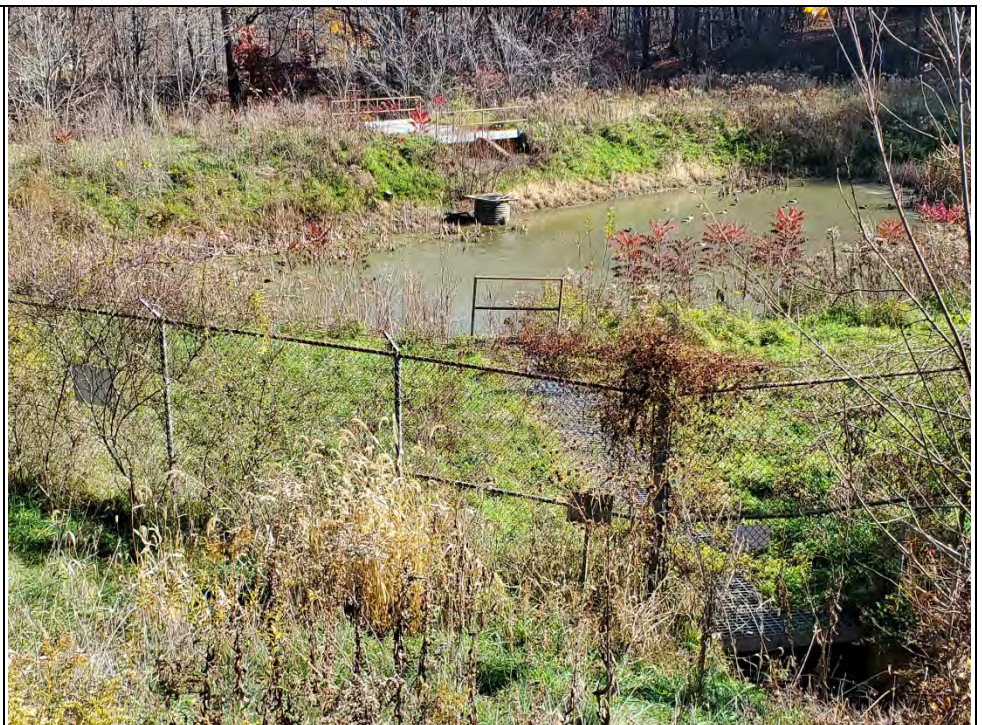
Image: 16  
Date: 11/03/2022  
Time: 12:58 PM  
Direction: East

View of non-contact stormwater channel leading to the Sedimentation Pond.

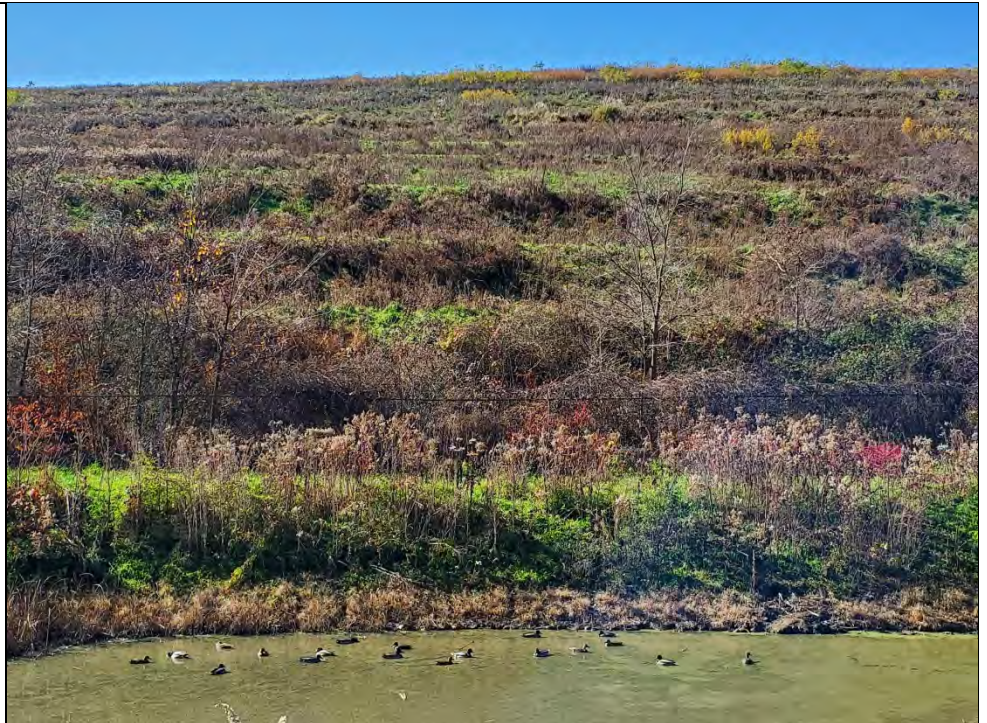
Image: 17  
Date: 11/03/2022  
Time: 1:01 PM  
Direction: West-Southwest

View of east side of landfill from Sedimentation Pond emergency spillway. Vegetation is well established with no indication of erosion or slope instability. Small trees are present which will be removed during the next mowing and maintenance event.

1. Continue operation and maintenance in the active areas as currently performed.
2. Clear woody vegetation from within landfill limits.
3. Ensure adequate access to the closed portions of the landfill to maintain the ability to perform weekly visual site structural inspections.

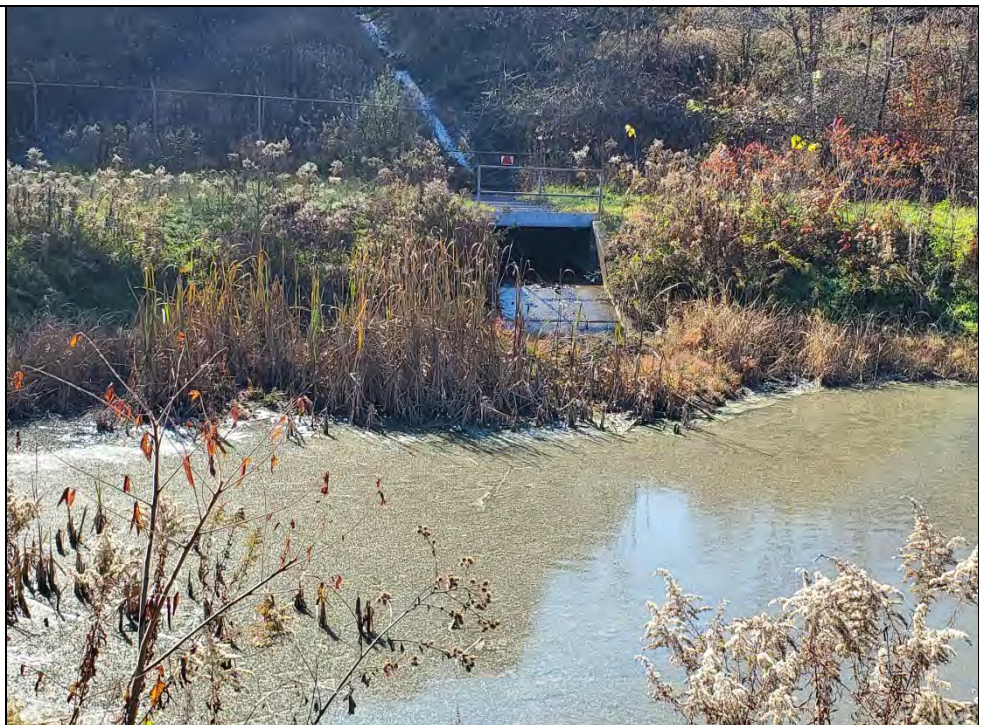
Image: 18  
Date: 11/03/2022  
Time: 1:01 PM  
Direction: Southwest

Concrete-lined non-contact stormwater channel entering the Sedimentation Pond. Surrounding area is vegetated with no indication of erosion or instability.

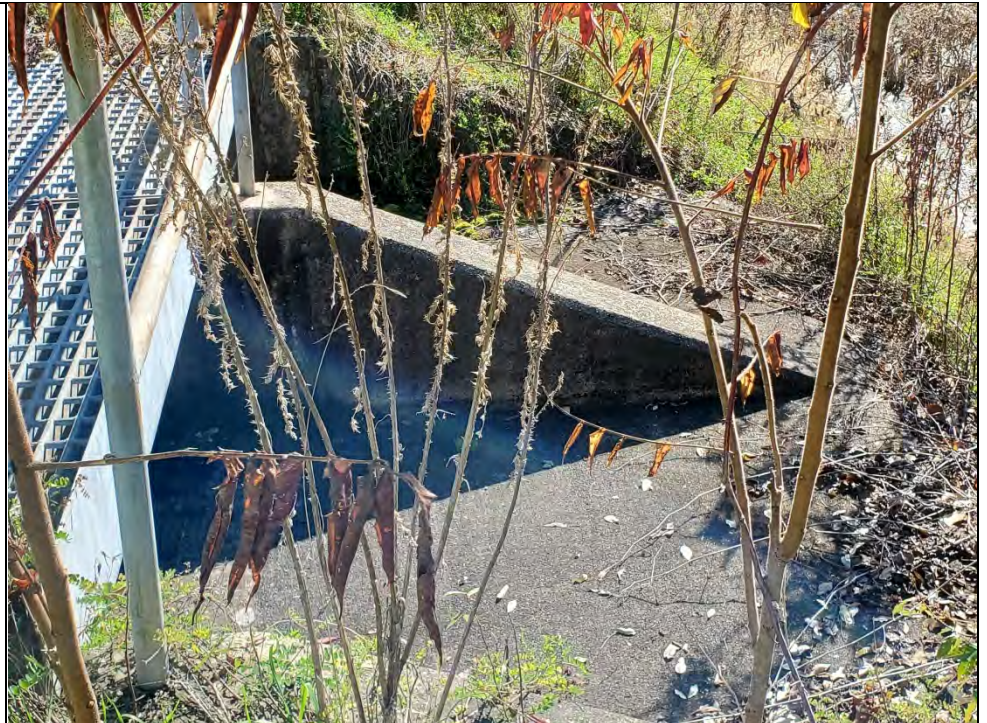
Image: 19  
Date: 11/03/2022  
Time: 1:02 PM  
Direction: Southeast

View of emergency spillway inlet at the Sedimentation Pond.

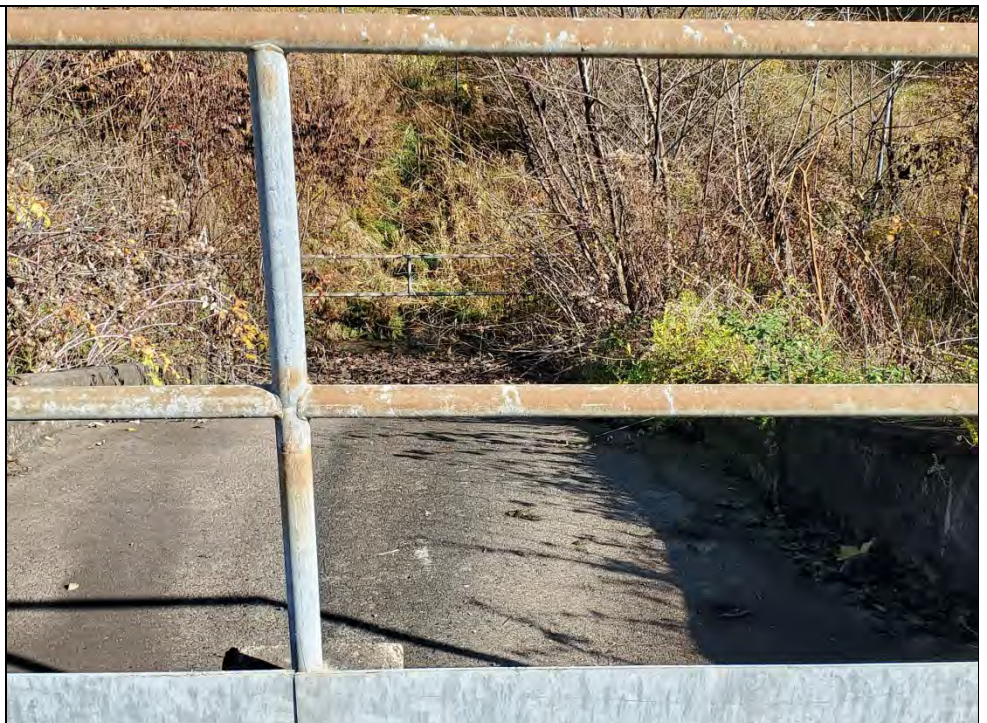
Image: 20  
Date: 11/03/2022  
Time: 1:02 PM  
Direction: Northeast

View of emergency spillway outlet at the Sedimentation Pond.

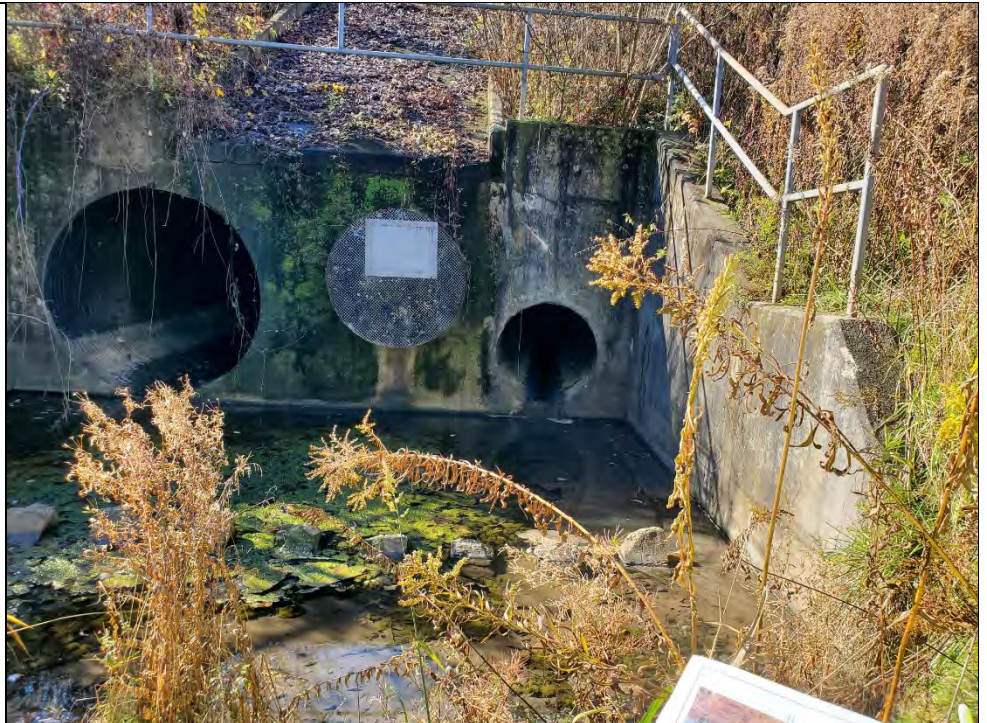
Image: 21  
Date: 11/03/2022  
Time: 1:07 PM  
Direction: Southwest

View of Sedimentation Pond emergency spillway outlet, non-contact stormwater outlet pipes, and capped contact stormwater (leachate) pipe. Contact stormwater drains to pump station.

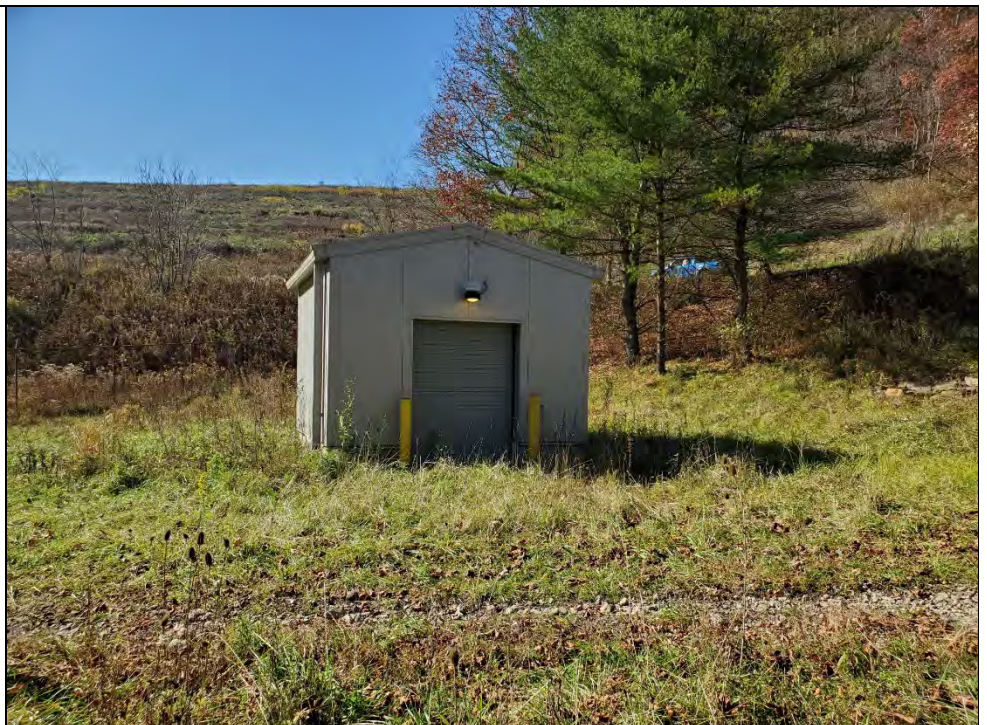
Image: 22  
Date: 11/03/2022  
Time: 1:10 PM  
Direction: Southwest

View of leachate pump station.
