## **Inspection Report**

**To:** Norman Divers (Charah Solutions, Inc.)  
**From:** Robert Stolz, P.E., P.G.  
**Re:** Cheswick Ash Disposal Site – Annual CCR Unit Inspection Report  
**Inspection Date:** December 04, 2024  
**Report Date:** January 14, 2025

**Project:** Cheswick Landfill 2024 Annual Inspection

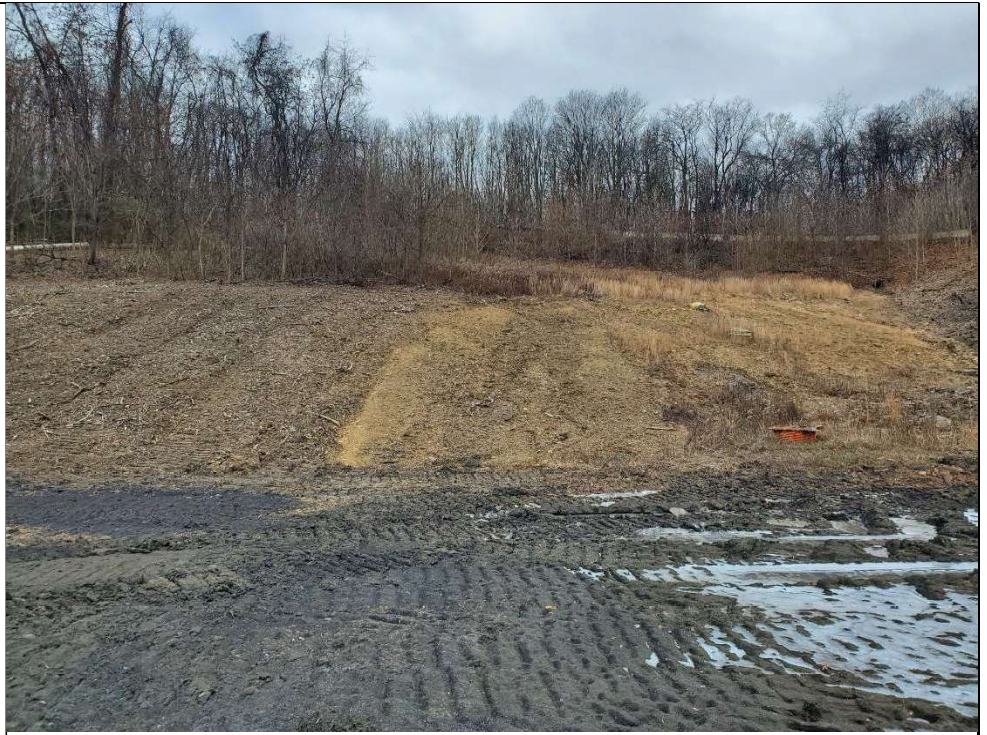
Image: 1  
Date: 12/04/2024  
Time: 10:10 AM  
Direction: West-Southwest

View upslope from active grading area with non-contact stormwater junction box riser visible to right. Slope cleared in preparation for re-grading.

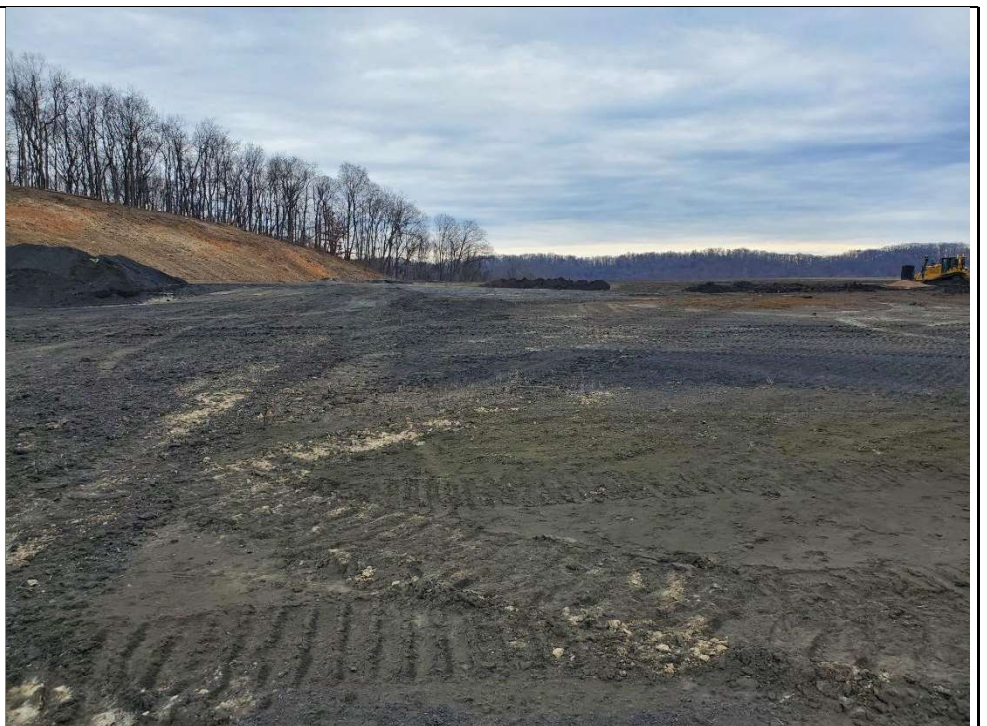
Image: 2  
Date: 12/04/2024  
Time: 10:11 AM  
Direction: East-Northeast

**Description:** View of active re-grading area.

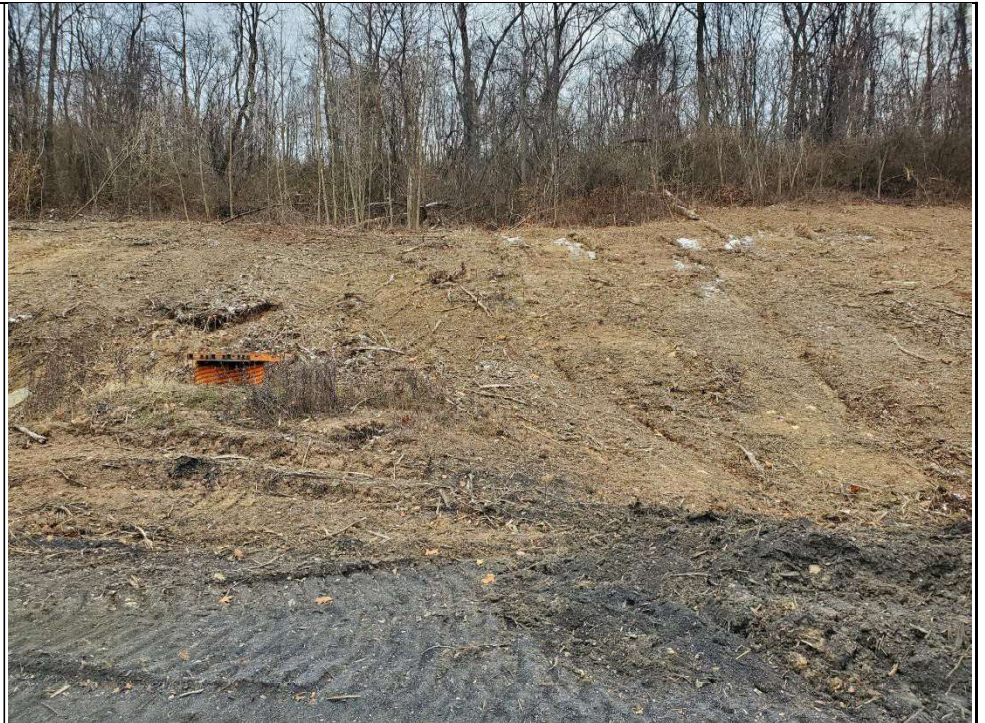
Image: 3  
Date: 12/04/2024  
Time: 10:13 AM  
Direction: West-Southwest

View upslope from active grading area with non-contact stormwater junction box riser visible to left. Vegetation cleared in preparation for re-grading activity.

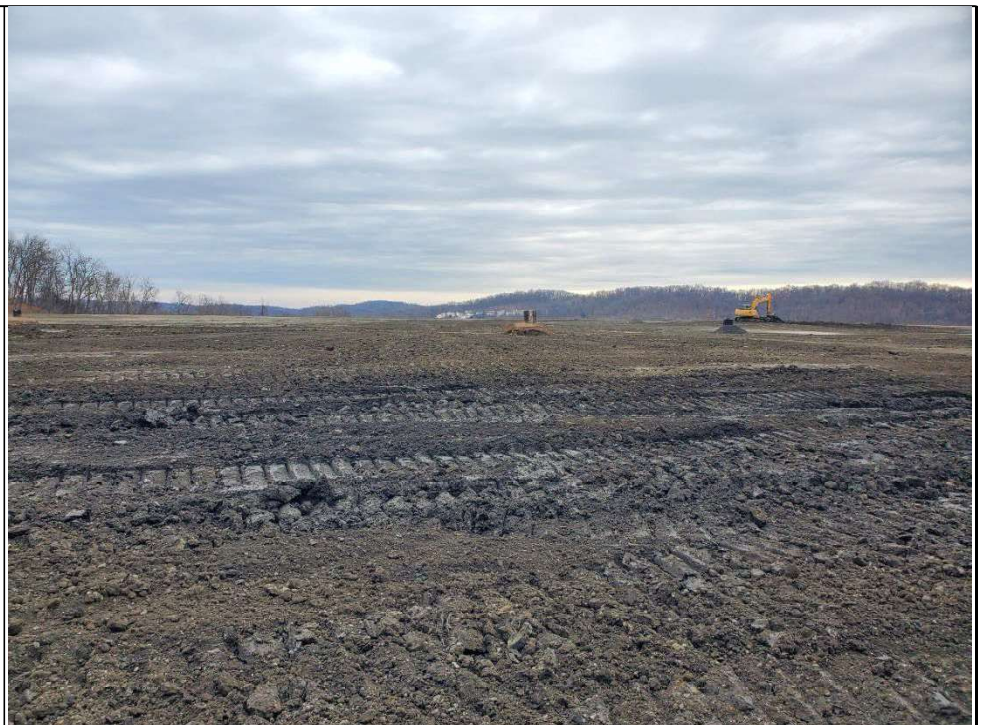
Image: 4  
Date: 12/04/2024  
Time: 10:14 AM  
Direction: East-Northeast

View of active re-grading.

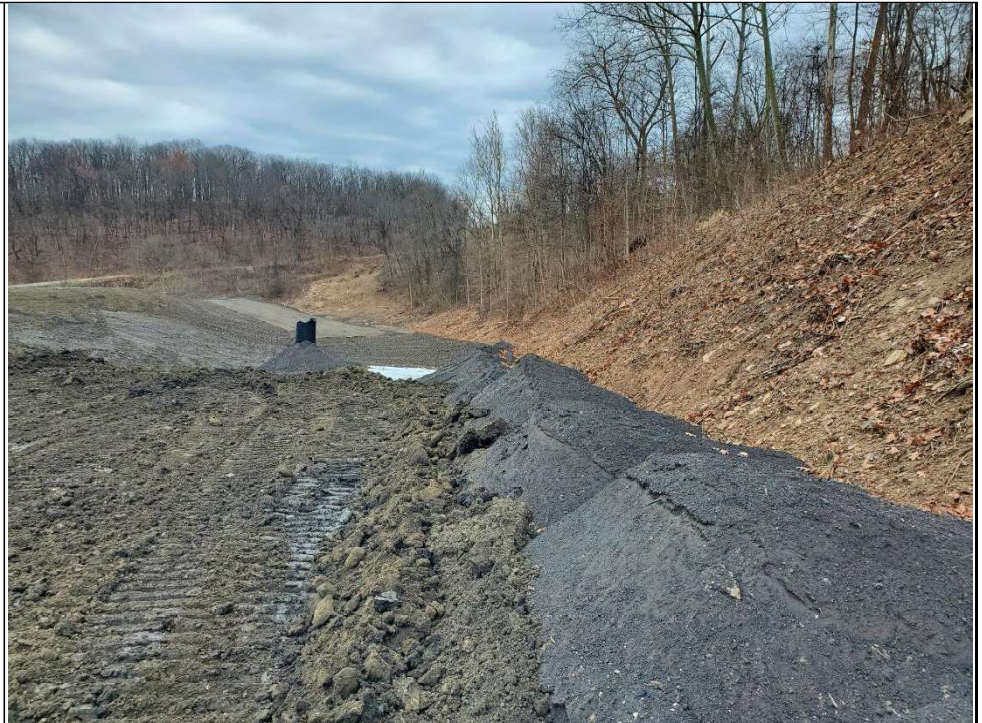
Image: 5  
Date: 12/04/2024  
Time: 10:16 AM  
Direction: South-Southeast

View of active re-grading.  
Contact water (leachate)  
drains to leachate  
collection layer.

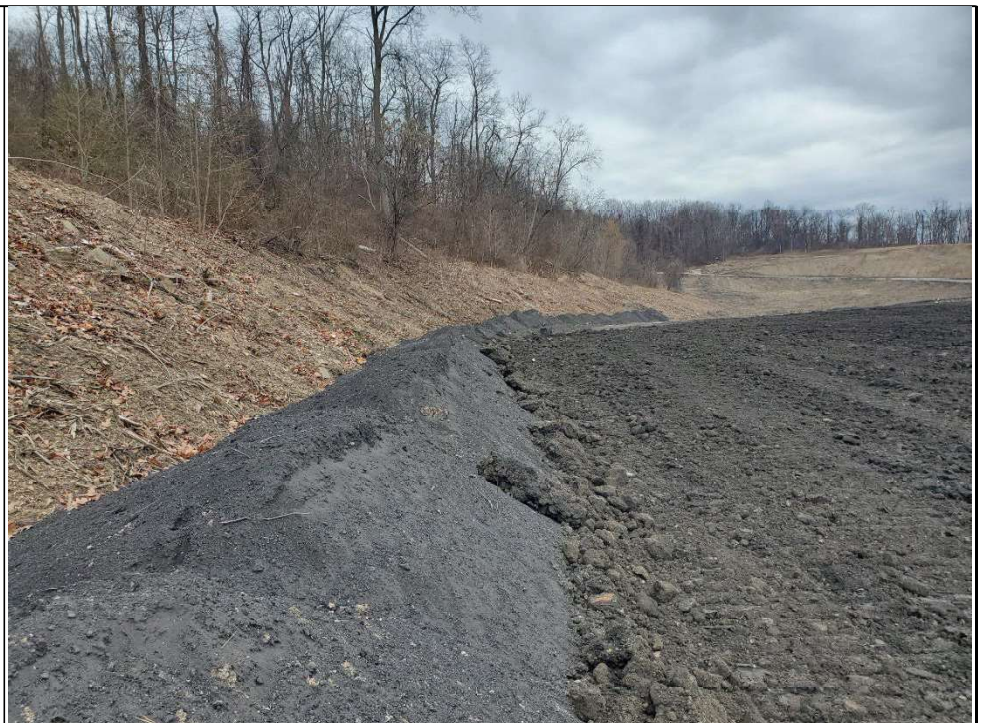
Image: 6  
Date: 12/04/2024  
Time: 10:16 AM  
Direction: North-Northwest

View of active re-grading.  
Contact water (leachate)  
drains to leachate  
collection layer.

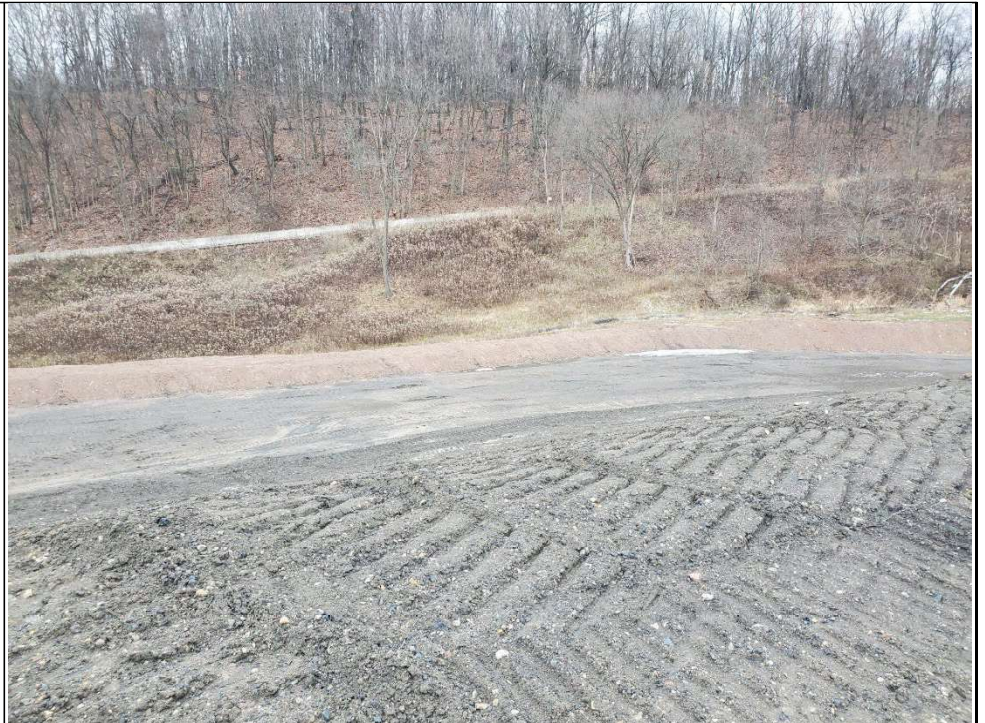
Image: 7  
Date: 12/04/2024  
Time: 10:19 AM  
Direction: South-Southeast

View of active re-grading.  
Contact water (leachate)  
drains to leachate  
collection layer.

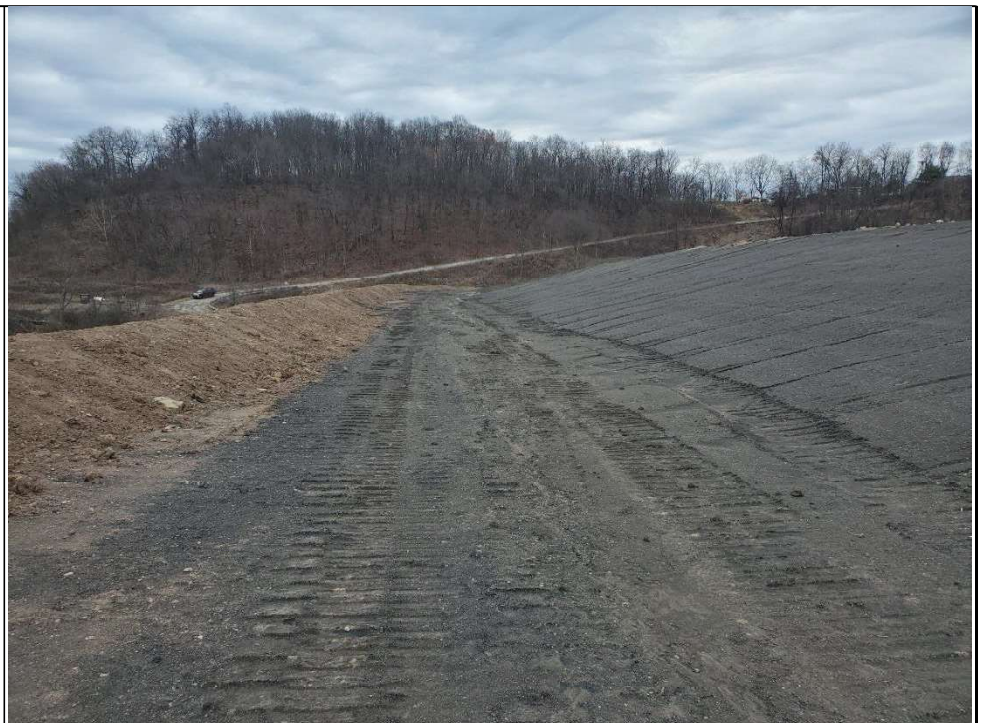
Image: 8  
Date: 12/04/2024  
Time: 10:22 AM  
Direction: South

View of active re-grading.  
Contact water (leachate)  
drains to leachate collection  
layer.

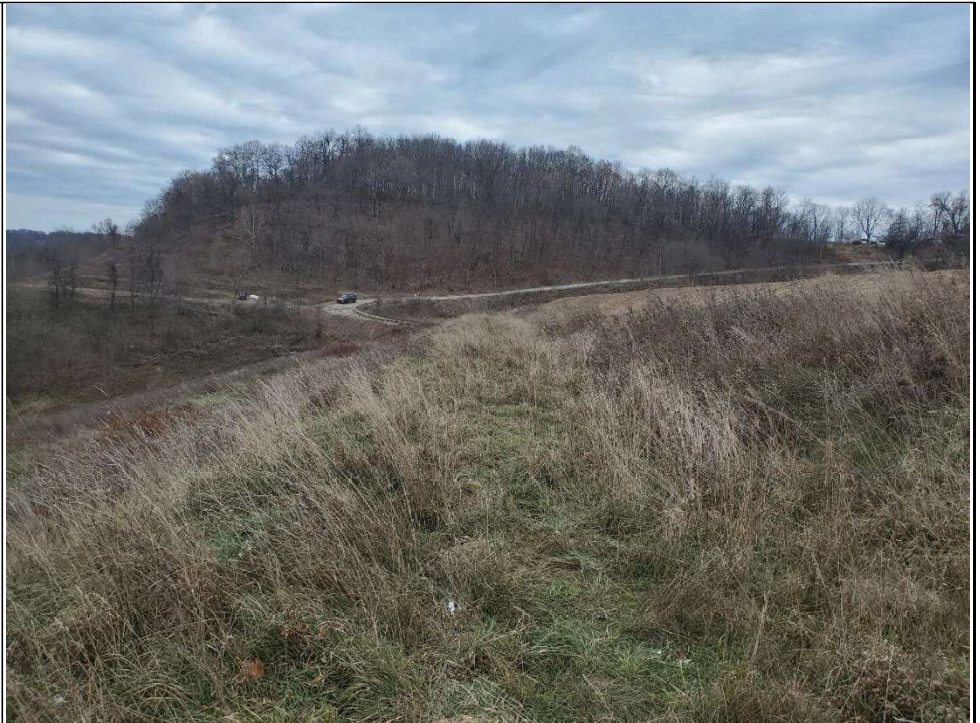
Image: 9  
Date: 12/04/2024  
Time: 10:23 AM  
Direction: South-Southeast

View of upper bench on east landfill slope. Well vegetated with no indications of erosion or instability.

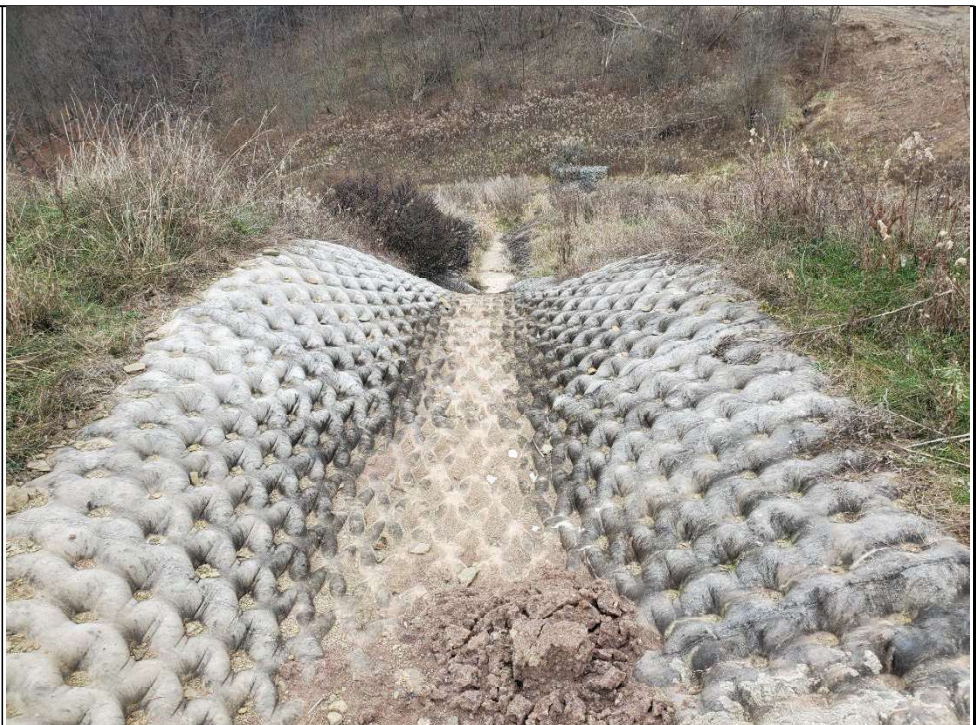
Image: 10  
Date: 12/04/2024  
Time: 10:26 AM  
Direction: Southeast

View of revetment-lined stormwater channel at the south end of the upper bench on the east landfill slope. Channel is in good condition with no obstructions.

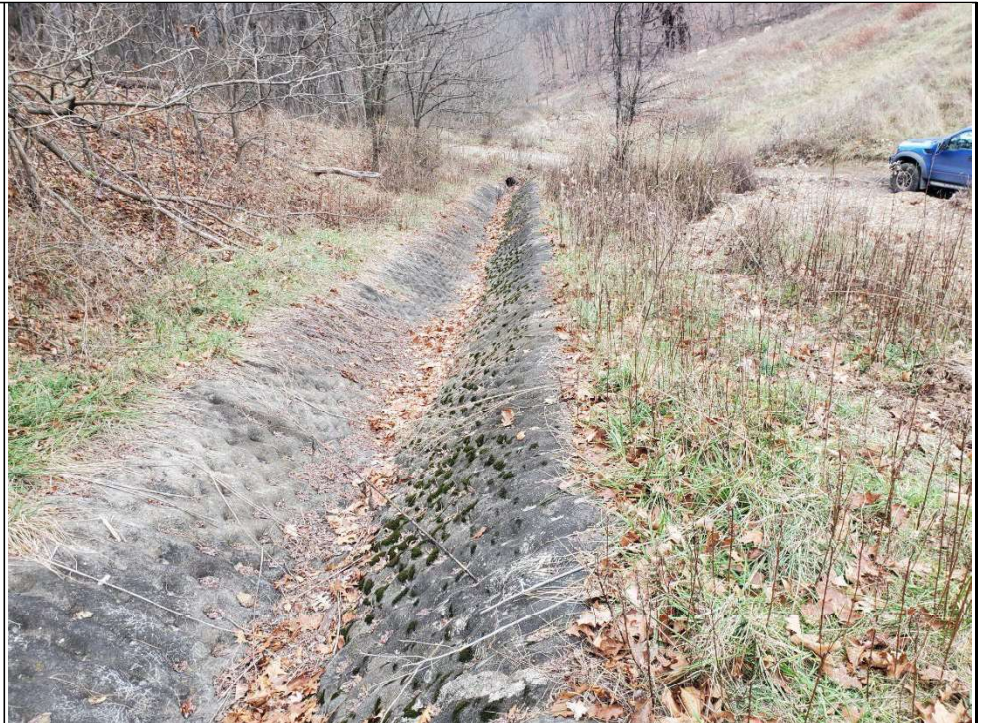
Image: 11  
Date: 12/04/2024  
Time: 10:30 AM  
Direction: Southeast

View of revetment-lined stormwater channel at the north edge of the east landfill slope. Channel is in good condition with no obstructions.

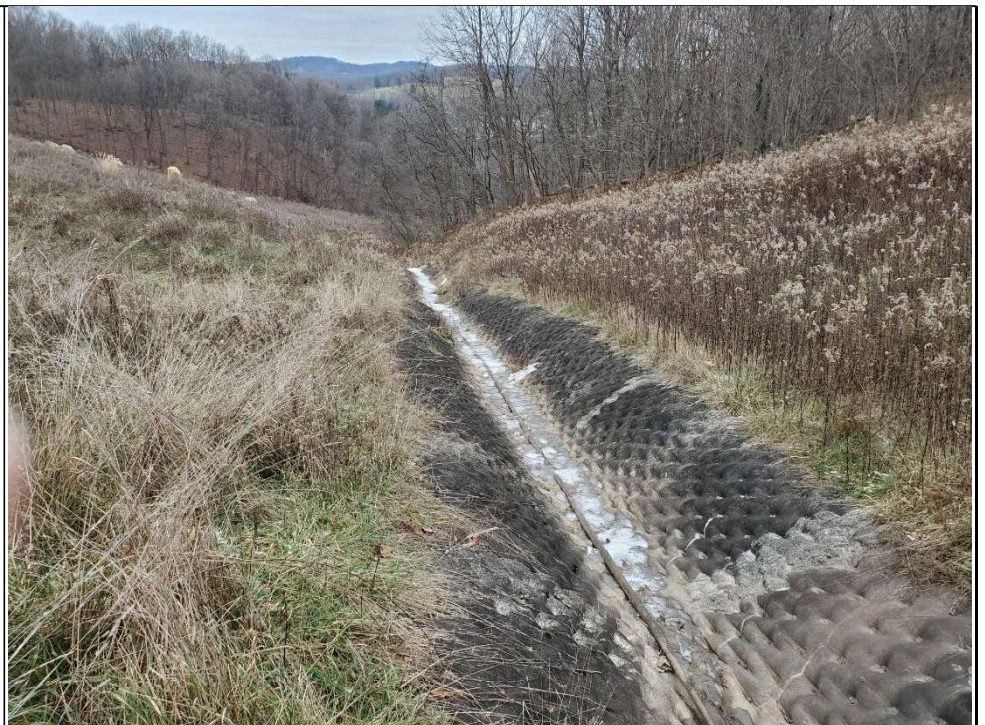
Image: 12  
Date: 12/04/2024  
Time: 10:36 AM  
Direction: Northeast

View of revetment-lined stormwater channel at the south edge of the east landfill slope. Channel is in good condition with no obstructions.

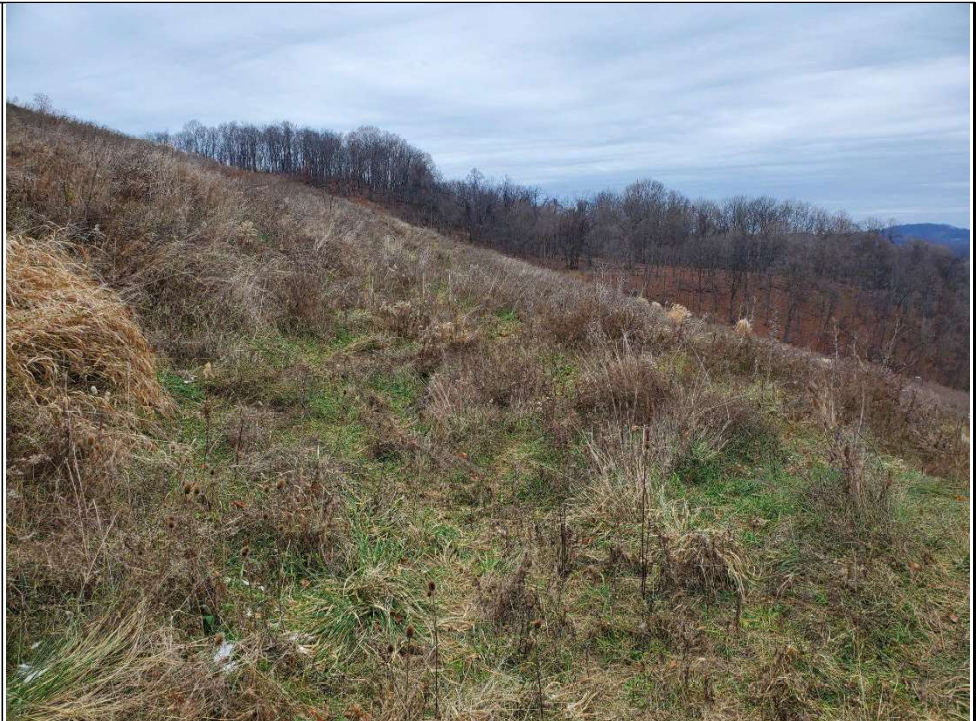
Image: 13  
 Date: 12/04/2024  
 Time: 10:37 AM  
 Direction: North

View of well vegetated east landfill bench with no indication of erosion or instability.

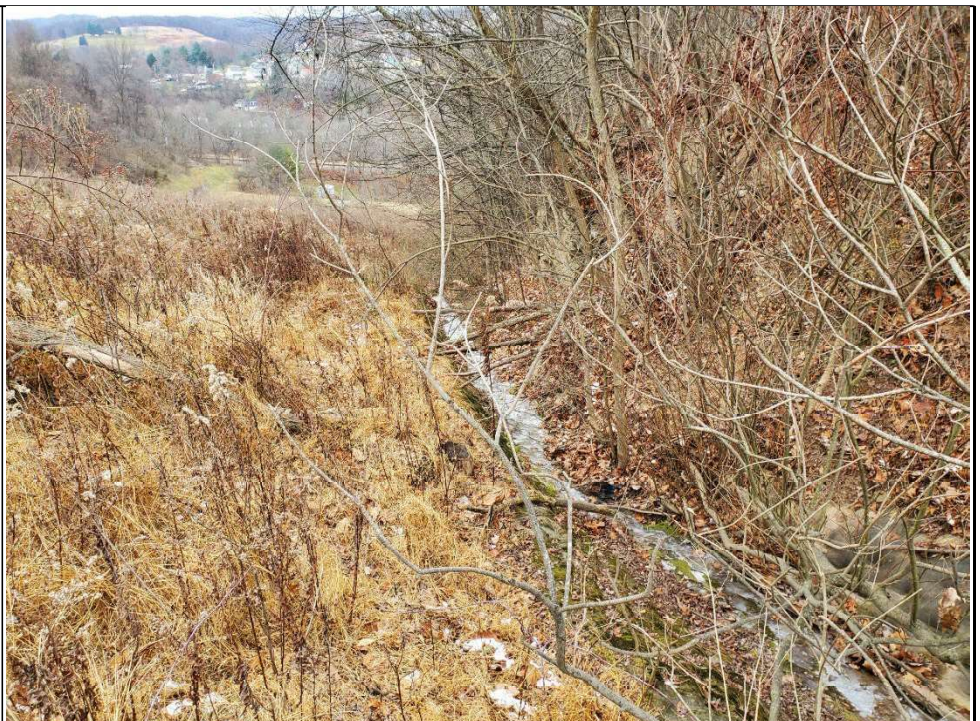
Image: 14  
 Date: 12/04/2024  
 Time: 10:38 AM  
 Direction: Northeast

View of concrete-lined stormwater channel at the south edge of the east landfill slope. Channel contains vegetative debris from adjacent wooded area.

1. Continue operation and maintenance in the active areas as currently performed.
2. Remove vegetative debris in the mid-slope portion of the Fabriform® swale at the south perimeter of the landfill (see Photo 14).
3. Clear woody vegetation near the non-contact water basin (see Photo 17).
4. Ensure adequate access to the closed portions of the landfill to maintain the ability to perform weekly visual site structural inspections.

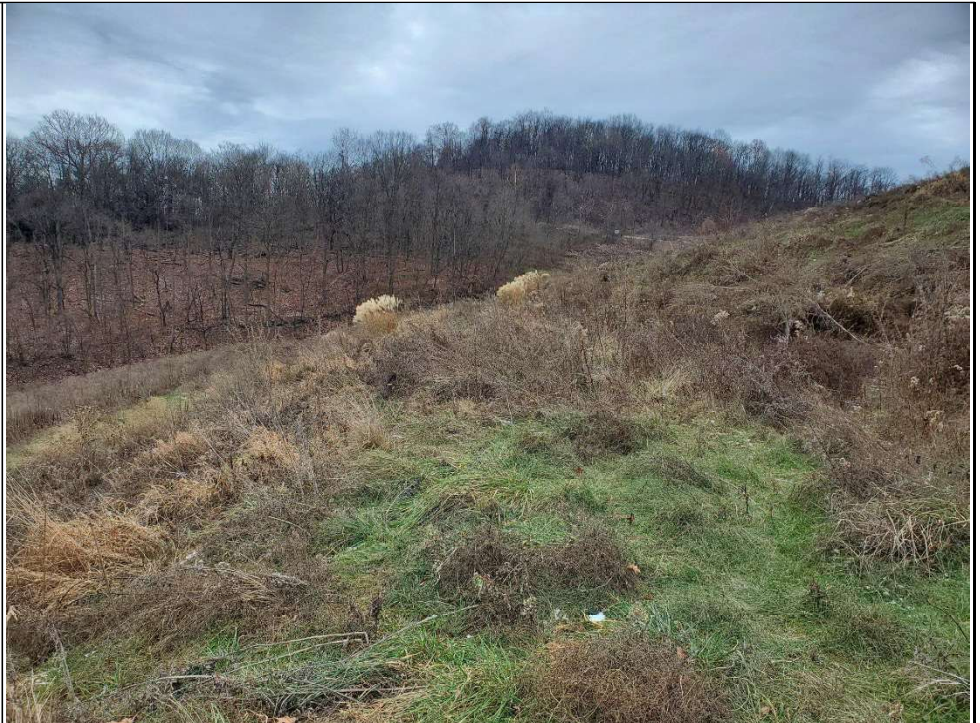
Image: 15  
Date: 12/04/2024  
Time: 10:49 AM  
Direction: South-Southeast

Southward view of well vegetated mid-slope landfill bench with no indication of erosion or instability.

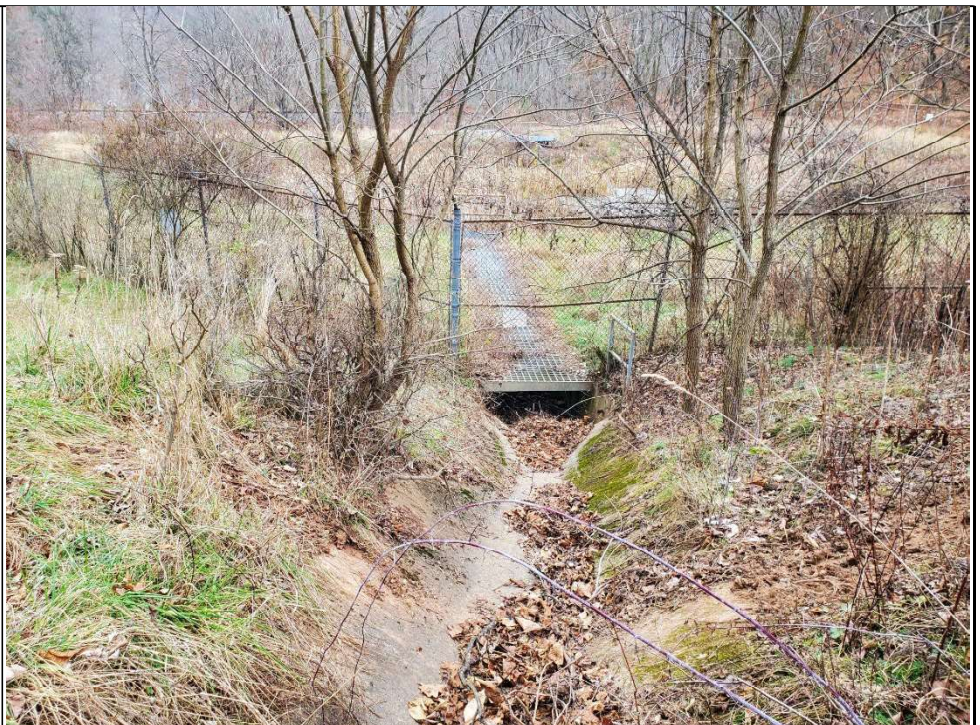
Image: 16  
Date: 12/04/2024  
Time: 11:00 AM  
Direction: East

View of non-contact stormwater channel leading to the Sedimentation Pond.

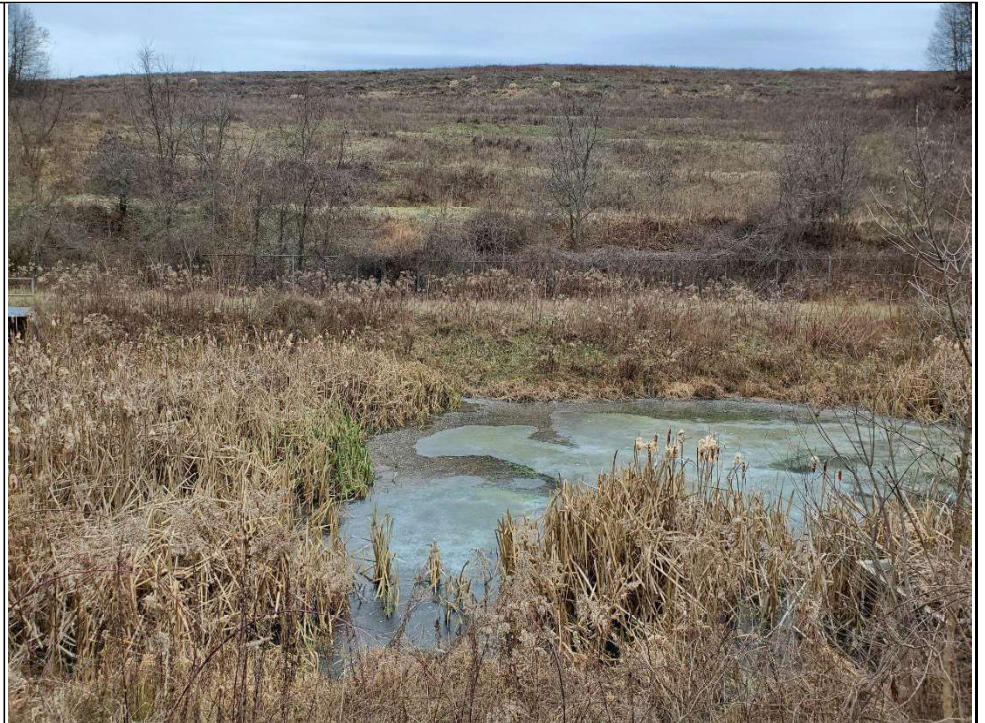
Image: 17  
Date: 12/04/2024  
Time: 11:01 AM  
Direction: West-Southwest

View of east side of landfill from Sedimentation Pond emergency spillway. Vegetation is well established with no indication of erosion or slope instability.

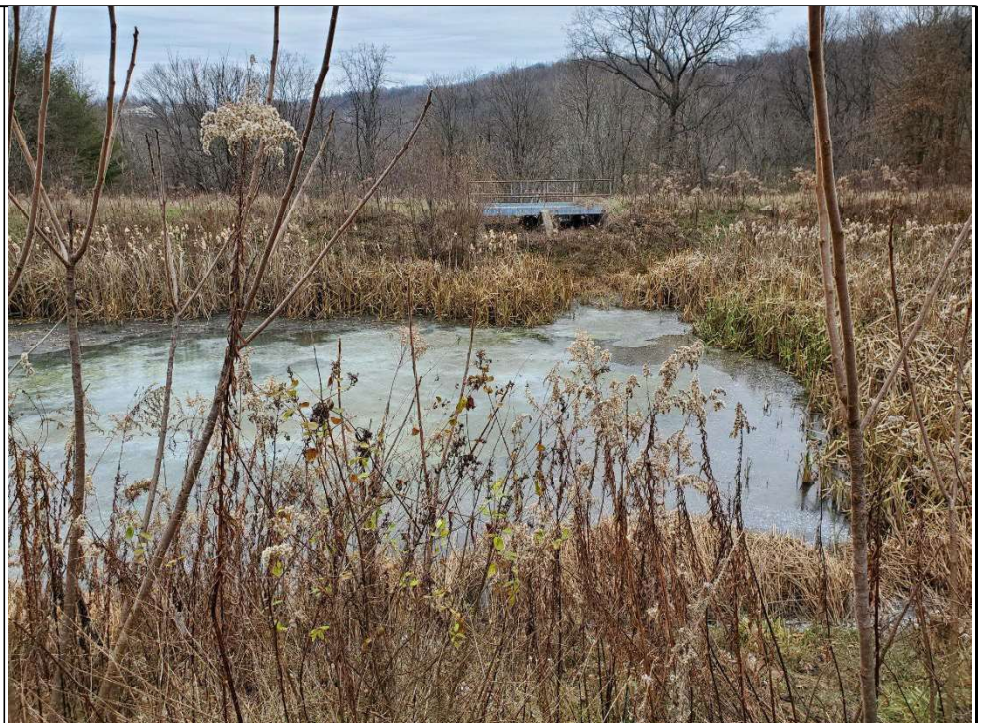
Image: 18  
Date: 12/04/2024  
Time: 11:03 AM  
Direction: Southwest

Concrete-lined non-contact stormwater channel entering the Sedimentation Pond. Surrounding area is vegetated with no indication of erosion or instability.

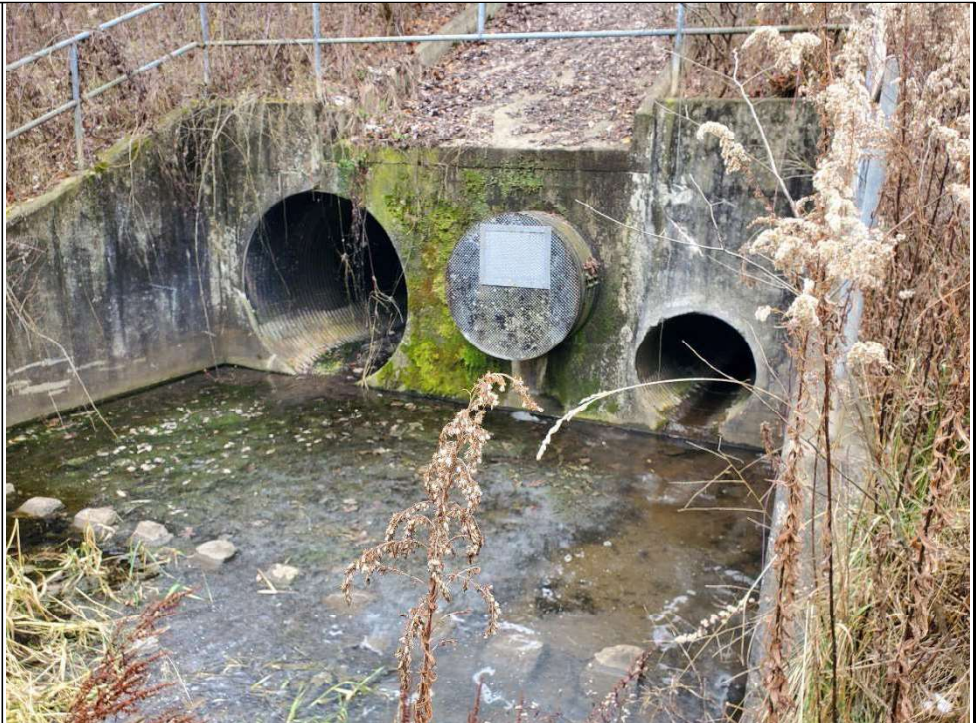
Image: 21  
Date: 12/04/2024  
Time: 11:12 AM  
Direction: Southwest

View of Sedimentation Pond emergency spillway outlet, non-contact stormwater outlet pipes, and capped contact stormwater (leachate) pipe. Contact stormwater drains to pump station.

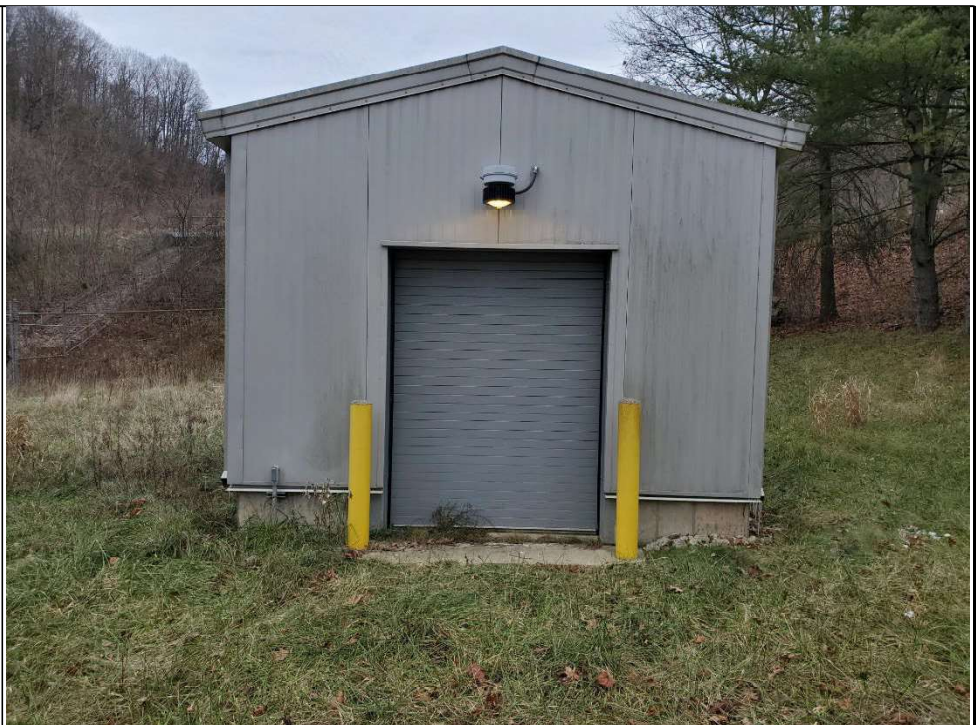
Image: 22  
Date: 12/04/2024  
Time: 11:11 AM  
Direction: Southwest

View of leachate pump station.
