Inspection Report

To: **Norman Divers (Charah Solutions, Inc.)**
From: **Robert Stolz, PE, PG**
Re: **Cheswick Ash Disposal Site – Annual CCR Unit Inspection Report**
Inspection Date: **November 19, 2025**
Report Date: **January 7, 2026**

Project: Cheswick Landfill 2025 Annual Inspection

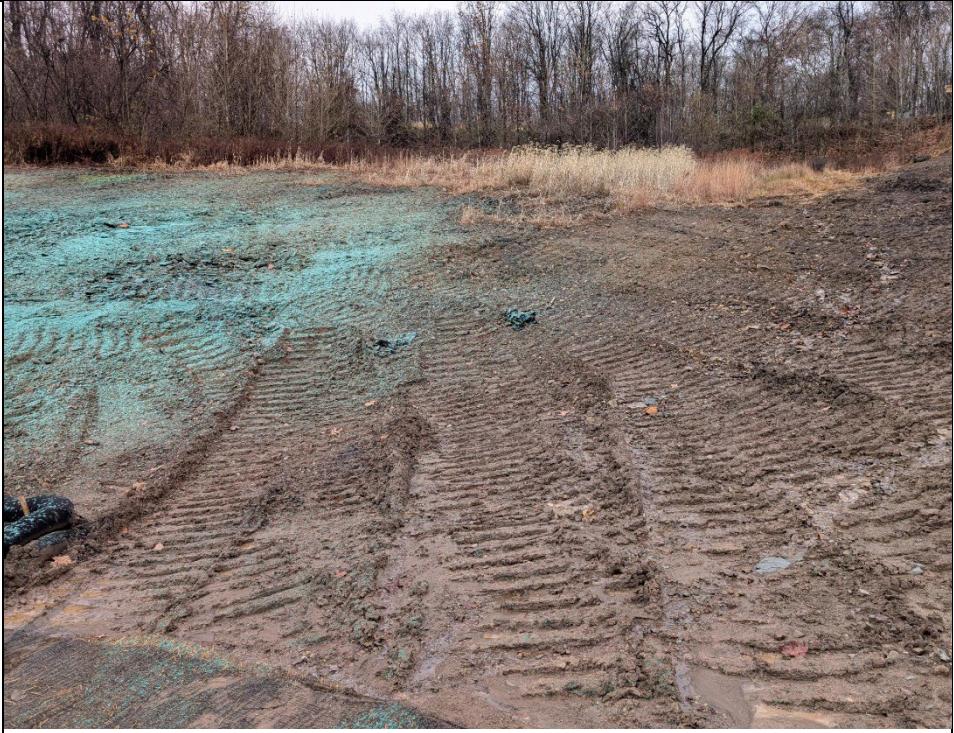
Image: 1
Date: 11/19/2025
Time: 10:23 AM
Direction: West-Southwest

Description: Re-graded area upslope of recent final cover placement.

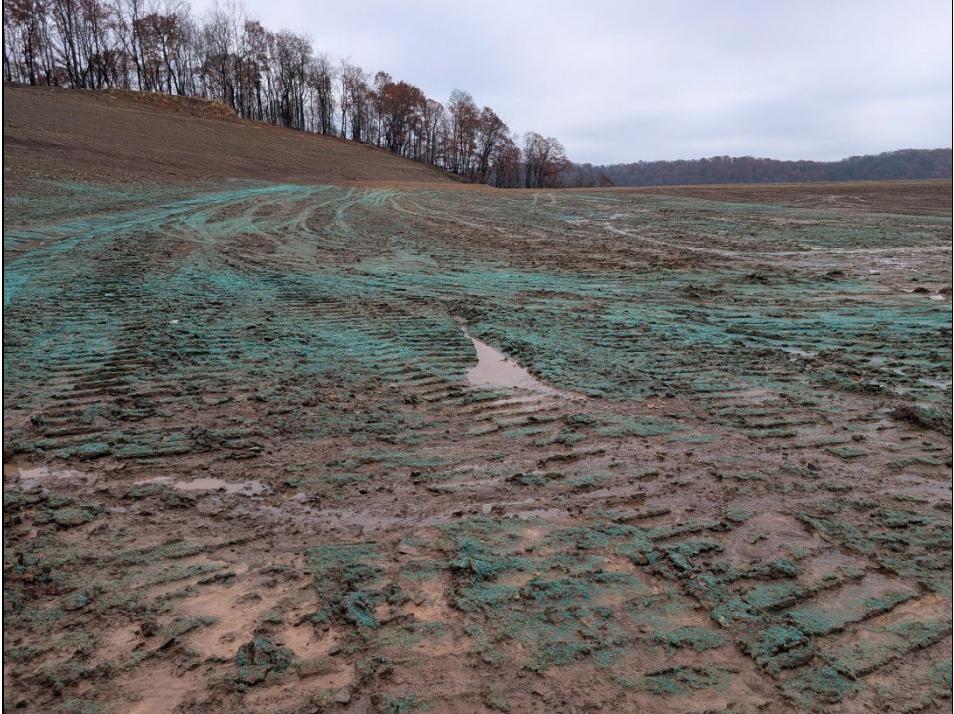
Image: 2
Date: 11/19/2025
Time: 10:23 AM
Direction: East-Northeast

Description: Recent final cover placement.

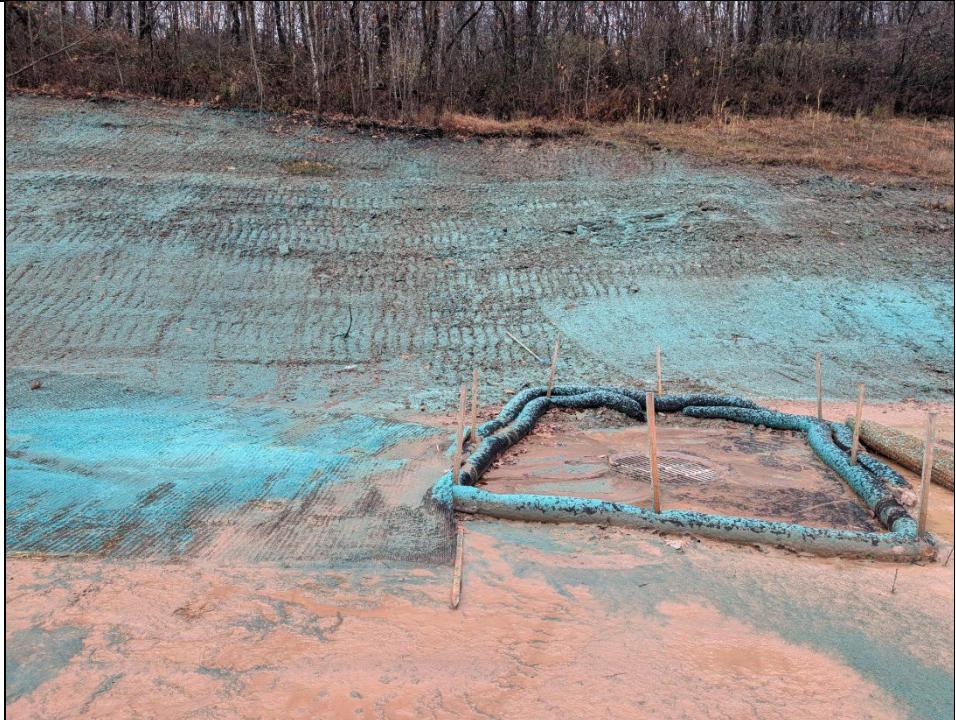
Image: 3
Date: 11/19/2025
Time: 10:26 AM
Direction: West-Southwest

Description: Regraded slope and non-contact stormwater inlet in foreground.

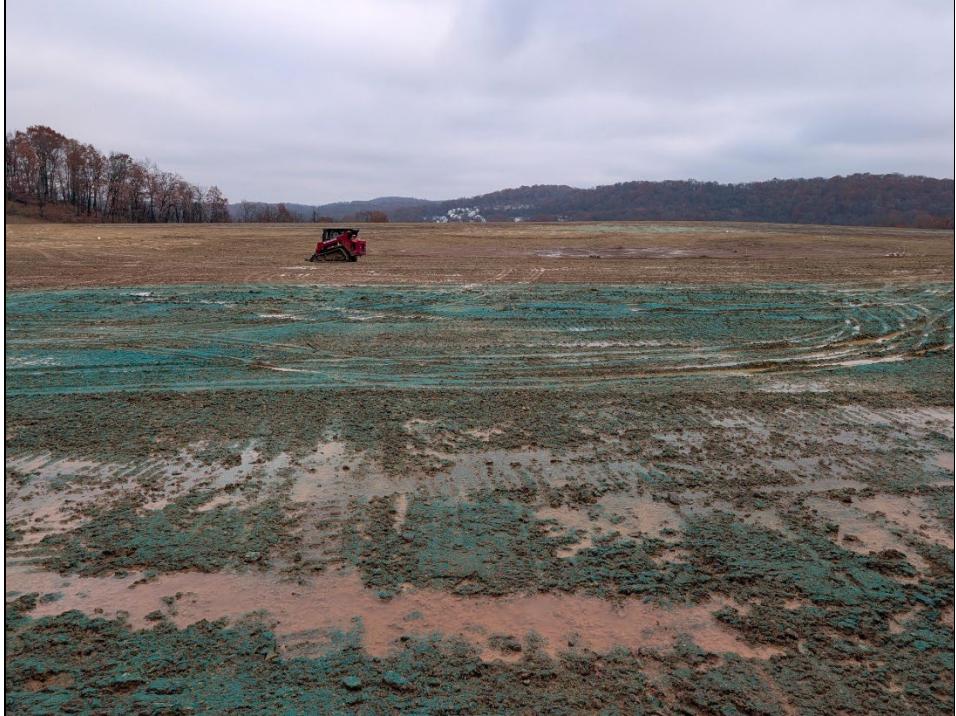
Image: 4
Date: 11/19/2025
Time: 10:28 AM
Direction: East-Northeast

Description: Recent final cover placement.

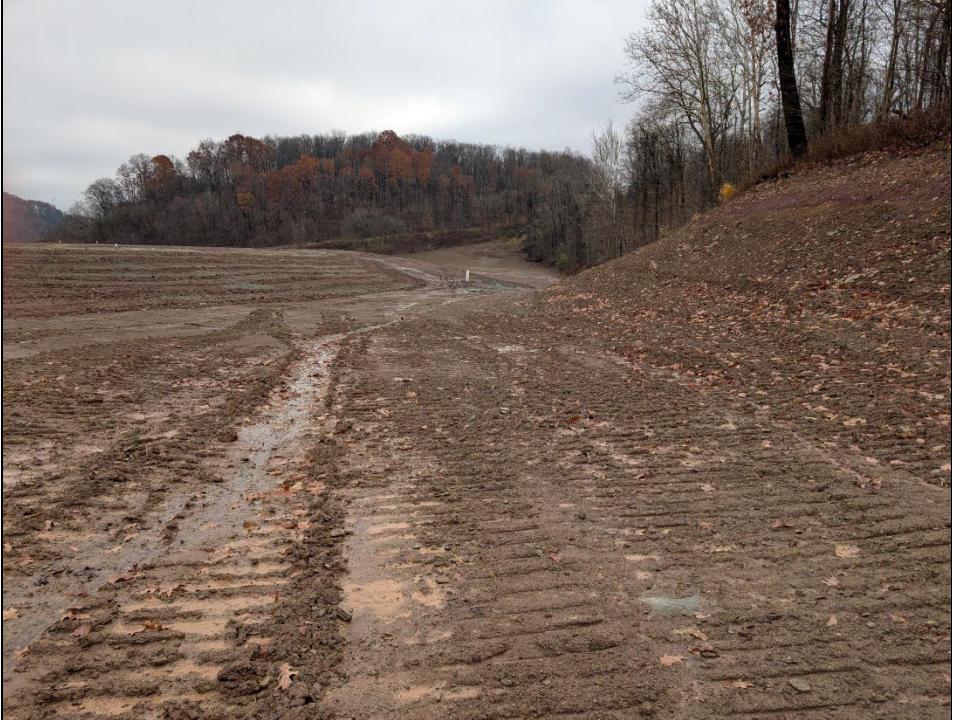
Image: 5
Date: 11/19/2025
Time: 10:30 AM
Direction: South-Southeast

Description: Recent final cover placement.

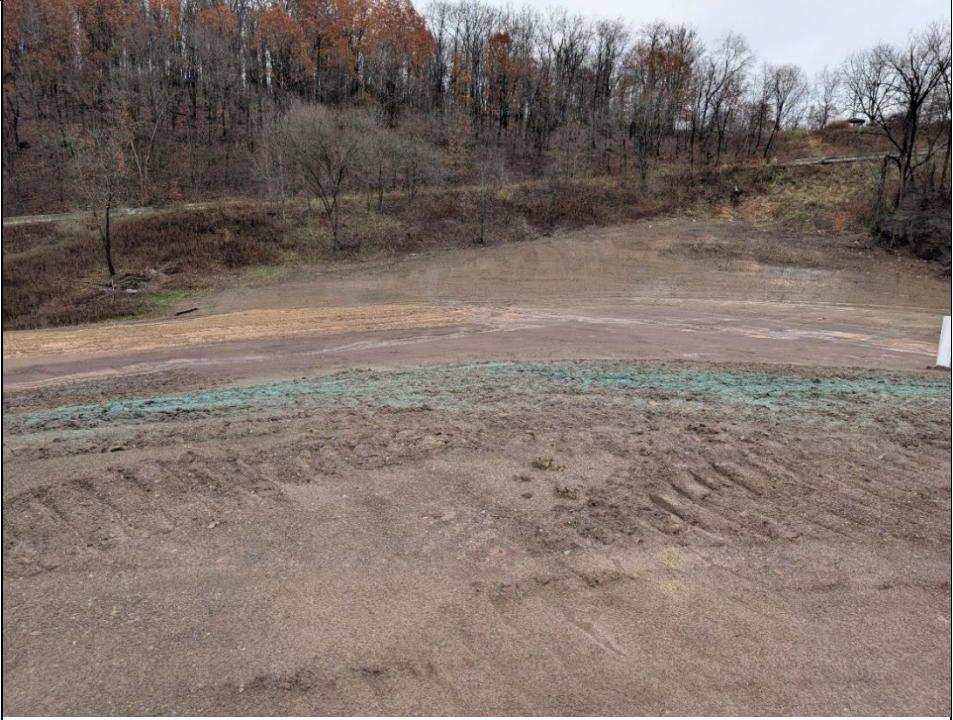
Image: 7
Date: 11/19/2025
Time: 10:33 AM
Direction: South-Southeast

Description: Recent final cover placement.

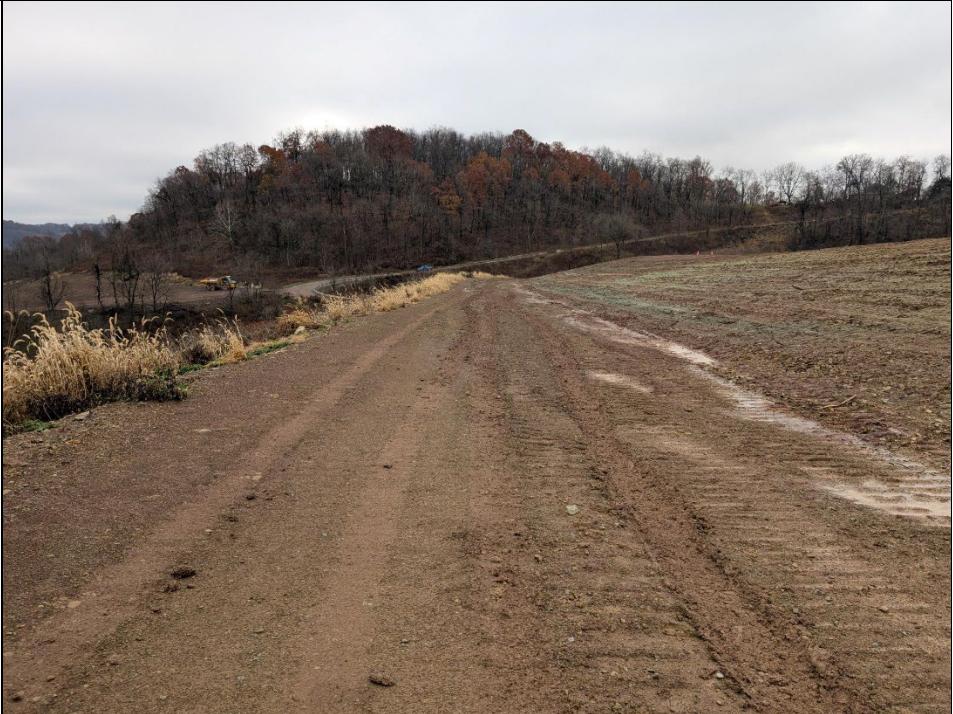
Image: 8
Date: 11/19/2025
Time: 10:35 AM
Direction: South

Description: Recent final cover placement.

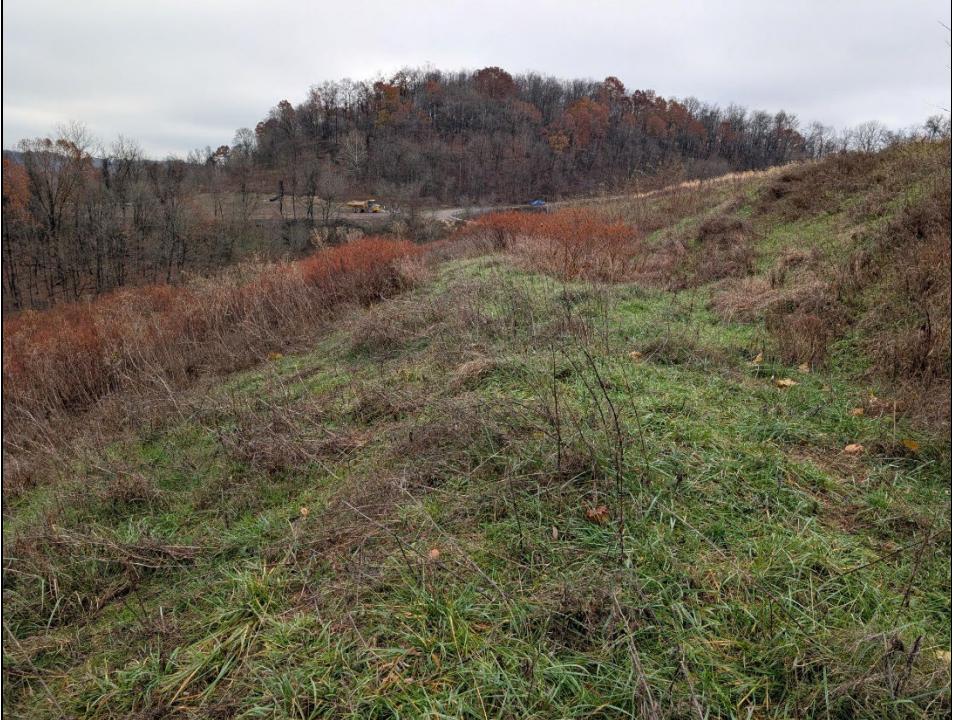
Image: 9
Date: 11/19/2025
Time: 10:36 AM
Direction: South-Southeast

Description: Upper bench on east landfill slope.

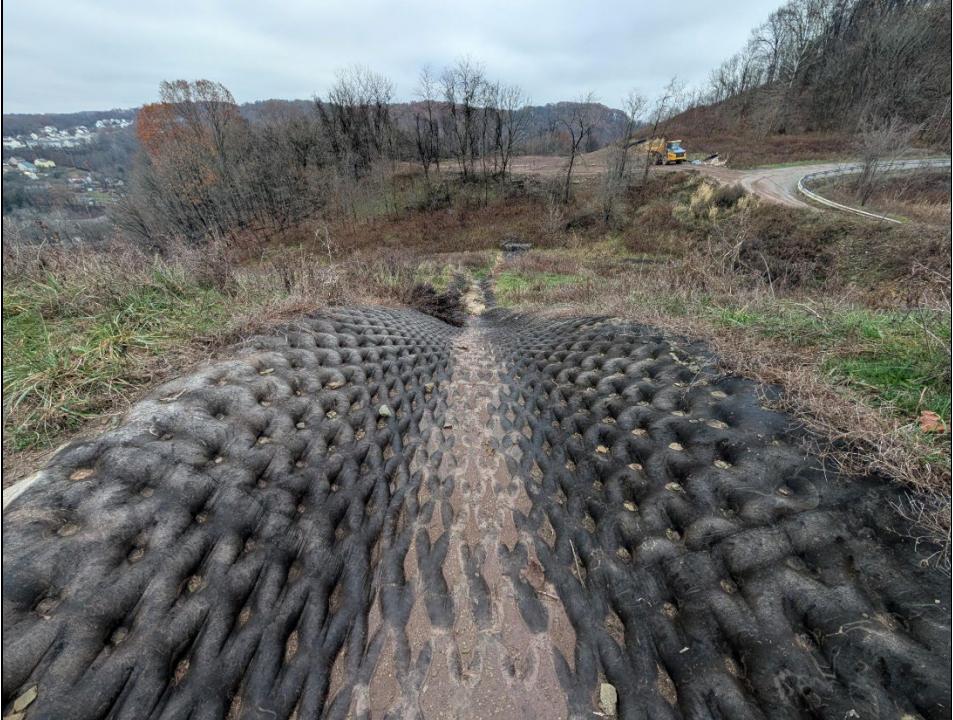
Image: 10
Date: 11/19/2025
Time: 10:39 AM
Direction: Southeast

Description: Revetment-lined stormwater channel at the south end of the upper bench on the east landfill slope.

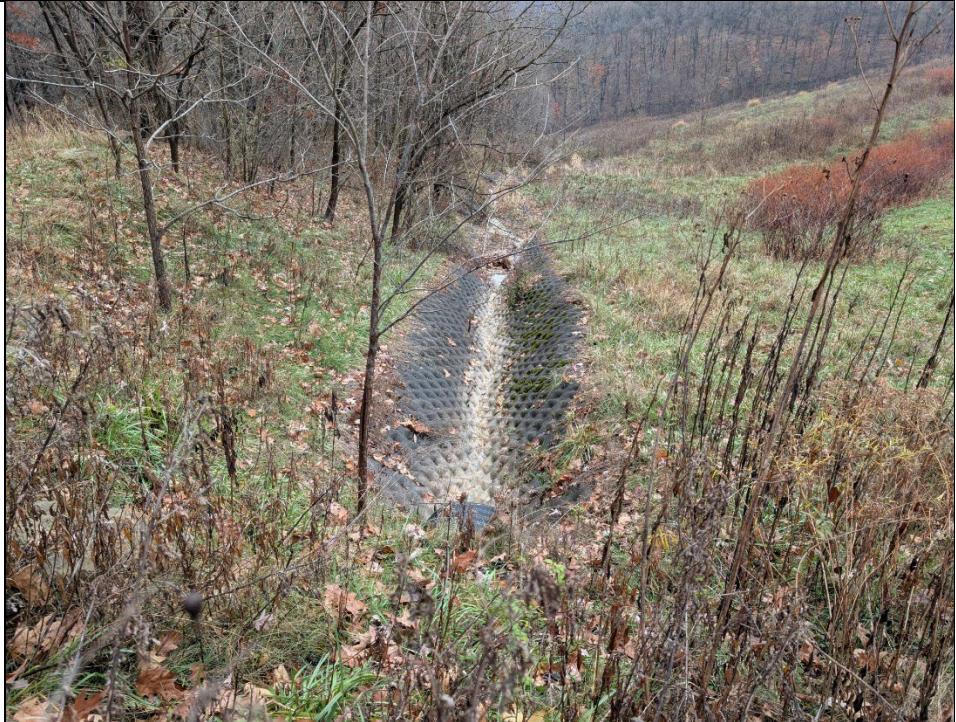
Image: 11
Date: 11/19/2025
Time: 10:17 AM
Direction: Southeast

Description: Revetment-lined stormwater channel at the north edge of the east landfill slope.

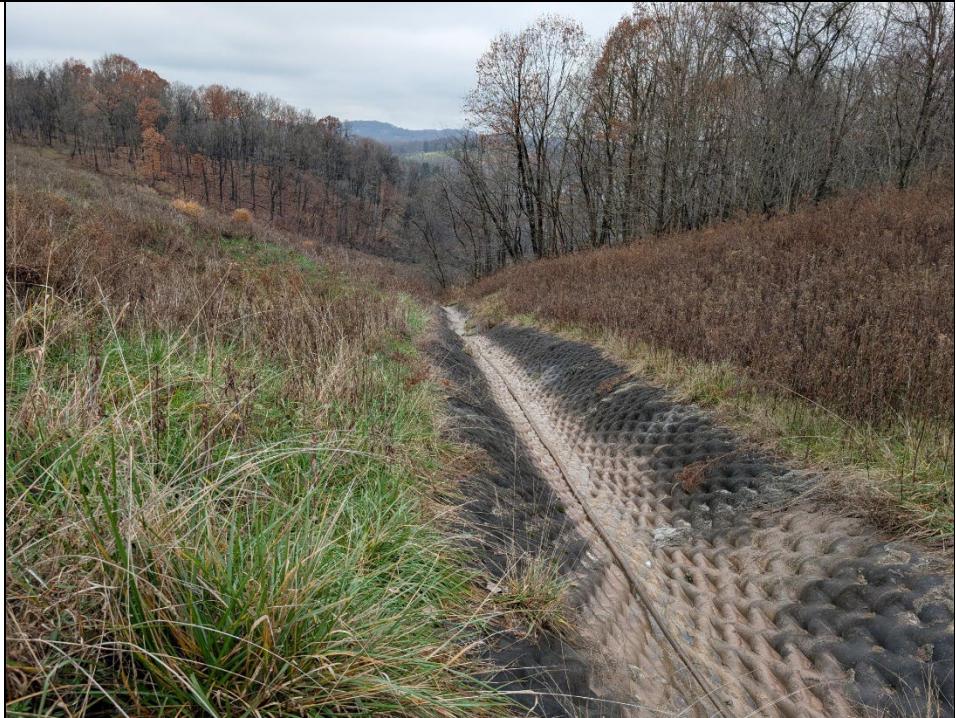
Image: 12
Date: 11/19/2025
Time: 10:45 AM
Direction: Northeast

Description: Revetment-lined stormwater channel at the south edge of the east landfill slope.

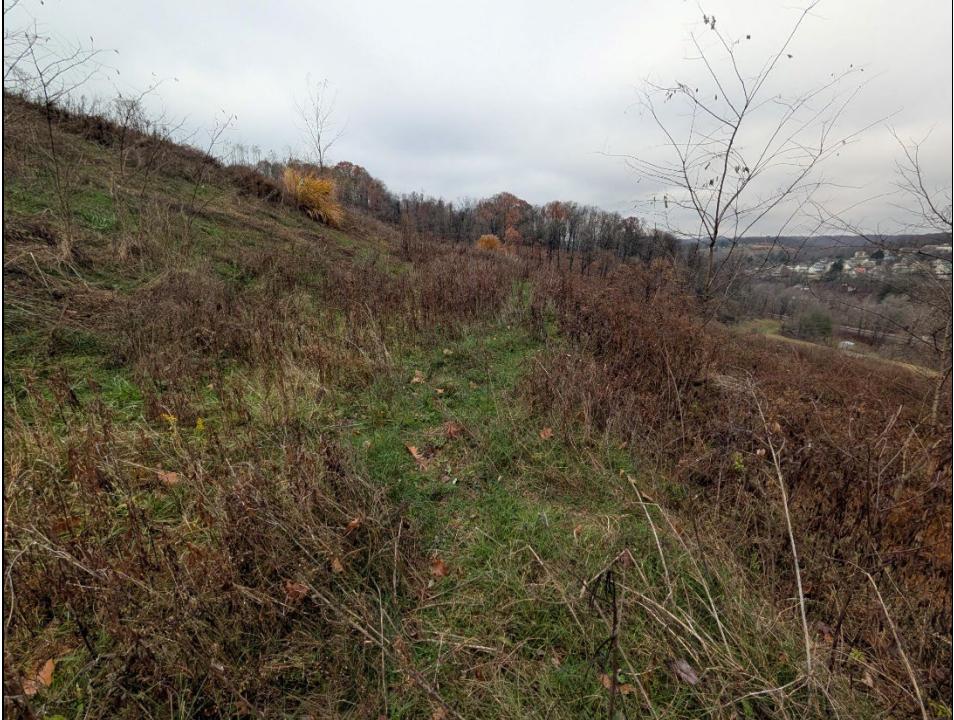
Image: 13
Date: 11/19/2025
Time: 10:41 AM
Direction: North

Description: Well vegetated east landfill bench.

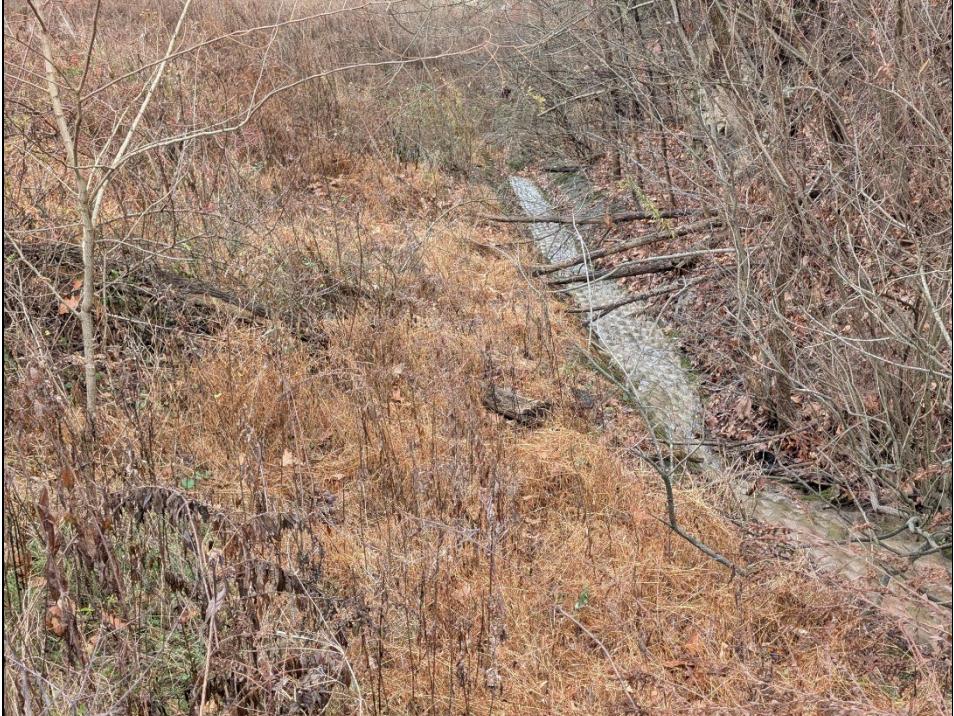
Image: 14
Date: 11/19/2025
Time: 10:42 AM
Direction: Northeast

Description: Concrete-lined stormwater channel at the south edge of the east landfill slope.

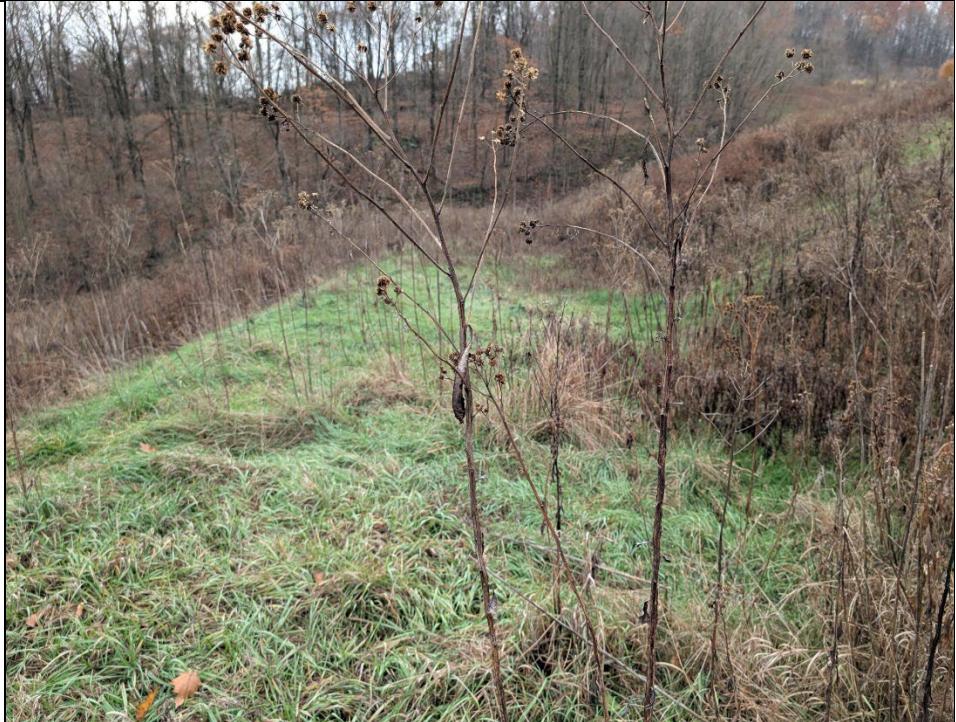
Image: 15
Date: 11/19/2025
Time: 10:51 AM
Direction: South-Southeast

Description: Well vegetated mid-slope landfill bench with no indication of erosion or instability.

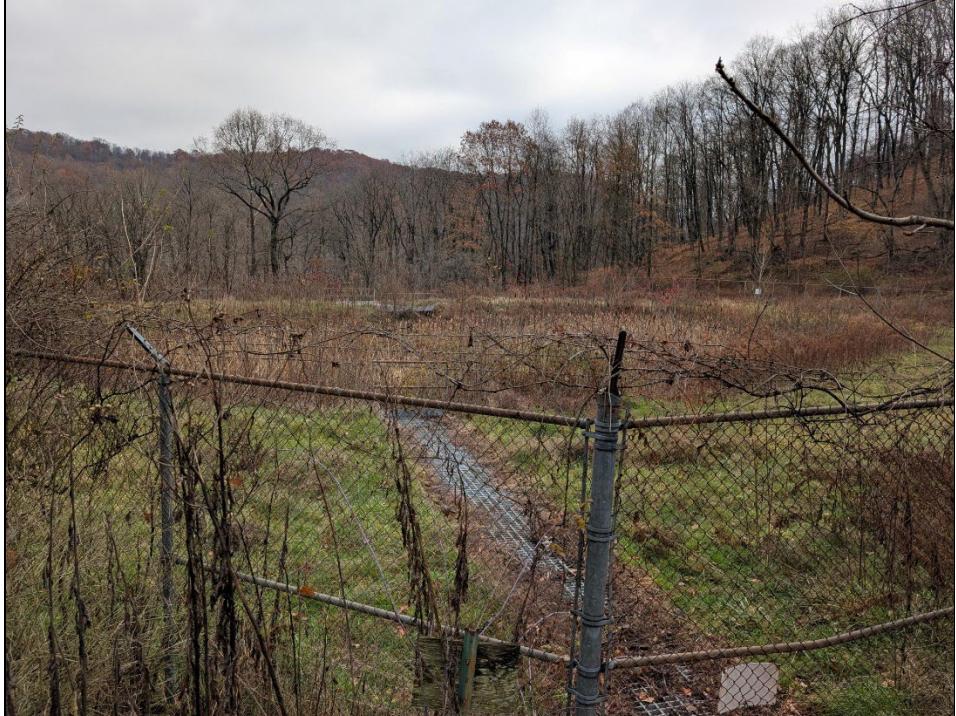
Image: 16
Date: 11/19/2025
Time: 11:01 AM
Direction: East

Description: Non-contact stormwater channel leading to the Sedimentation Pond.

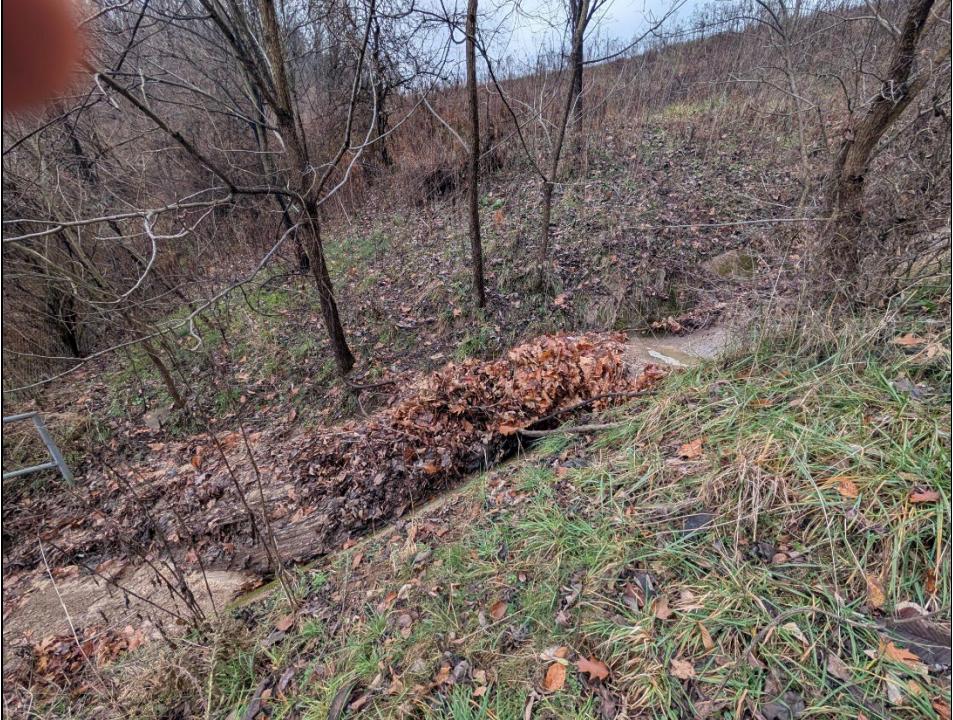
Image: 17
Date: 11/19/2025
Time: 11:00 AM
Direction: West-Southwest

Description: Lower slope at the east side of the landfill. Slopes are well vegetated.

entrances to the Fabriflume® swales. Remove accumulated vegetative debris and sediment in the non-contact stormwater management system (Photos 17, 18, 21).

3. Inspect, repair, and stabilize the localized ground disturbance on the slope below the approximate midpoint of the second terrace.
4. Clear woody vegetation where present, especially near the non-contact water basin (see Photo 17).
5. Ensure adequate access to the closed portions of the landfill to maintain the ability to perform weekly visual site structural inspections.

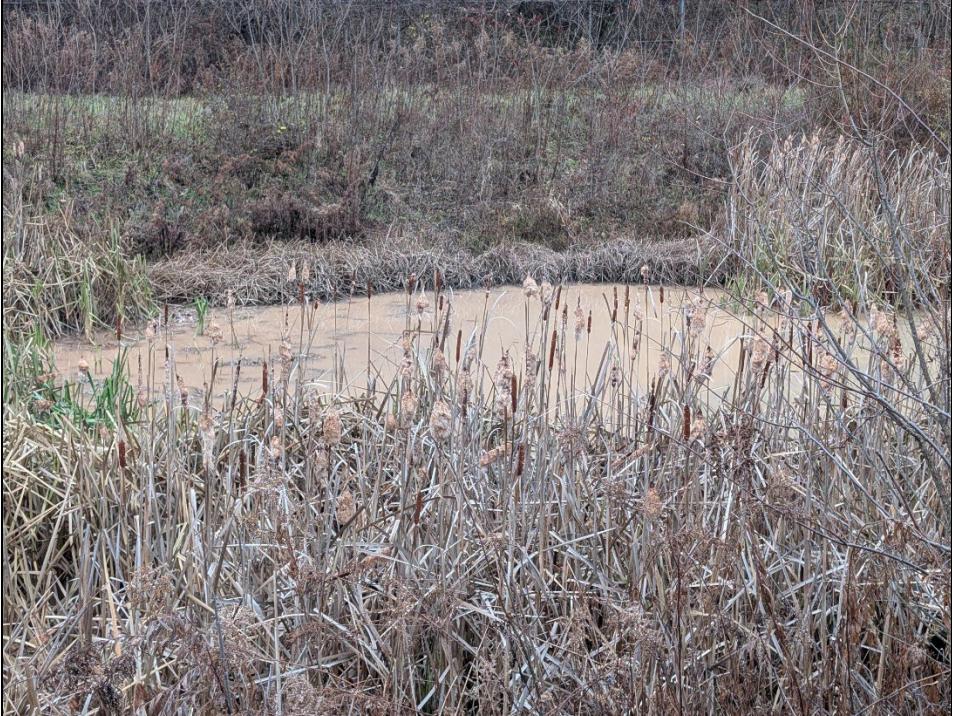
Image: 18
Date: 11/19/2025
Time: 11:17 AM
Direction: Southwest

Description: Sedimentation Pond and vicinity. Area is well vegetated.

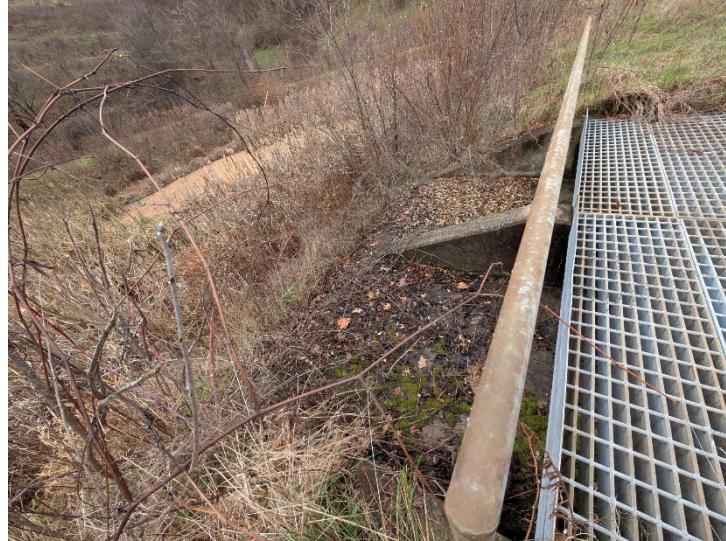
Image: 19
Date: 11/19/2025
Time: 11:18 AM
Direction: Southeast

Description: Emergency spillway inlet at the Sedimentation Pond.

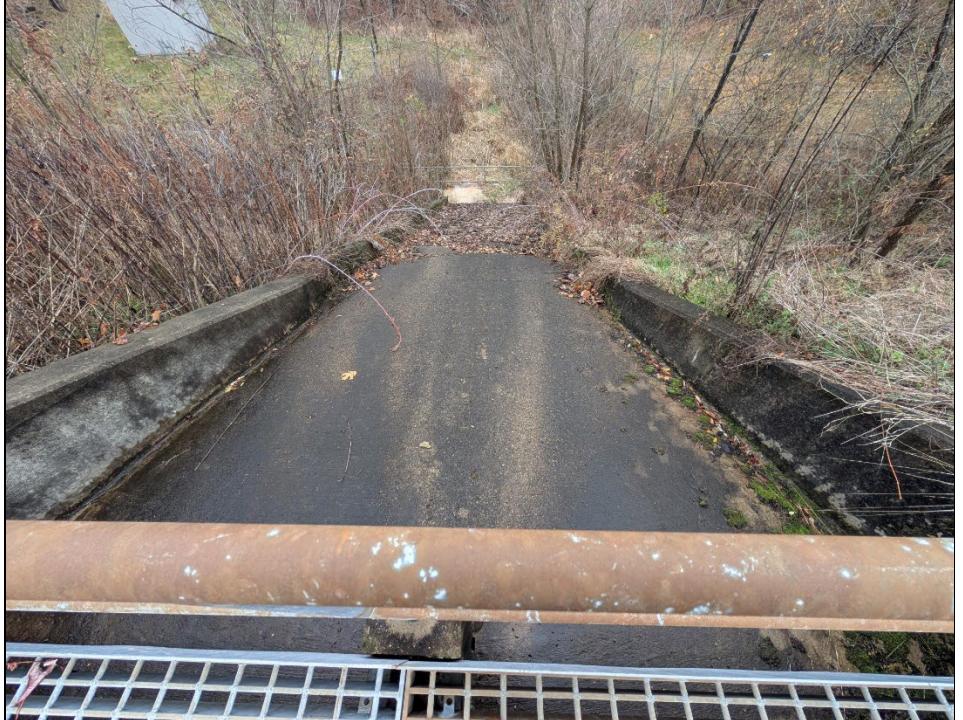
Image: 20
Date: 11/19/2025
Time: 11:18 AM
Direction: Northeast

Description: Emergency spillway outlet at the Sedimentation Pond.

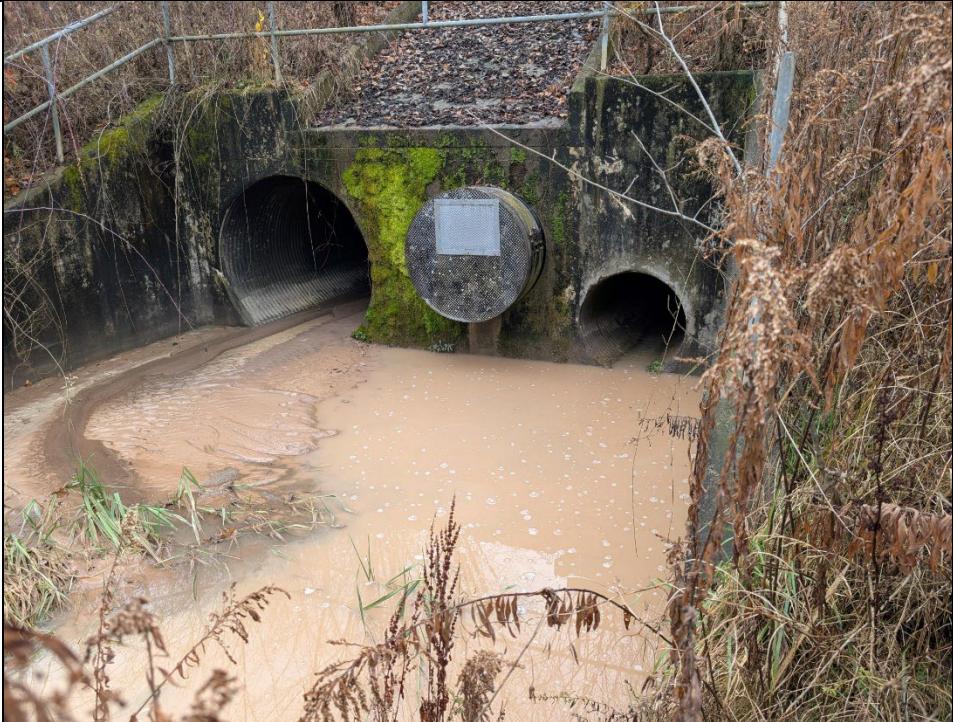
Image: 21
Date: 11/19/2025
Time: 11:11 AM
Direction: Southwest

Description: Sedimentation Pond emergency spillway outlet, non-contact stormwater outlet pipes, and capped contact stormwater (leachate) pipe.

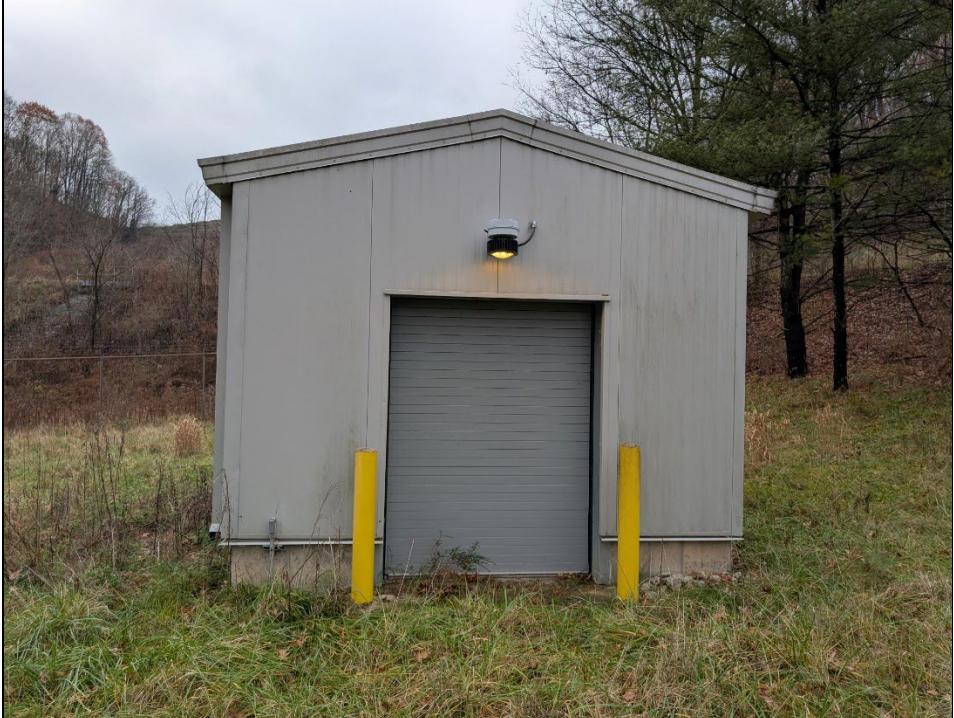
Image: 22
Date: 11/19/2025
Time: 11:07 AM
Direction: Southwest

Description: Leachate pump station.
