ANNUAL CCR UNIT INSPECTION REPORT 2021

CHESWICK ASH DISPOSAL SITE INDIANA TOWNSHIP, ALLEGHENY COUNTY, PENNSYLVANIA

CEC Project 313-015.0002

INSPECTION DATE: 12/28/2021 REPORT DATE: 1/14/2022

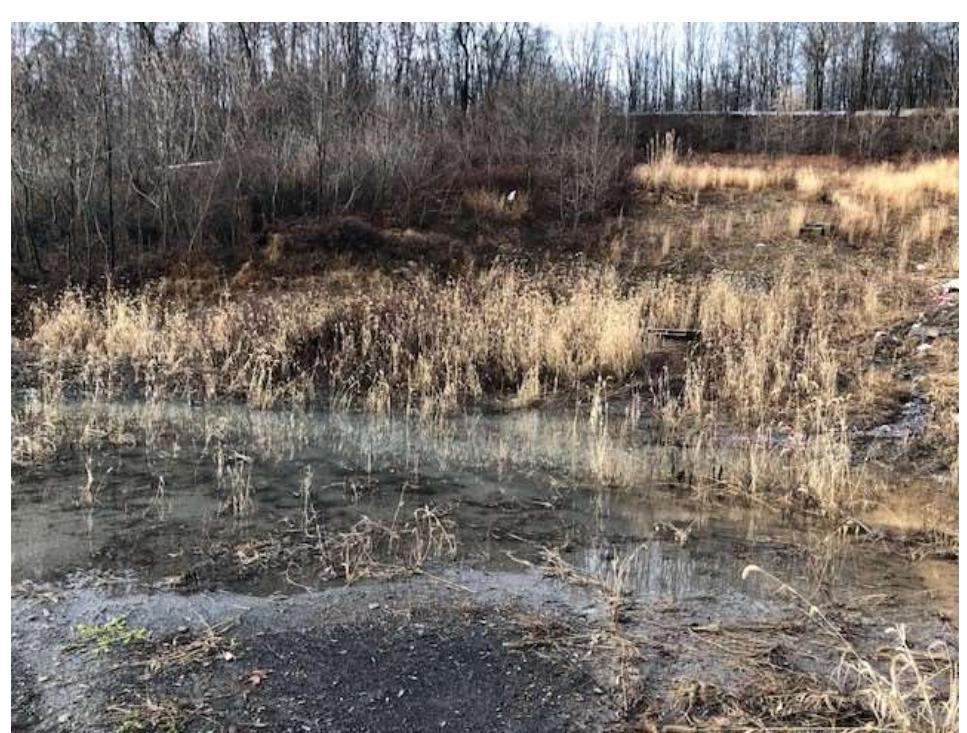
Photograph 1: Non-contact stormwater junction box riser installed in 2020 located northwest of landfill.

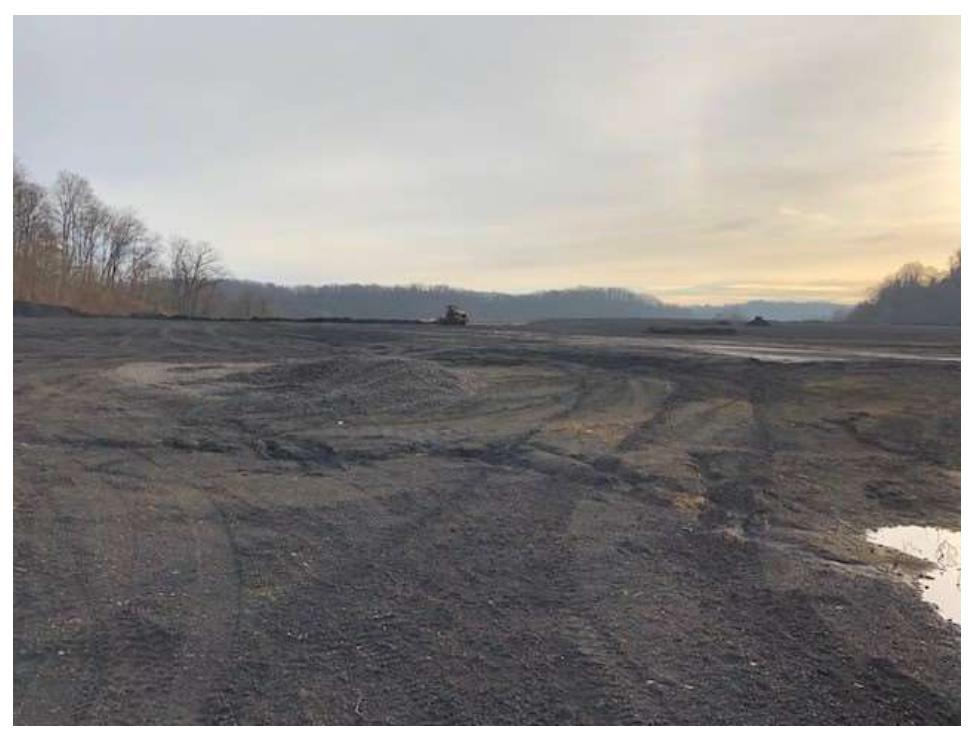
Photograph 2:

Eastern view of active area. Material is graded and compacted.

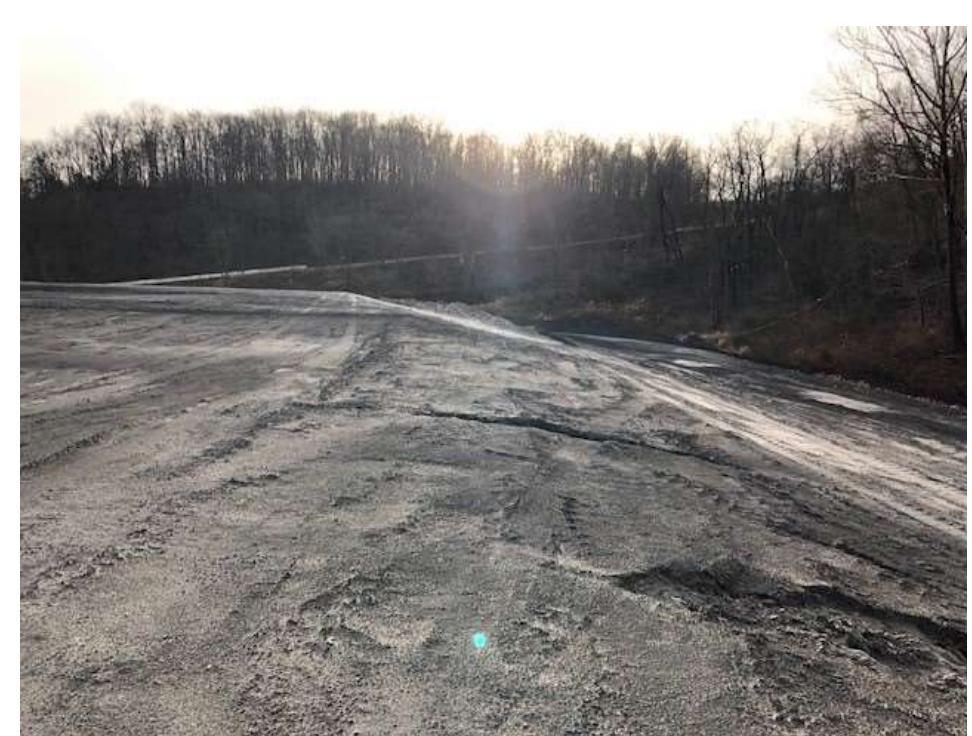
Photograph 5: South view of active area outside west slope. Contact water (leachate) drains to leachate collection layer.

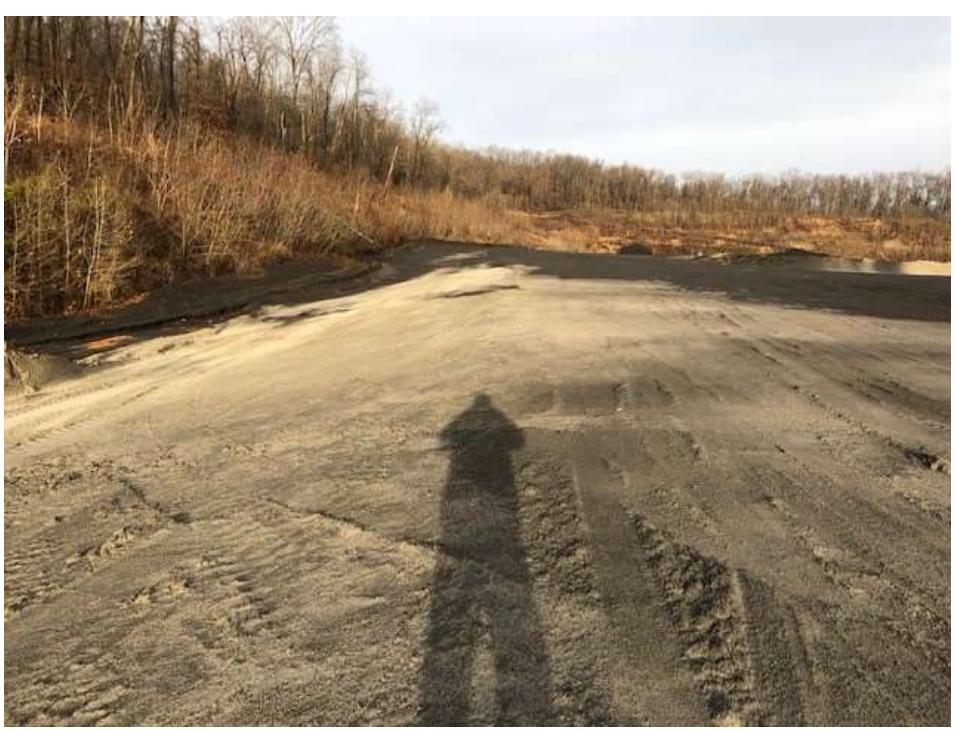
Photograph 6: North view of active area outside west slope. Contact water (leachate) drains to leachate collection layer.

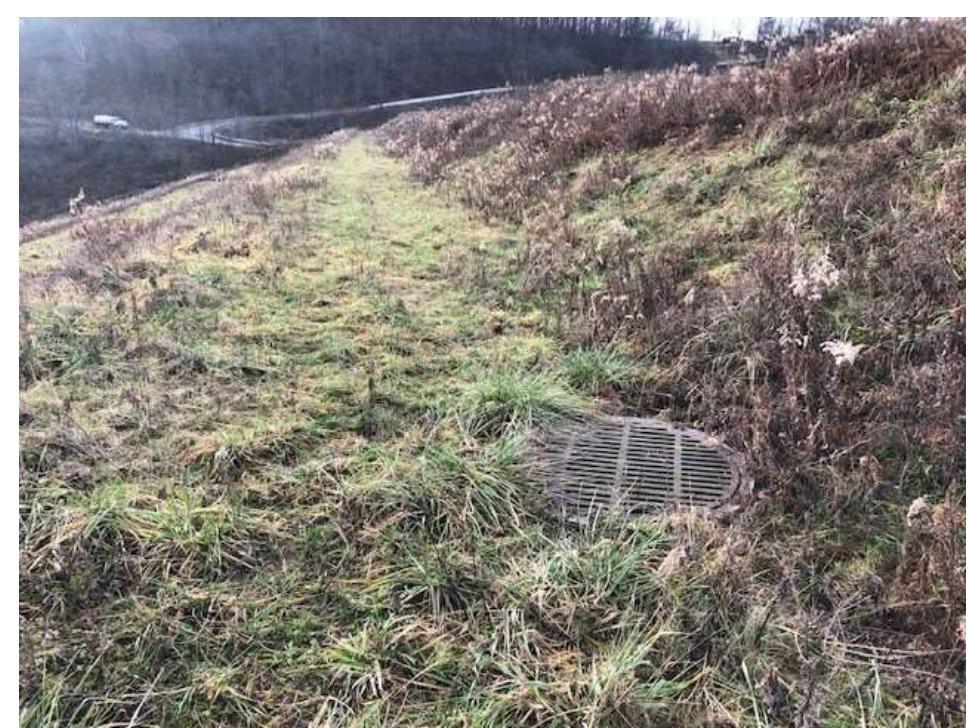
Photograph 9: South view of upper bench and non-contact stormwater inlet on east landfill slope. Vegetation is established with no indications of stability issues.

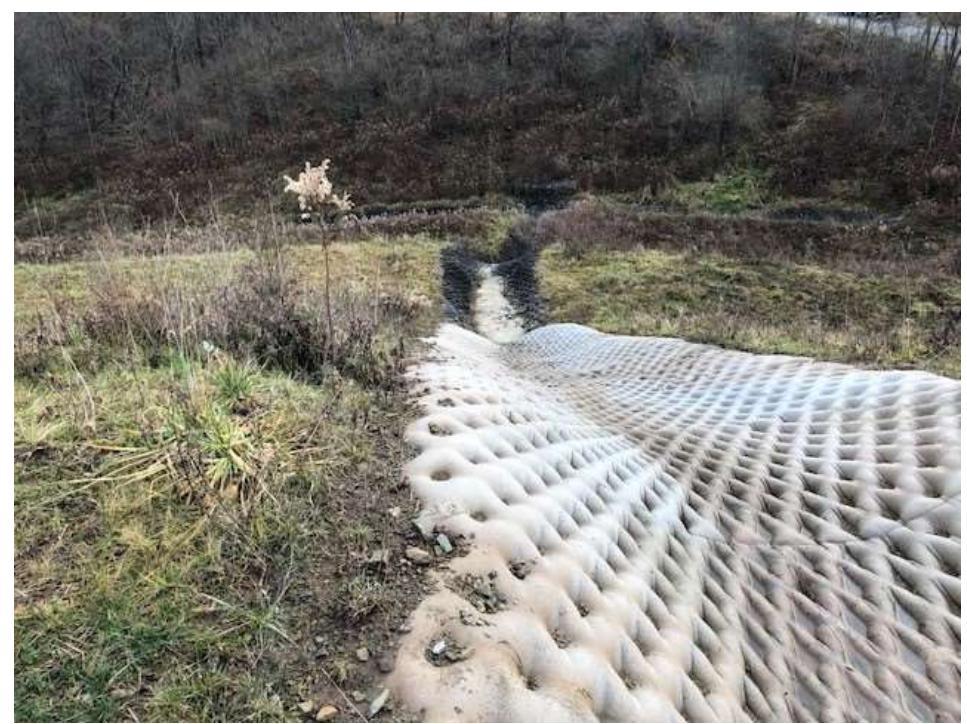
Photograph 10: View of revetment matt lined stormwater channel installed in 2020 at south end of upper bench on east landfill slope.

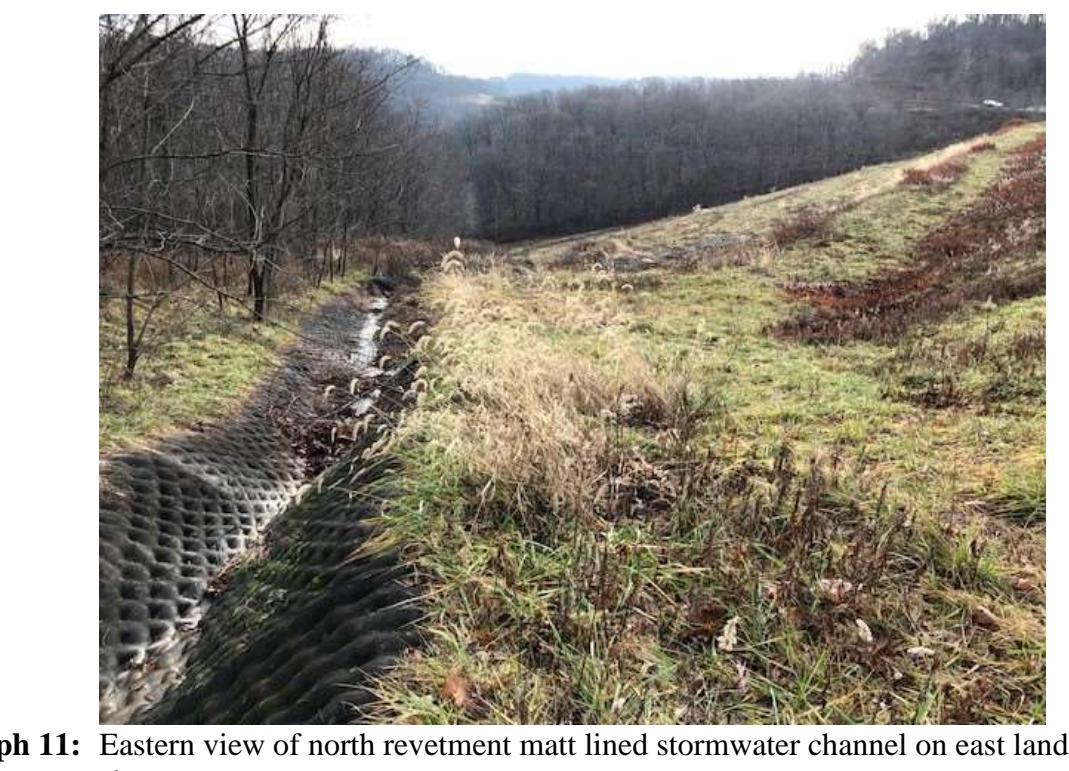
Photograph 11: Eastern view of north revetment matt lined stormwater channel on east landfill slope.

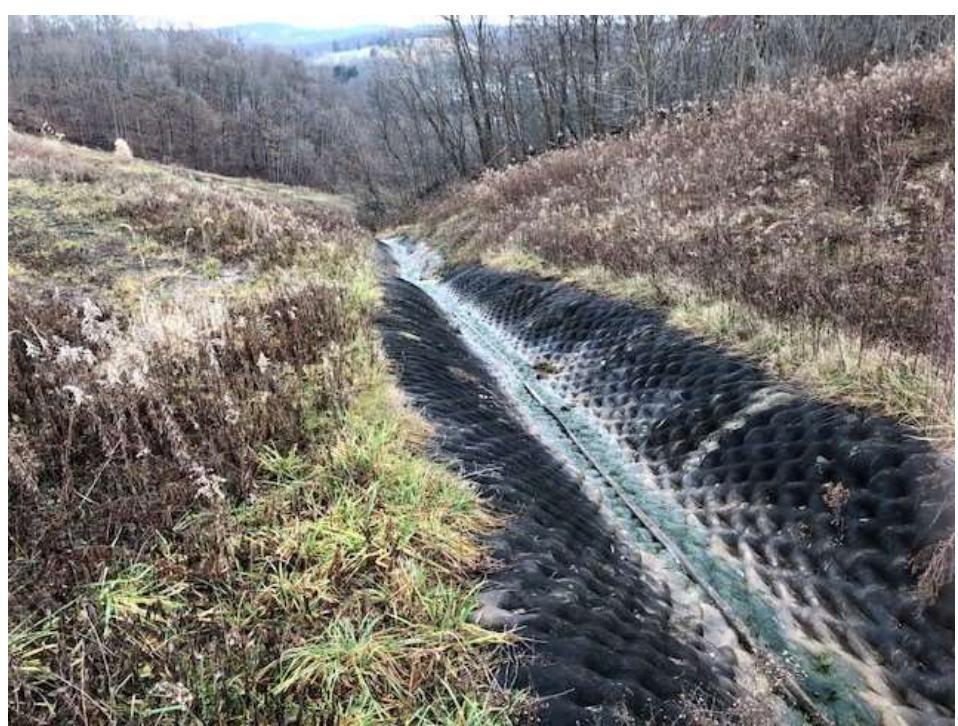
Photograph 12: Eastern view of south revetment matt lined stormwater channel on east landfill slope.

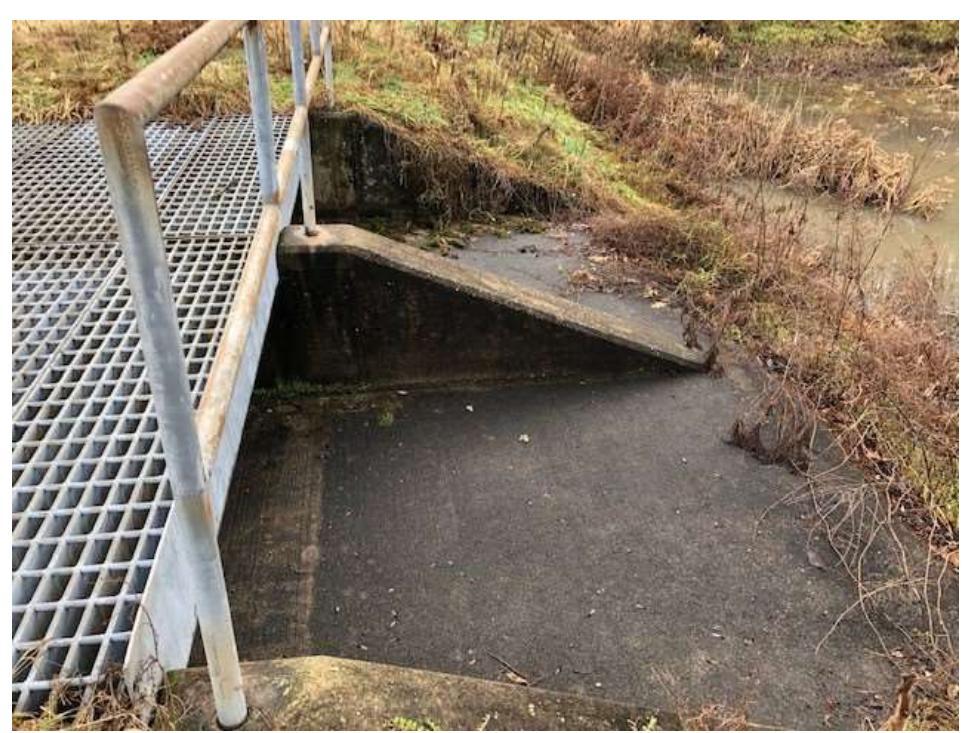
Photograph 19: View of Sedimentation Pond emergency spillway inlet.

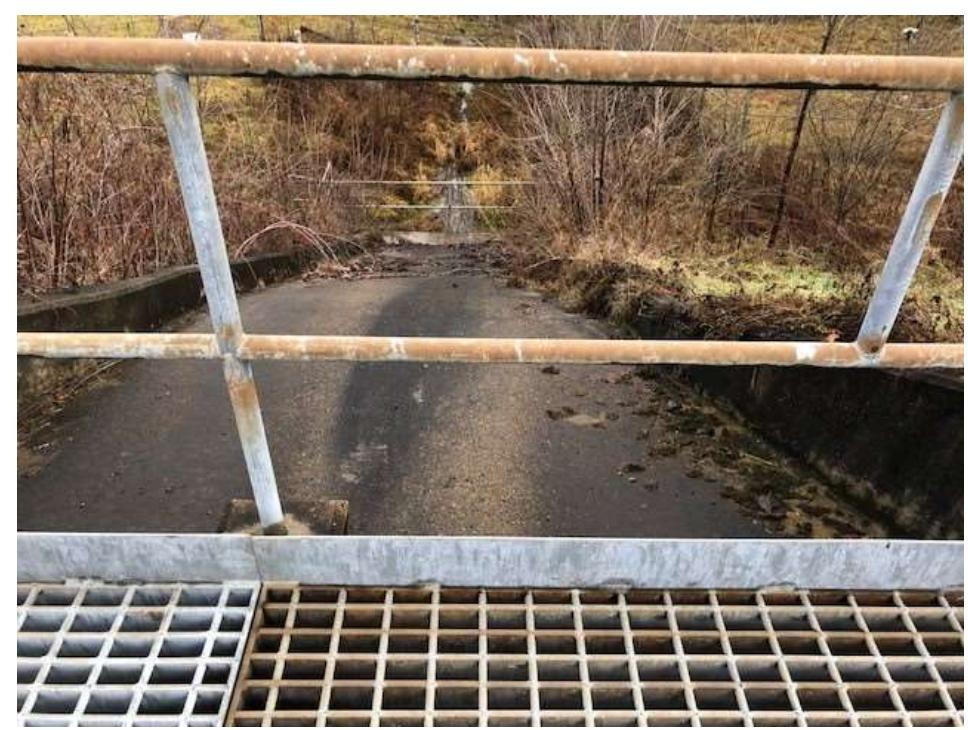
Photograph 20: View of Sedimentation Pond emergency spillway outlet.

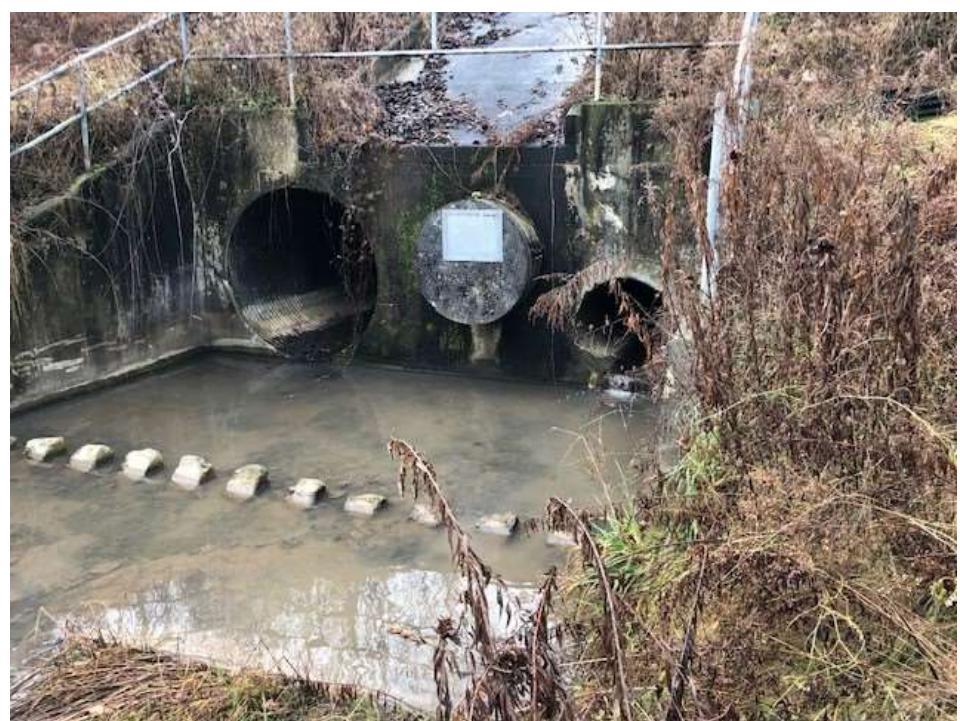
Photograph 21: View of Sedimentation Pond emergency spillway outlet, non-contact stormwater outlet pipes, and capped contact stormwater (leachate) pipe. Contact stormwater drains to pump station.

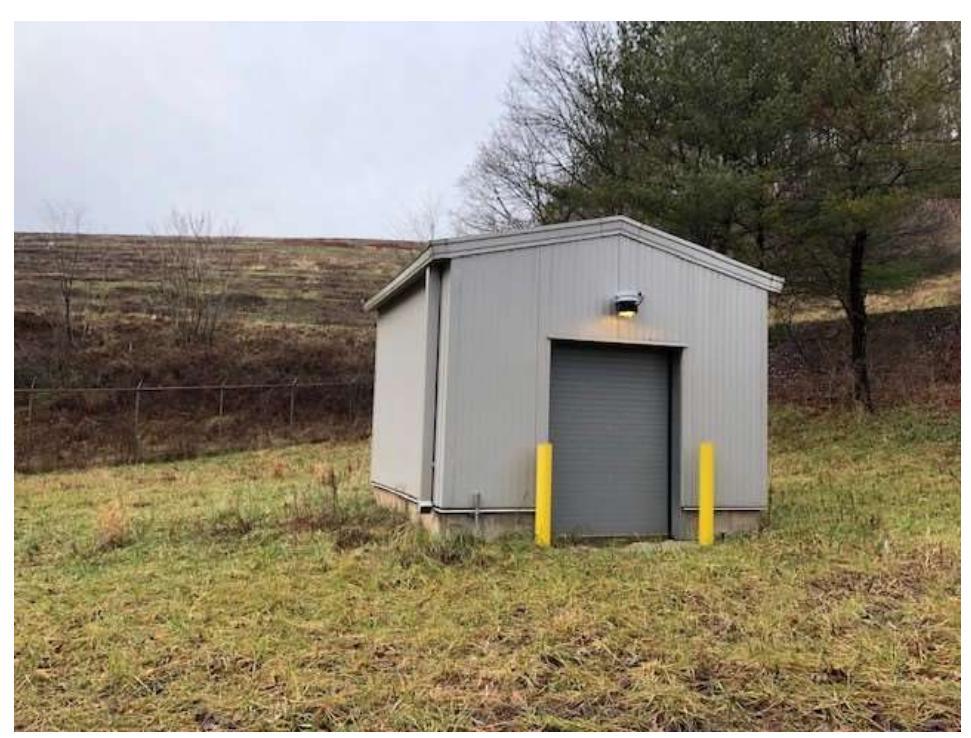
Photograph 22: View of leachate pump station.
